Monitoring of a historic sacral building on an example Basilica St. Nicholas in Gdańsk

Abstract

The paper describes the case of monitoring the technical condition of a historic sacral building after a failure and during renovation works. In order to monitor the condition of the building, safely conduct diagnostic work, identify the causes of failures and safely carry out renovation works, a detailed Facility Monitoring Program has been developed, which has been implemented, is operational and is a source of valuable data used to assess the current condition of the facility.

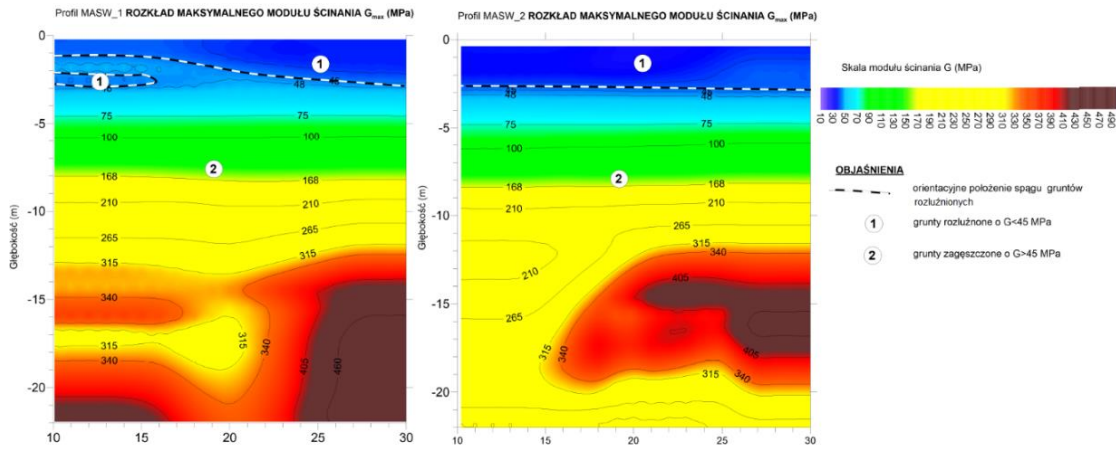
Basic and extended geotechnical surveys of the ground under the building and in its immediate vicinity were also performed. Basic research included geotechnical drilling and probing [33]–[36] and installation of piezometers, advanced geophysical methods were used for extended research: electroresistance tomography (ERT) [37]–[39], georadar (GRP) [40]–[43] and multi-channel surface wave analysis (MASW) [44]–[45]. Selected results of the above-mentioned studies are presented in Fig. 4, Fig. 5 and Fig. 6, as well as described in [24]–[25], [31], [46]–[49].

Fig. 6. Distributions of the G_{max} shear modulus values in the axes of the southern aisle (left figure) and the northern aisle (right figure) of the Basilica of St. St. Mikołaja in Gdańsk based on measurements using multi-channel surface wave analysis (MASW) [31]

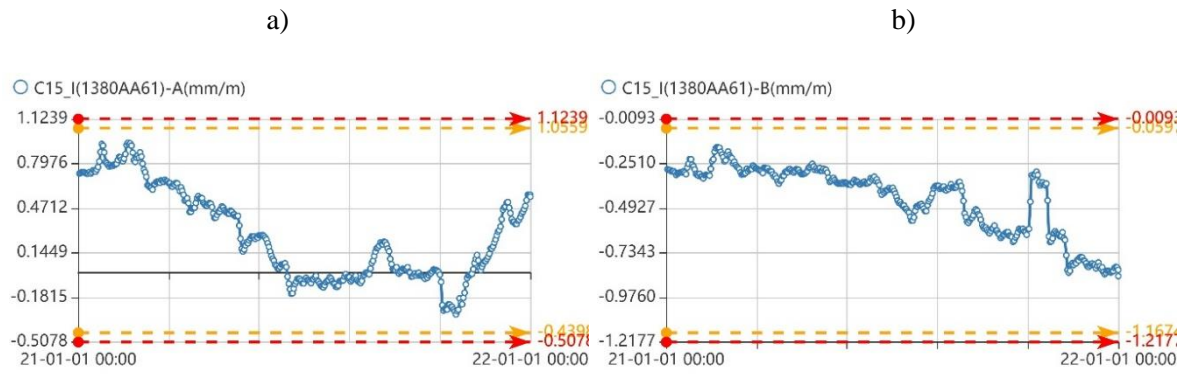
A cracked inter-column arch is based on the F2 and F3 pillars, Fig. 9, Fig. 10 and Fig. 11 show the results of inclination measurements of three selected pillars, F1, F2 and F3, respectively. Fig. 12 shows changes in vertical displacements (settlements) of piers F1 (a) and F2 (b) recorded in 2021. by distance sensors D17_I and D18_I. The charts show changes in the trend of recorded values caused by an increase in the load from the weight of the concrete ribs and the shell reinforcing the arches.

Fig. 11. Inclination of the pillar F3 of the southern aisle in the direction of axis A (a) and axis B (b): readings of the C15_I sensor in the period 01.01÷31.12.2021

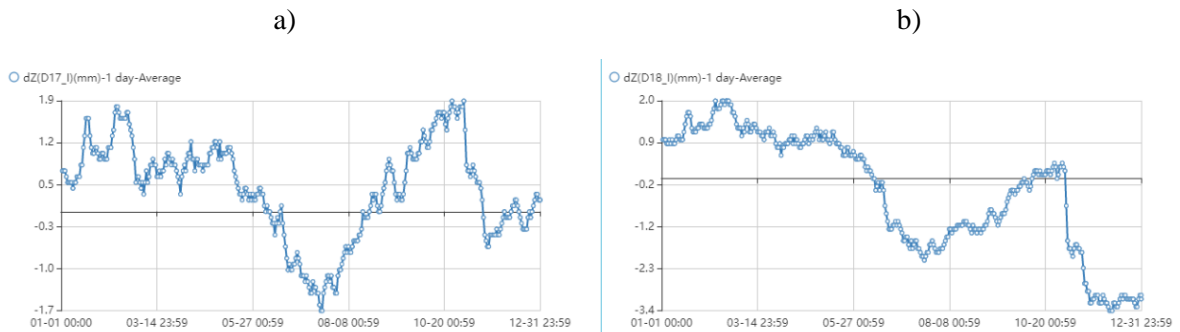
Fig. 12. Vertical displacement of the pillars of the southern aisle based on readings from distance sensors: a) C17_I (F1) and b) C18_I (F2) in the period 01.01÷31.12.2021
