## METHODOLOGY FOR THE REPAIR OF DENSO COMMON RAIL SOLENOID INJECTORS

*This paper presents the problems of Denso Common Rail solenoid injector verification and repair. Due to conscious policy of the manufacturer who does not offer spare parts or special tooling, their servicing comes down most frequently to external cleaning, internal rinsing by the thermo-chemical method, and testing on test benches. Based on the analysis of failures and malfunctions being most frequently observed, own methodology for the repair process have been presented, specifying the successive stages of disassembly and final assembly. A possibility of effective fuel metering correction has been demonstrated, which is presented on the example of injectors in a 2.2 HDI engine of Citroën Jumper II delivery van.*

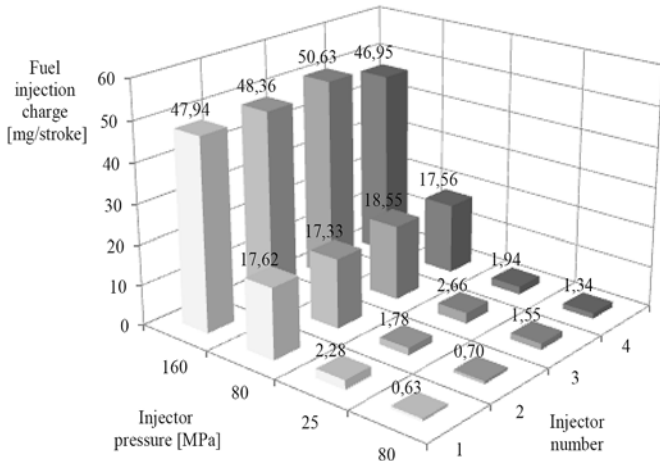
The analysis of fuel delivery rate in the „iVM” test showed that idle run fuel charges for injector 2 and 4 were too small, amounting to 1.78 mg/stroke and 1.94 mg/stroke, respectively. The results pointed to the worsening of the needle and nozzle assembly co-operation, which became apparent only when setting low pressure on a tester. Malfunction of this type is one of the most frequently detectable defects, being also encountered in the products of other manufacturers, but it is usually observed in the injectors of engines with a relatively low operational mileage. In such cases, a change in the initial stress of lower spring is required, which reduces the lift of needle at low pressure and in consequence the charge of injected fuel. The correction of fuel charge is conducted by reducing needle washer thickness.

Fig. 4. Results for injected fuel delivery rate according to injection pressure obtained from the initial test for the injectors being analysed

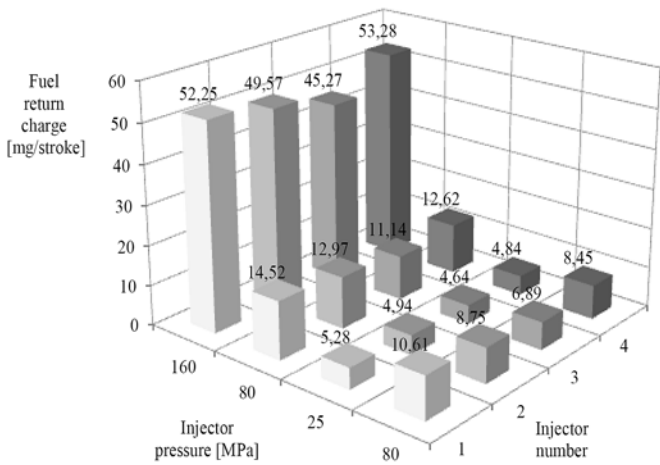
Fig. 5. Results for fuel return charge according to injection pressure obtained from the initial test for the injectors being analysed

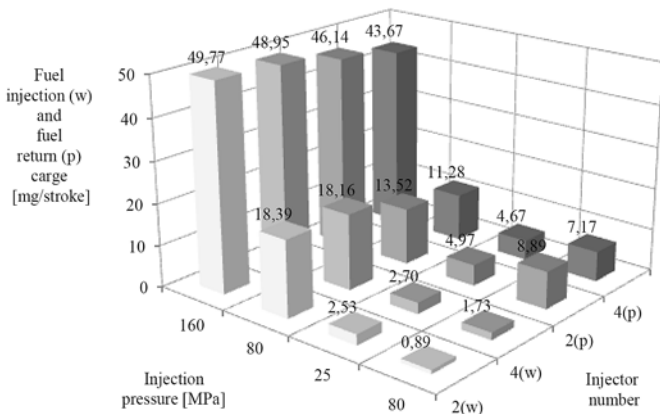
The findings of main tests show that adjustment of the injectors being repaired produced advantageous results (Figs 6 and 7). An increase in idle run fuel charges by a predicted value of 0.75 and

Fig. 6. Results for fuel injection and fuel return charge according to injection pressure obtained from the initial test for the analysed injectors after repair

0.76 mg/stroke. This means an improvement in the co-operation of needle and nozzle assemblies because needles in both products stopped to be blocked when setting low pressure. As a result, more fuel will go to given cylinders of the drive unit, while the rotational speed will not be lowered.

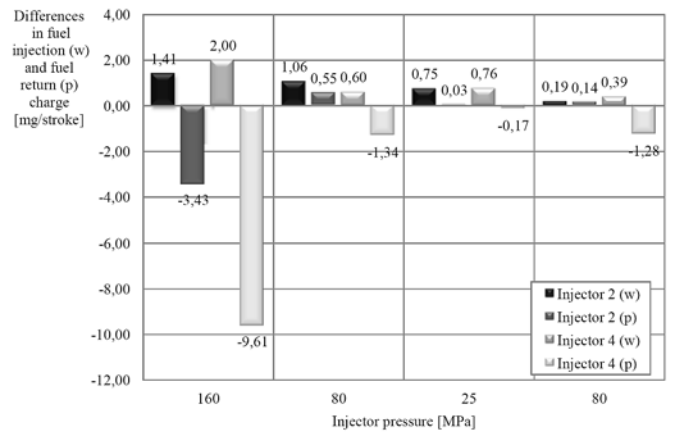
Fig. 7. Differences in fuel injection and fuel return charge according to injection pressure in the injectors being repaired

An intermediate effect on other fuel delivery rates was observed, in particular reduction of the fuel amount on most overflows. In injector 2, this effect occurred only with the full load, while for other fuel charges (emission, idle run and pilot fuel charges) the increase was negligibly small. In this respect, the repair process should be also positively assessed because excessive amount of fuel on the return might manifest in difficulties in starting the engine, its spontaneous stoppage, and observable loss of power at different load ranges. In the products being analysed, these problems should not be found. The test results being obtained on test benches and the verification of parts, in which other causes were excluded, e.g. damages to valve unit, loss of internal leak-tightness, nozzle hole plugging, is evidence of this.

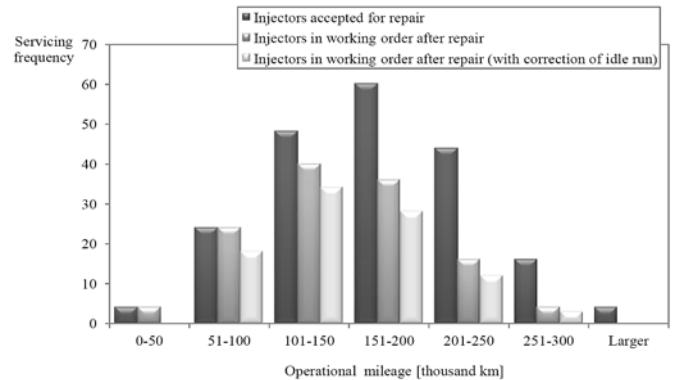
Fig. 8. Histogram of Denso solenoid injector repairs

Figure 8 presents the histogram of Denso solenoid injector repairs in VASCO Co. Ltd which were performed in the time period of October 2012 – February 2013. The data referring to the products being acknowledged operational represent the unimodal distribution, being characterised by a moderate right-side asymmetry. The obtained results indicate a high efficiency of this process with mileage to 200 thousand km but in most cases a correction of idle run fuel charge was necessary. Considerably less observations are grouped within the ranges being found at the end of the series. This is because the repairs become groundless with no spare parts, while the cleaning itself and adjustment brought selective benefits only. As a consequence, it was decided to limit acceptance of the injectors from motor-car engines with high operational mileage for repair.
