IMPACT LOADS AND CRASH SAFETY OF THE COCKPIT OF A COMPOSITE GLIDER

Łukasz Lindstedt • ORCID 0000-0001-9481-4694,
Mirosław Rodzewicz • ORCID 0000-0003-1424-8624,
Cezary Rzymkowski • ORCID 0000-0003-1131-8113,
Krzysztof Kędzior • ORCID 0000-0002-0411-9039.

Warsaw University of Technology, Institute of Aeronautics and Applied Mechanics
plac Politechniki 1, 00-661 Warsaw, Poland

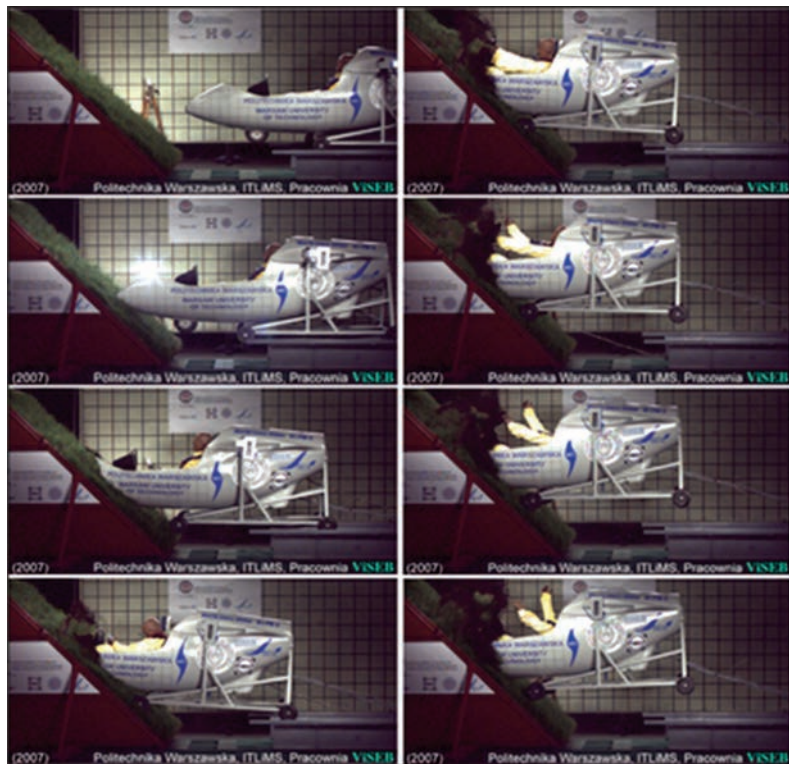
Figure 7. Selected movie frames illustrating the course of Test 1 ($\Delta t = 50$ ms)

In the course of the test, it turned out that the soil covered with grass was quite soft. As a result, the glider moved quite gently and the fuselage nose softly penetrated the ground (because such deep penetration is not observed during real impacts on grass airfields, the problem should be thoroughly investigated to find appropriate surface models, satisfying, for example the AVSCOM recommendation $CBR=25$ [2], before similar tests are performed in the future). As a result, the loads acting upon the pilot as well as on the structure of the cockpit turned out to be relatively low, and the fuselage experienced only some non-critical damages in its front part. However, the analysis of the records from the high-speed cameras showed that there were some other potential hazards, e.g. a serious risk of the pilot being injured after his head and arms hitting against the canopy.

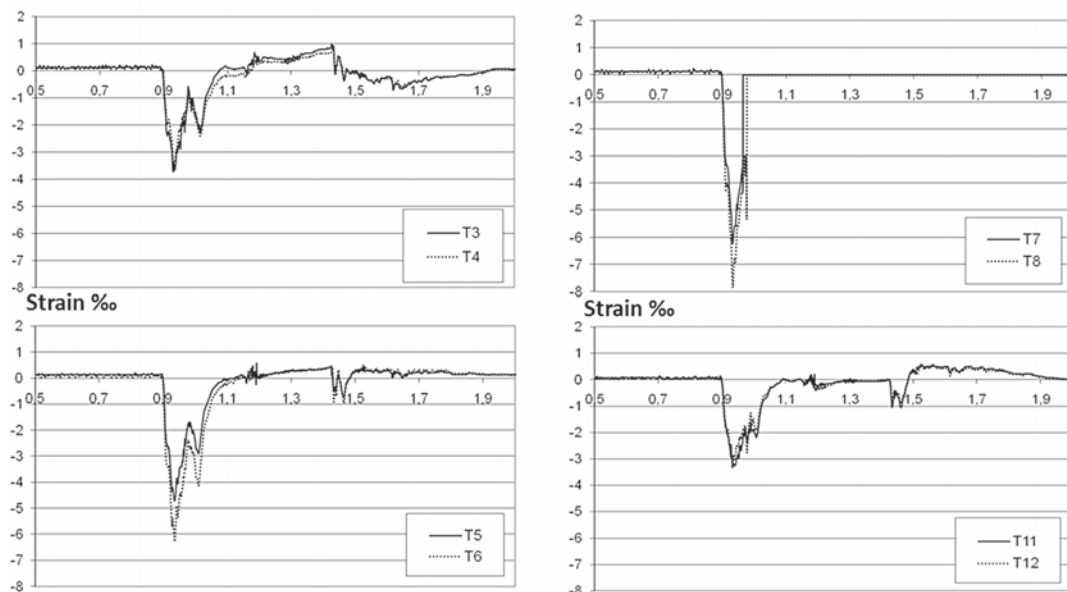
- maximum acceleration of the glider mass center: 21.4g in the moving direction and 12.5g in the vertical direction,
- maximum accelerations under the pilot seat: 23g and 15g, respectively,
- deformations observed on the cockpit side at two points slightly exceeded 6‰ (operational limit) and at one point reached 8‰ (close to strength limit).

Figure 8 shows the time history of the strain at the cockpit sill point subjected to the highest load.

Figure 8. The time course of the strain in the cockpit still points (ref. to Fig. 4)

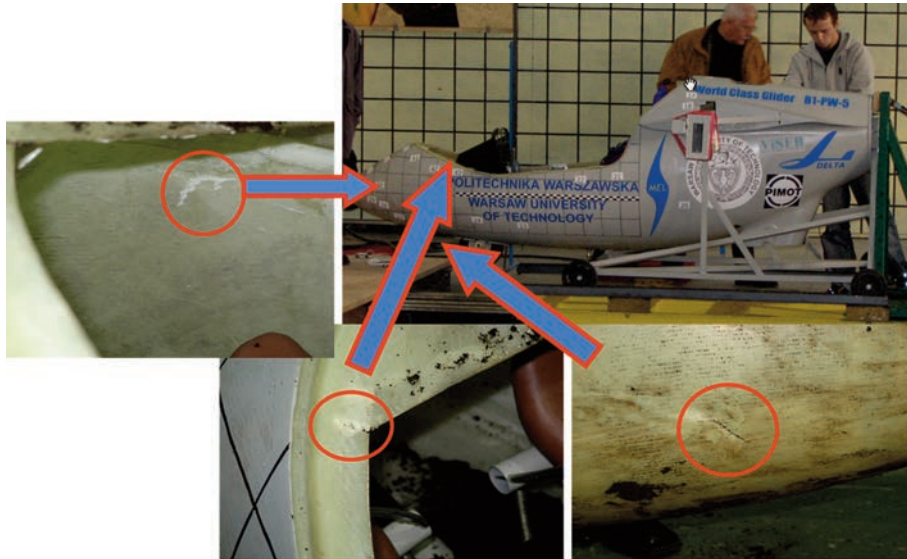
There was no serious damage observed. Nevertheless, at a few points, small cracks appeared (see Fig. 9).

Figure 9. Location of small damage of the fuselage composite shell obtained during Test 1

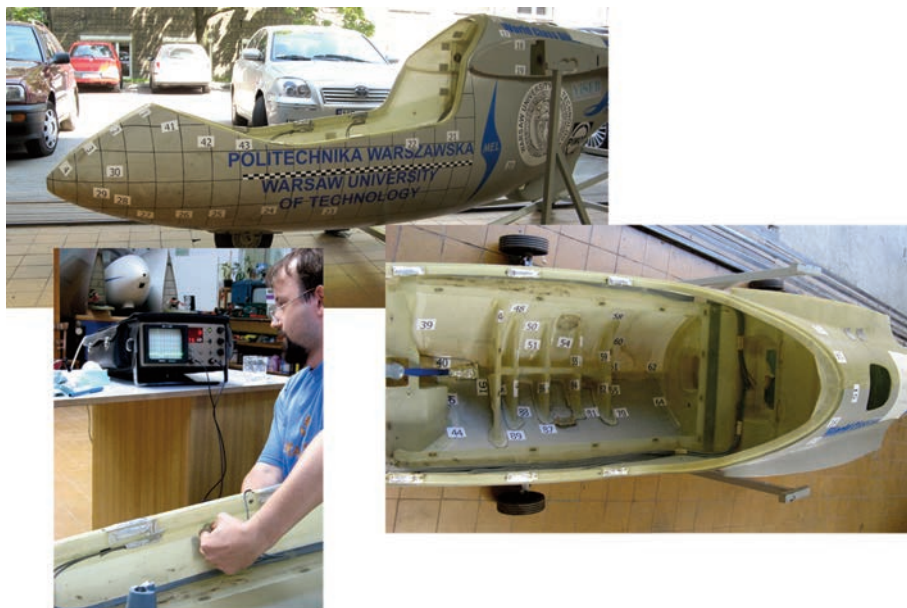
After cleaning the glider cockpit of soil and dust, the structure was examined using the ultrasonic method. The main aim of the examination was to check all places and points on the surface which could not be examined by a simple visual assessment but could have been damaged (e.g. thick layers of glued joints). The simplified ultrasonic method was used (Fig. 10). Based on expert opinions, about 100 points were selected for close examination.

Figure 10. Examination of the fuselage structure after the Test 1

In the course of the examination, no serious faults were observed. This means that the cockpit structure at selected points withstood the imposed loads.

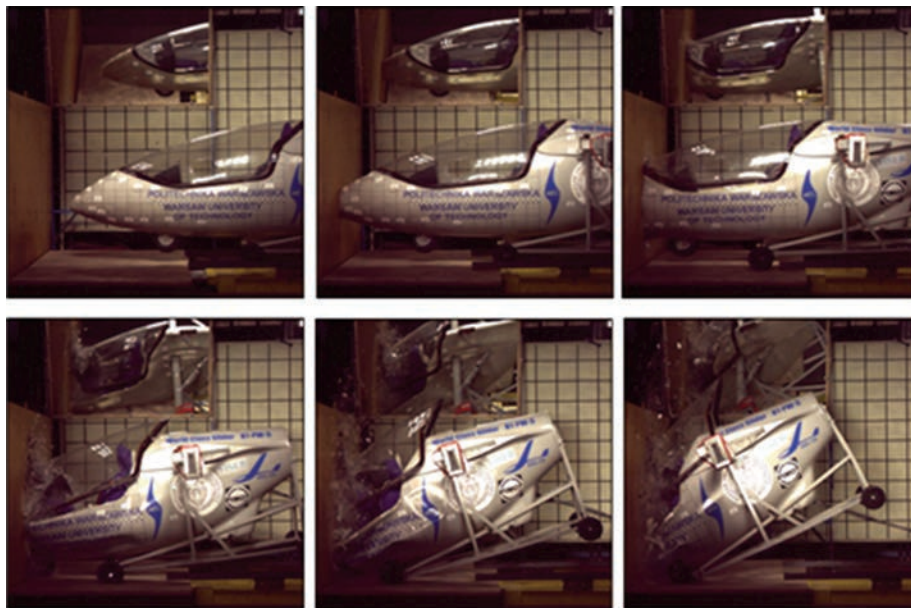
In the course of the test, one can distinguish two stages. The first stage is the time between the moment when the glider hits the rigid wall barrier ($t = 0.067\text{s}$ after starting the registration) and the time when the cockpit starts to rotate ($t = 0.095\text{s}$). During this phase of the crash, one can observe the rapidly increasing structure deformation leading to damage of the frontal part of the cockpit. The structure was heavily damaged. From the experiment's point of view, this 30ms is decisive. After this time (the motion of the failed structure), the registration of deformations and accelerations has no practical meaning considering the later validation problems and safety issues.

Figure 12. Selected movie frames illustrating the course of Test 2 ($\Delta t = 10\text{ ms}$)

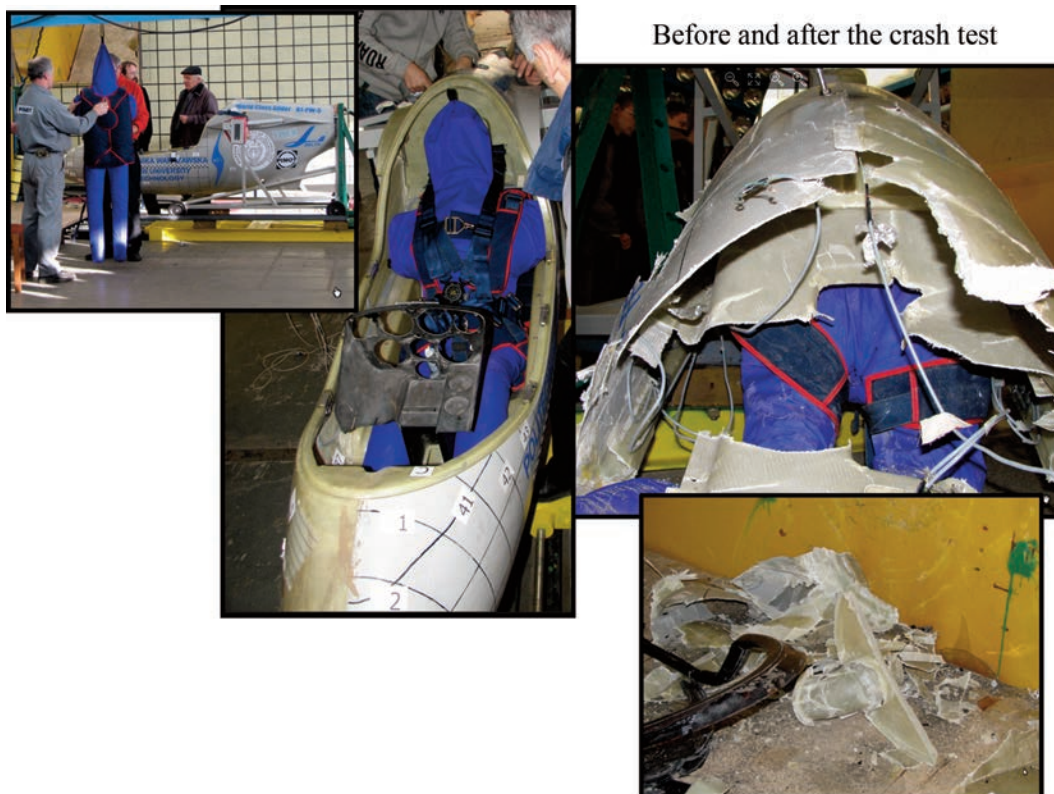
- maximum acceleration under the pilot seat: 53.8g in the moving direction and 93.6g in the vertical direction, deformations observed on the cockpit at the majority of points exceeded 20 ‰ (registration limit) and the cockpit was heavily damaged,
- in the course of the examinations, complete damage of the nose cone, cockpit sill and frontal part of the fuselage were observed. This means that the structure of the cockpit failed under the loads imposed.

As for this ultimate test a simplified manikin without any sensors was used – no signal was recorded. The manikin was completely destroyed, which means that for a real human being this would be an accident leading to death.

Figure 13. View of the fuselage and manikin before and after Test 2
