DEGRADATION OF THE CONCRETE RAILWAY TRACK BED LOCATED IN THE VICINITY OF THE LOADING WHARF

Maciej Niedostatkiewicz

Gdańsk University of Technology, Faculty of Civil and Environmental Engineering, Poland

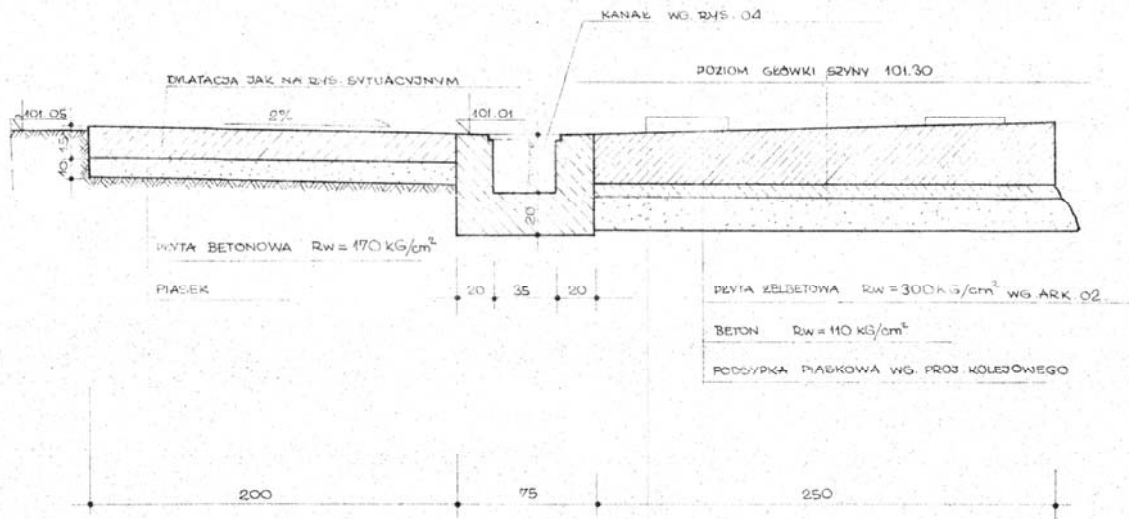
PRZEKRÓJ POPRZECZNY UTWARDZENIA
1: 20

Fig. 1. The design solution of the concrete railway subgrade-cross-section (based on archival project documentation)

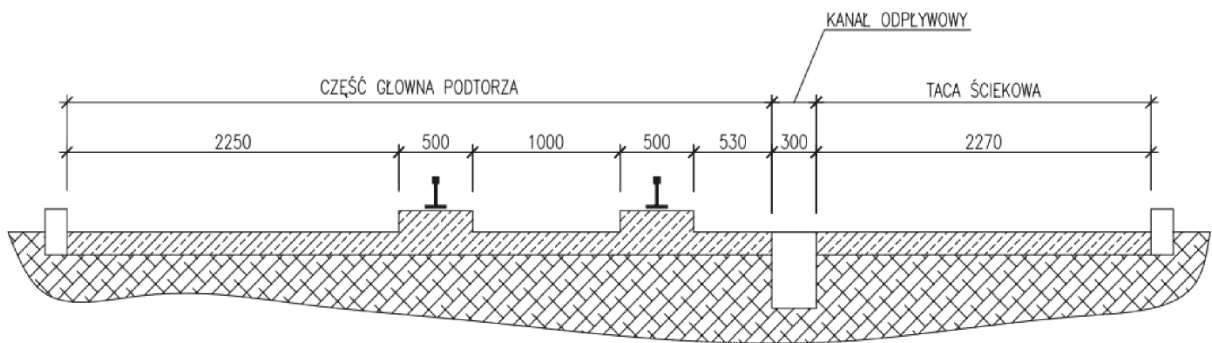
Fig. 2. Diagram of the concrete structure of the railway subgrade-stocktaking

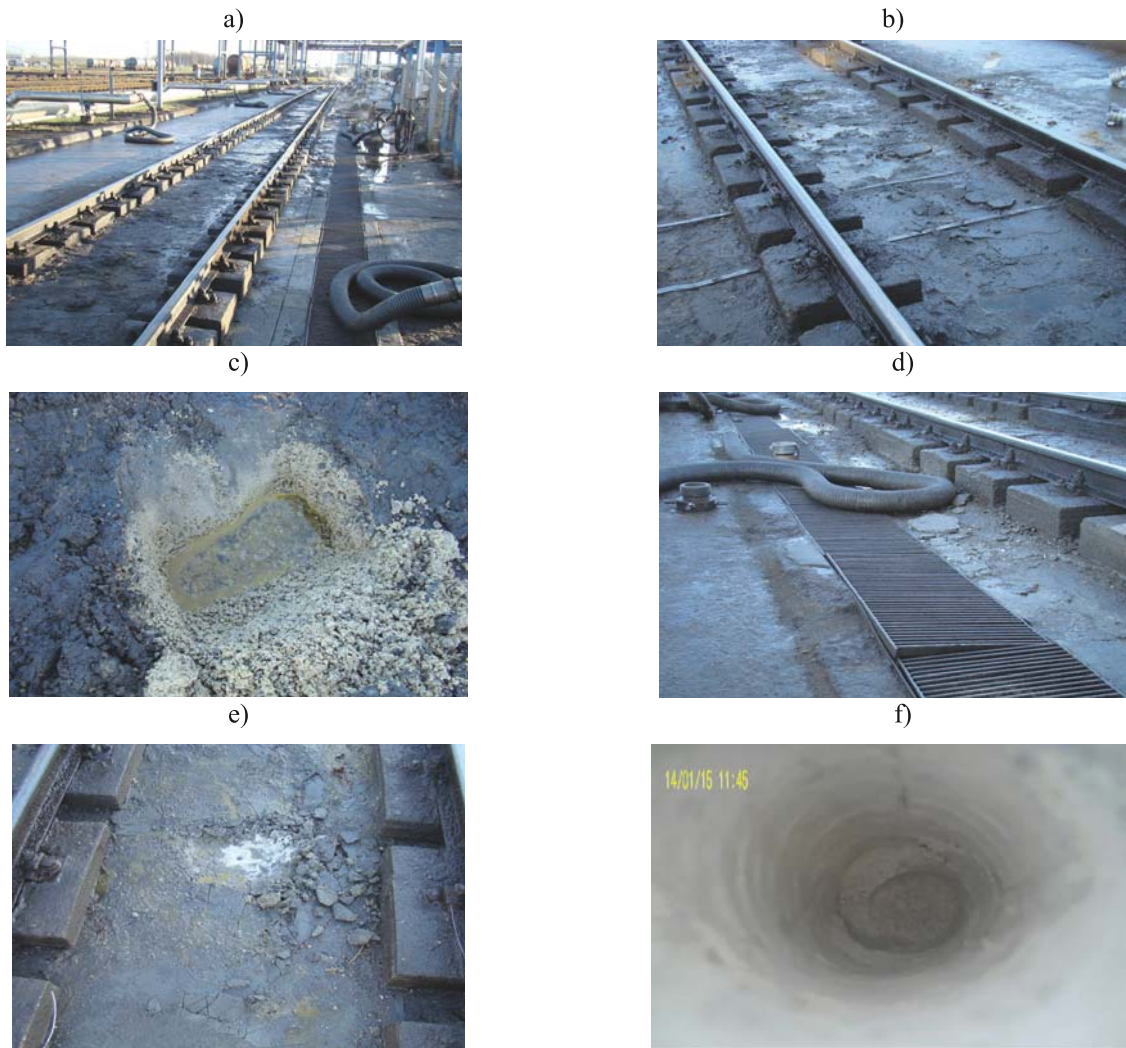
The most intense damage occurred at the length of the middle part of the track bed with a length of about 40 m. In this part the most damaged element was the middle section of the plate located between the rail heads (Fig.3a and Fig.3b). In the main part of the track bed the following damage to the upper surface of the board was found: separation of the PCC layer from the cracking ground, scratches and oil saturation of the concrete slab and PCC. Made in the past (~ 2 years ago), the layer was intensely fractured and carried traces of freezing (frosty scratches). Open pits ascertained that oil-based liquids gathered (by inflowing) from the sub-surface of the subgrade due to unloading of railway tanks (Fig. 3c). The depth of damage to the concrete layer was up to 6 cm, and structural reinforcement bars were visible. The drainage channel located along the road, located between the main part of the track bed and the drainage tray (Fig.2) was

deformed in an intensive manner. The concrete had extensive damage along drainage grates - a sectional drainage channel was replaced ~ 2 years ago as part of the works related to the reprofiling of the substrate. Despite the application of systemic repair solutions (built-in reinforced concrete, prefabricated elements of linear drainage) along the channel, the joints of the channel profiles were found to be broken and the surface layer of the concrete damaged (Fig.3d).

Fig. 3. Track with track bed: a) general view, b) damage to the main part of the track bed, c) open pit in the middle of the track between the rails, d) damage to the drainage channel, e) open pit - control hole, f) the interior of the control hole

In the described case of a concrete railway subgrade, soil saturation with petroleum products was found, based on the conducted ground tests. The soil did not soften despite the contamination. The homogeneity of concrete in the made-out pits was sufficient for surface repairs - the concrete had a compact structure [2], [5]-[6]. Also on the concrete surface, after removing the damaged PCC trip layer, no crayfish or caverns were found (Fig.3e and Fig.3f). The maximum depth of damaged concrete was 6 cm.

The direct cause of damage to the concrete substructure structure, including the PCC repair mortar layer, was the poor quality of the works performed and the use of materials not intended for use in the aggressive operating environment (with agents negatively affecting the concrete). The repair materials used did not provide the designed durability and resistance of the concrete railway sub-floor.

Due to the range of damages, renovation works had to be carried out in the STAGE system.

STAGE 1 (for urgent implementation) included:

I) ad hoc removal of loose fragments of the PCC and concrete,

II) initial geodetic surveying of rectilinearity and inclination of the track rails as well as running control measurements of the subgrade at regular intervals. It was recommended to perform geodetic measurements at intervals of 4 weeks in winter and at intervals of 2 weeks in the spring and summer. During the measurements, particular attention should be paid to the measurement of linearity, verticality and inclination of the heads of the rails with respect to each other,

III) sub-division of the subgrade to working plots and execution of works including:

- a) pressure washing with water and detergents,
- b) priming washed concrete surface: for matt-damp concrete applying a protective layer of epoxy resin for oily floors and sprinkling it with quartz sand (annealed with fire),
- c) making buffer layer of epoxy resin and sprinkling it with quartz sand,
- d) reprofiling the upper surface a mortar based on epoxy resin mixed with quartz aggregate,
- e) applying a support layer of resin resistant to petroleum products.

At the same time, work related to the repair of dilatation had to be carried out in parallel with the work related to the construction of the strain, buffer and putty layers.

STAGE 2 (for the final implementation during the overhaul) included reconstruction of the main part of the track bed and the sewage tray based on systemic prefabricates made of polymer concrete resistant to oil-based liquids - in the newly designed subgrade layer system horizontal damp insulation was to be designed, also fulfilling the role of anti-oil insulation laid on the foundation layer of lean concrete B15 (C12 / 15). As insulation material, it has been recommended to use, for example, oil and bitumen protective foil with a minimum thickness of 2 mm..

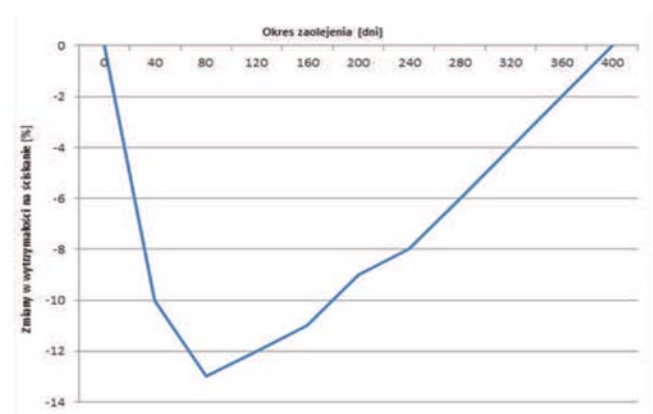
In oily concrete, bacteria (aerobic and anaerobic) develop in the presence of water, while organic acids, hydrogen sulphide are produced and the pH of the water decreases. In oiled concrete durability decreases compared to the condition before oil formation - there is the phenomenon called concrete softening, and the long-term impact of organic acids results in a decrease in the mass of concrete, as a result of the dissolution of the cement binder and increase in its porosity. As a result of the dissolution of the binder, the durability of the concrete decreases significantly. The drop in concrete strength depends on the type of oil and the time of exposure of the concrete to oiling [3-4] (Fig.4).

Fig. 4. Change in compressive strength of concrete (vertical axis-%) contaminated with diesel oil versus (horizontal axis-time (days)) (Błaszczczyński 1995)
