PANSI XIE^{*,**}, YONGPING WU^{*,**}**DEFORMATION AND FAILURE MECHANISMS AND SUPPORT STRUCTURE TECHNOLOGIES FOR GOAF-SIDE ENTRIES IN STEEP MULTIPLE SEAM MINING DISTURBANCES****MECHANIZMY POWSTAWANIA ODKSZTAŁCEN I PEKANIA ORAZ TECHNOLOGIE WZMACNIANIA I ZABEZPIECZANIA ŚCIAN CHODNIKÓW W WYROBISKACH NACHYLONYCH**

Entries in steeply pitching seams have a more complex stress environment than those in flat seams. This study targets techniques for maintaining the surrounding rock mass stability of entries in steep seams through a case study of a steep-seam entry at a mine in southern China. An in-depth study of the deformation and instability mechanisms of the entry is conducted, employing field measurement, physical simulation experiment, numerical simulation, and theoretical analysis. The study results show that the surrounding rock mass of the entry is characterised by asymmetrical stress distribution, deformation, and failure. Specifically, 1) the entry deformation is characterised by a pattern of floor heaving and roof subsidence; 2) broken rock zones in the two entry walls are larger than those in the roof and floor, and the broken rock zone in the seam-floor side wall is larger tha

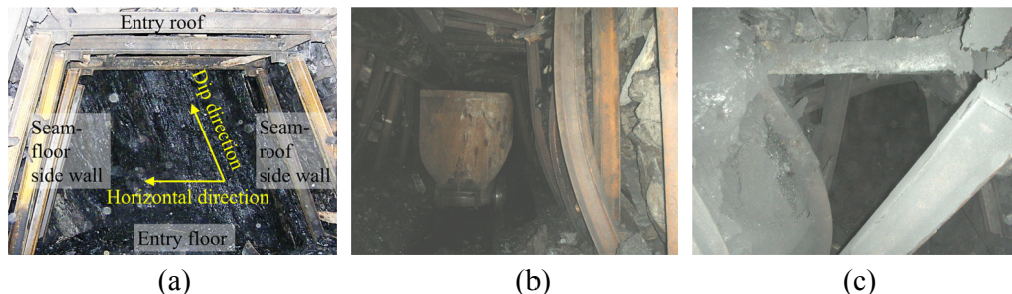
As shown in Fig. 2b, the entry of panel No. 3964 was severely deformed during entry driving and panel production. As observed on-site, the deformation began at the floor, manifesting as floor heaving, then induced wall-feet instability, and finally caused roof subsidence; the I-beam feet of the shed support at the seam-floor side was severely bent, twisted, and deeply penetrating the floor. The deformation was asymmetrical and characterised by floor heaving and roof subsidence, and the entry cross-sectional shape changed from a trapezoid to an irregular quadrangle. The local convergence in some areas of the roof was up to approximately 1 m when mining panel No. 3966, as shown in Fig. 2c. The deformed entry necessitated multiple and highly frequent repairs to maintain the minimum stability level; this incurred high maintenance costs and severely affected the normal production operations of the panel (Zhang, 2014).

Fig. 2. Deformation and failure characteristics of panel No. 3964 entry during different stages of mining operation: (a) Initial stage of entry driving, (b) mined-out panel No. 3964, and (c) mined-out panel No. 3966 (adjacent to No. 3964)

(1) The entry was special in terms of its half-coal-half-rock structure, complex stress distributions in the surrounding rock mass, and multiple mining disturbances. The entry deformation was characterised by an asymmetrical pattern. The floor heaved, and the roof subsided; as a result, the seam-floor side feet of the shed support structure were severely bent and twisted, and deeply penetrated the floor.

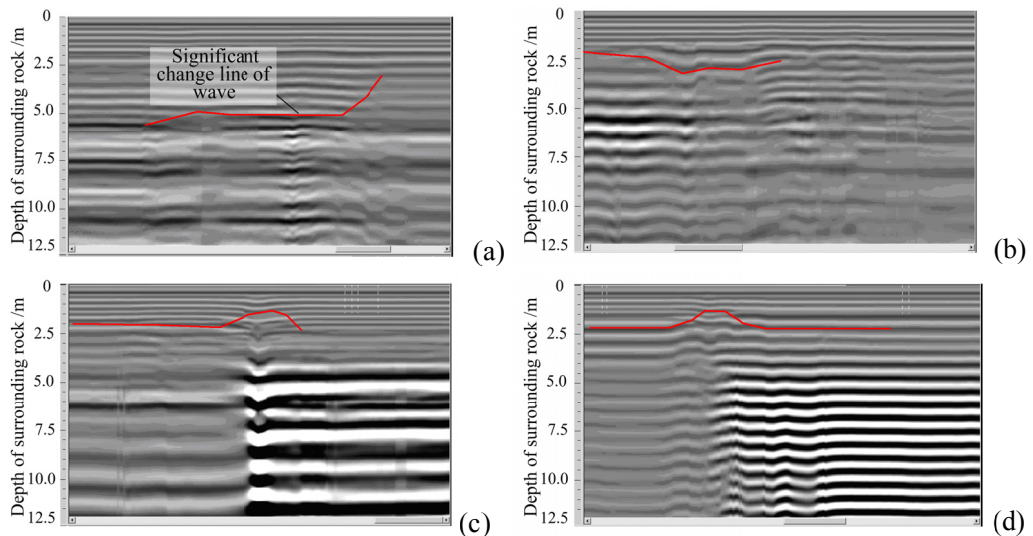
The resulting waveforms generated by the radar device were then analysed. A clear bend in the waveform indicates a broken rock zone in the surrounding rock mass, whereas an irregularity in the vertical waveform pattern indicates cracking or manifestation of a structural failure (Wang et al., 2013). Based on an on-site investigation and analysis of the obtained measurement data, the broken rock zones were found to differ at different measurement points and at different locations near the same measurement point. Fig. 3 shows the results obtained from measurement point No. 7, which is located 40 m away from the panel face. A clear bend at a depth of 5.2 m in the waveforms of the entry floor (Fig. 3a) is apparent, indicating a stable rock-broken rock interface in the surrounding rock mass. A bend at a depth of approximately 2.5 m is apparent in the waveforms obtained by each of the other three test leads (Figs. 3b-d).

Fig. 3. Waveforms obtained from measurement point No. 7 using ground-penetrating radar, for entry (a) floor, (b) seam-floor side wall, (c) roof, and (d) seam-roof side wall

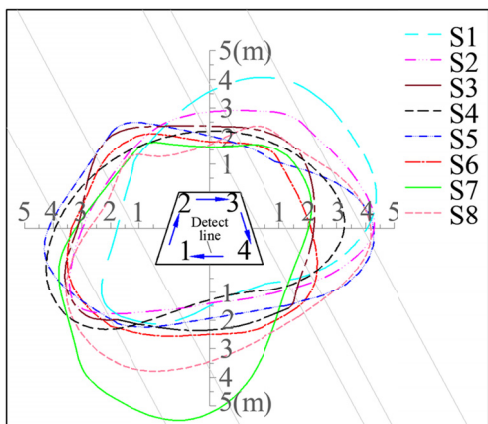
Based on the broken rock zones in the surrounding rock mass of panel No. 3964 entry identified through measurement, as well as the occurrence conditions and convergence of the surrounding rock mass observed on-site, the breaking characteristics of the surrounding rock mass were graphically represented as a broken contour, as shown in Fig. 4. This figure shows six broken rock zones greater than 4.0 m in size. The size of the broken-rock-zone showed ranges of 1.4-5.2 m in the entry floor (test lead No. 1), 1.8-4.5 m in the seam-floor side wall (test lead No. 2); 1.5-4.0 m in the roof (test lead No. 3), and 1.8-4.1 m in the seam-roof side wall (test lead No. 4). Generally, the broken contour of the surrounding rock mass is asymmetrical, with larger broken rock zones in the two entry walls than in the roof and floor, and a larger broken rock zone in the seam-floor side wall than in the seam-roof side wall. In addition, the broken rock zones identified through measurement are consistent with the convergence characteristics of the surrounding rock mass observed on-site. Based on the theory of broken rock zones in the surrounding rock proposed by Dong et al. (1994), the majority of the surrounding rock mass

can be classified as type-V unstable surrounding rock with a large broken rock zone. However, the surrounding rock near the seam-floor side wall can be classified as type-VI very unstable surrounding rock with a large broken rock zone. Based on the above classifications as well as the tested lithological properties of the surrounding rock mass (Table 1), the surrounding rock of the entry can be classified as fractured soft rock.

Fig. 4. Broken contour of surrounding-rocks

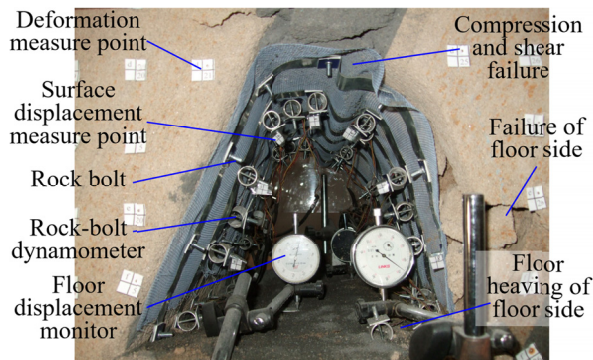
Vertical and lateral loads were simultaneously applied to the model. At 5-MPa pressure, the deformation rate of the surrounding rock began to increase, with relatively large deformation in the entry floor and seam-floor side wall. The deformation and failure of the surrounding rock that developed along the direction of the seam dip angle was monitored. At 15-MPa pressure, failure of the coal seam occurred in the entry roof and floor as well as in the seam-floor side wall; specifically, transpression failure occurred in the entry roof owing to slipping and squeezing of the rock strata on both sides, as well clear heaving in the seam-floor side of the floor, as shown in Fig. 7.

Fig. 7. Physical simulation experiment results of panel No. 3964 entry

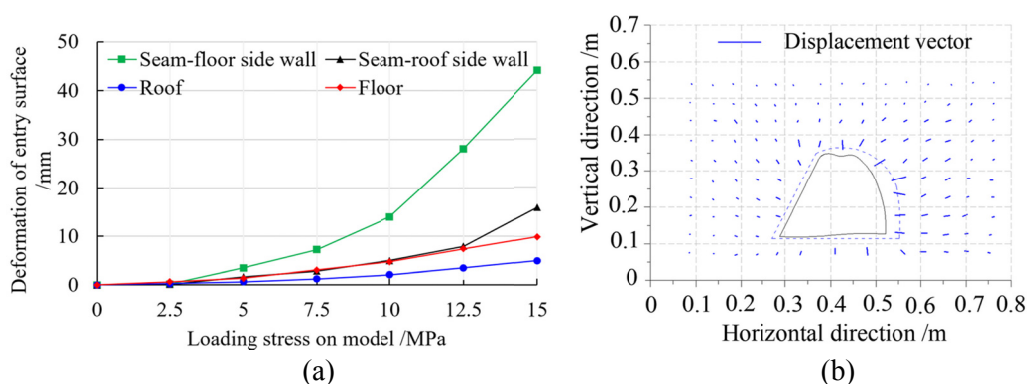
Throughout the experiment, the model was monitored for entry surface displacement using an optical total station and dial gauges. The entry surface displacement gradually increased with an increase in the confining pressure, as shown in Fig. 8a. The order of monitoring entry deformation rate and its magnitude was undertaken with respect to the seam as follows, from high to low: the seam-floor side wall, floor and seam-roof side wall, and roof. The maximum accumulative convergence in the roof and floor was 0.15 m and 0.6 m in the two entry walls. In addition, the monitored displacement of the surrounding rock exceeded 2 m, with the largest

displacement occurring for the seam-floor side wall, at 3-4 m (Fig. 8b). The rock displacement in the roof was approximately 2-3 m, which was basically consistent with the broken-rock-zone measurement results.

Fig. 8. Deformation and failure characteristics of entry surrounding rock mass: (a) Surface deformation and (b) displacement characteristics

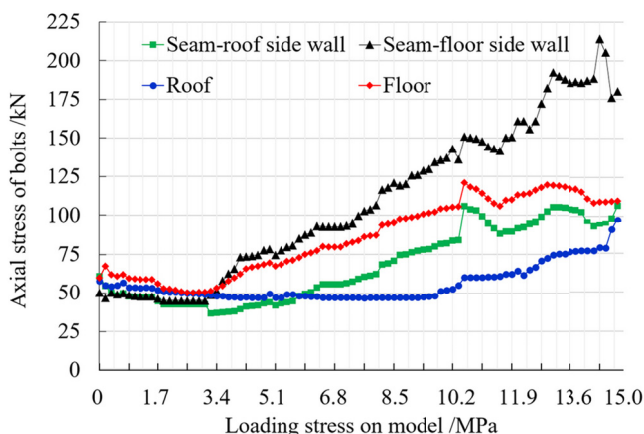
Throughout the physical simulation experiment, the stresses experienced by the rock bolts (initial force: 50 kN) were monitored using a load cell, as shown in Fig. 9. The monitored results indicate that the rock bolts located in different cross-sectional areas of the entry model experienced different stresses. The rock bolts in the seam-floor side wall experienced the greatest axial stress, with a maximum value of 213.4 kN, followed by the bolts in the floor, with a maximum value of 119.6 kN. The maximum axial stress experienced by the bolts in the seam-roof side wall was 105.0 kN. Finally, the bolts in the roof experienced the smallest axial stress, with a maximum value of 99.6 kN. The uneven stresses experienced by the bolting structure can be attributed to the uneven deformation distribution shown in Fig. 8a. The largest deformation occurred for the seam-floor side wall; thus, the rock bolts in that location experienced high tensile stress. The deformation

Fig. 9. Axial stress curves of rock bolts

of a similar magnitude occurred for the seam-floor side of the floor; thus, the rock bolts in that location also experienced high axial stress. The seam-roof side wall had high-strength surrounding rocks and good structural integrity, and it could buffer the stress; hence, smaller deformation occurred and the rock bolts in that location experienced relatively even load and small axial stress.

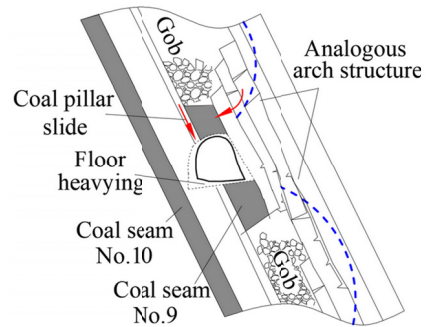
arches and the caved-in roof of the mined-out area constitutes the arch body (Shi, 1999). This was the fourth mining disturbance, which induced transpression and slipping of the entry roof and floor and finally caused the small coal body at the entry roof to break, as shown in Fig. 12.

Fig. 12. Arching effect on entry instability due to mining operations in downstream panel

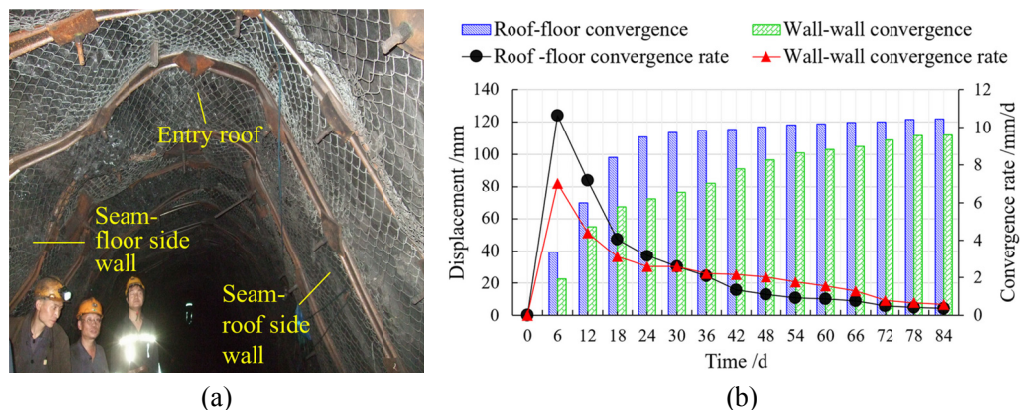
A field test of the improved support structure design for the entry was conducted, as shown in Fig. 13a. The monitored field results show that the entry remained stable, as demonstrated by the magnitude of the convergence of the two walls, roof, and floor measured on the 30th (experiencing the second mining disturbance) and 48th day (experiencing the third mining disturbance) after implementation. The maximum rib-rib and floor-roof convergences were 112 and 122 mm, respectively; the maximum convergence rates were 7.02 and 10.63 mm/d, respectively, and the minimum convergence rate was 0.35 mm/d, as shown in Fig. 13b. The deformation in the walls was clearly reduced, demonstrating a clear effect of the improved design, and the deformation in the roof and floor was also reduced to some degree, thereby providing a basic guarantee of entry stability. With the implemented rock bolt-wire mesh-anchor cable asymmetrical support system, the deformation rate was increased in the initial stage. When the upstream and downstream panels were being mined out, the rib-rib convergence rate gradually decreased and severe deformation of the surrounding rock was effectively curtailed. Therefore, repair was no longer needed to maintain the entry stability level during the multiple mining disturbances; furthermore, the maintenance cost of the entry was largely reduced, thereby ensuring that normal mining operations could be performed.

Fig. 13. (a) Improved support structure design for entry of panel No. 3964 and (b) monitored results of entry deformation after implementation of the improved design

Based on the above analysis of the entry instability mechanism under the impact of multiple disturbances, the root cause of the instability of the softrock gob-side entry is believed to be the asymmetrical load of the surrounding rock mass on the support structure. Therefore, it was necessary to fully utilise the support capacity of a rock bolt-wired mesh-anchor cable support structure in accordance with the uneven load distribution in the surrounding rock of the entry. This allowed a more even stress distribution in the surrounding rock mass, with more harmonious deformation of the support structure and surrounding rock mass. In addition, it ensured the stability of the latter. Considering the above, the following principles for controlling the stability of the surrounding rock mass of the entry were proposed: active support, additional reinforcement at critical points, and coupled support. Improvement of the existing support structure by an asymmetrical support structure design coupling high-strength rock bolts, long anchor cables, W-steel straps, and steel-bar meshes was proposed. The design parameters are detailed below.

(1) Rock bolts: spaced at 800 mm × 800 mm 12 bolts per grille (four in the roof, all perpendicular to the roof, three in each wall, with the middle bolt perpendicular to the wall; two on the seam-floor side of the floor). Material specifications: Φ20 mm × 2500 mm (2200 mm for the two bolts on the seam-floor side of the floor), high-strength screw-thread steel, left-turning thread, equal strength along the total length, initial compression exceeding 50 kN. Rock-bolt supporting plate: 200 mm × 200 mm × 20 mm (length × width × thickness). Each bolt grille was reinforced with three high-strength W-steel straps and joined with a lap length exceeding 200 mm.

(2) Anchor cables: material specifications: Φ17.8 mm × 7000 mm, twin wire, cage type; one in the middle of the roof; one in the middle of the seam-roof side wall; one each in the top, middle, and bottom of the seam-floor side wall; spaced 1000 mm × 3200 mm.

(3) Wire mesh: material specifications: #10 galvanised wire; dimensions: 2000 mm × 1000 mm for the two walls, 4100 mm × 1000 mm for the roof; mesh size: 80 mm × 80 mm; joined mesh-by-mesh with a lap length of 200 mm.
