REPAIR AND RENOVATION OF THE HISTORIC CHURCH IN RUDA ŚLĄSKA AFTER MANY FAILURES CAUSED BY MINING EXPLOITATION

Łukasz DROBIEC¹

Silesian University of Technology, Faculty of Civil Engineering, Gliwice, Poland

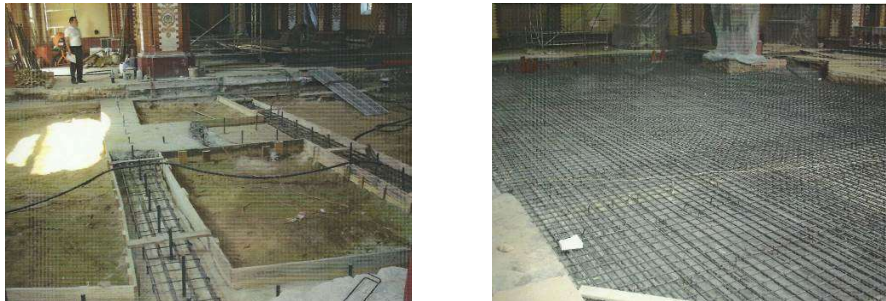
Fig. 5. Strengthening performed in the years 1986-1987: internal tie rods (left) and reinforcement of reinforced concrete slab (right)

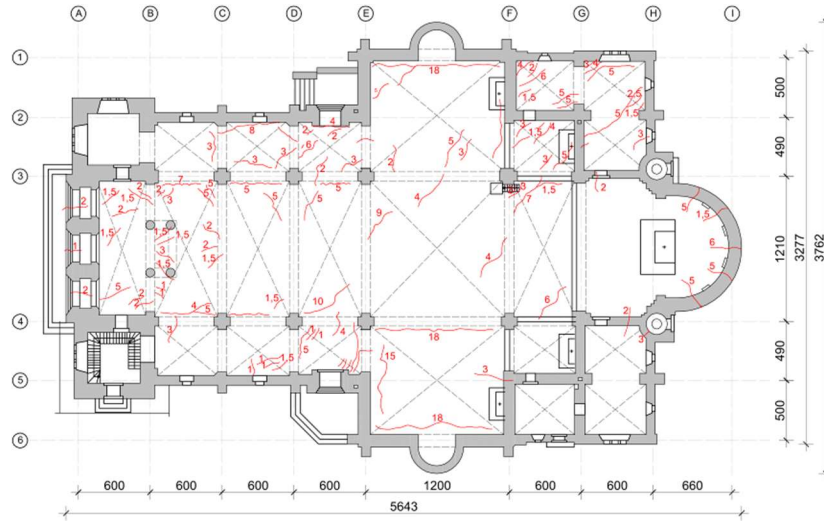
The repair works for new cracks and fractures developed in the walls and vaults of the church began in 2002. Their width was up to 18 mm. However, no cracks were observed in the towers. After injecting the cracks with epoxy resin, the church was plastered and painted wall decorations were restored. New damages were formed directly after finishing the works. At first, cracks were observed in the arches of the main wall. They were so big (with the width up to 20 mm – Fig. 6 and 7) that they posed a risk of falling out of the masonry units. Thus, it was recommended to wedge the arches and ribs of the vaults (Fig. 8 and 9) and to support them locally with arch centerings adjusted to their geometry.

Fig. 6. Cracks found in 2003

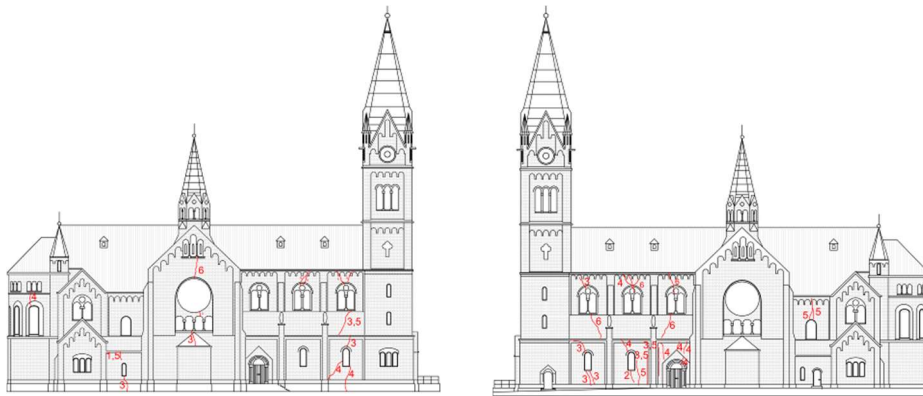
Fig. 7. Cracks of the elevation found in 2003

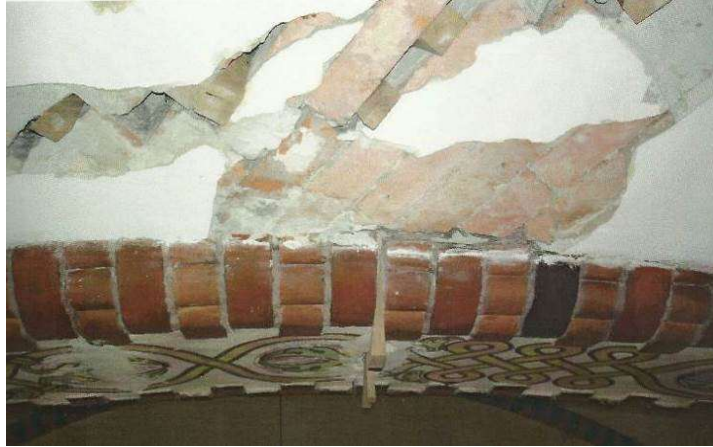
Fig. 8. Damage to the arch and wood wedges driven in the place of cracking (2003)

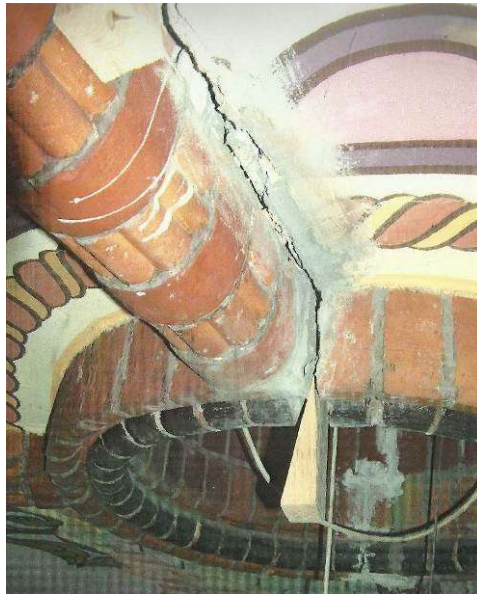
Fig. 9. Damaged area near the vault ribs and wood wedges driven in the place of cracking (2003)

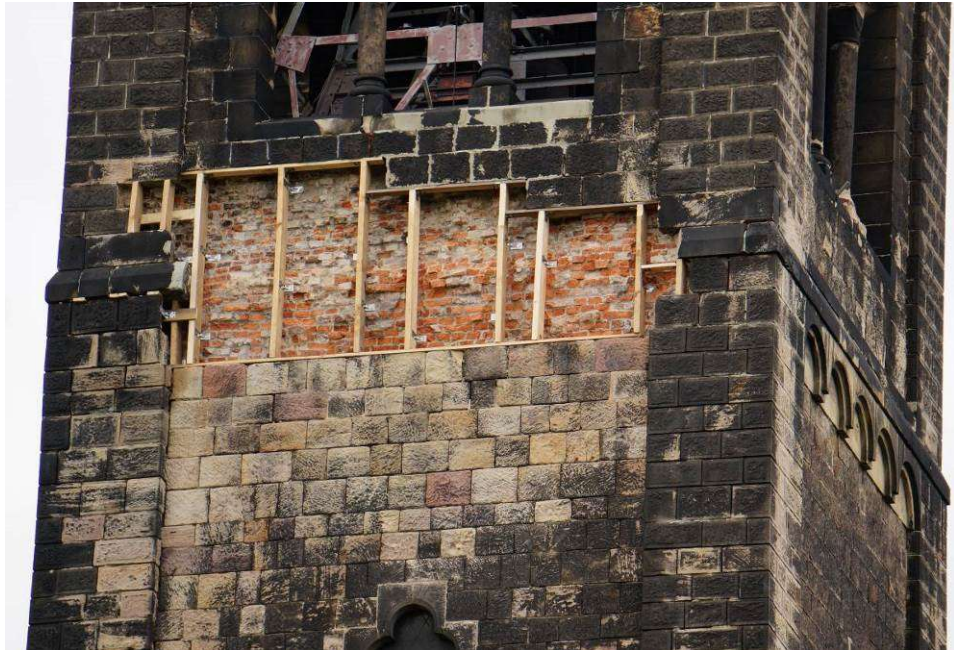
Fig. 13. Temporary protection of the debonding zone

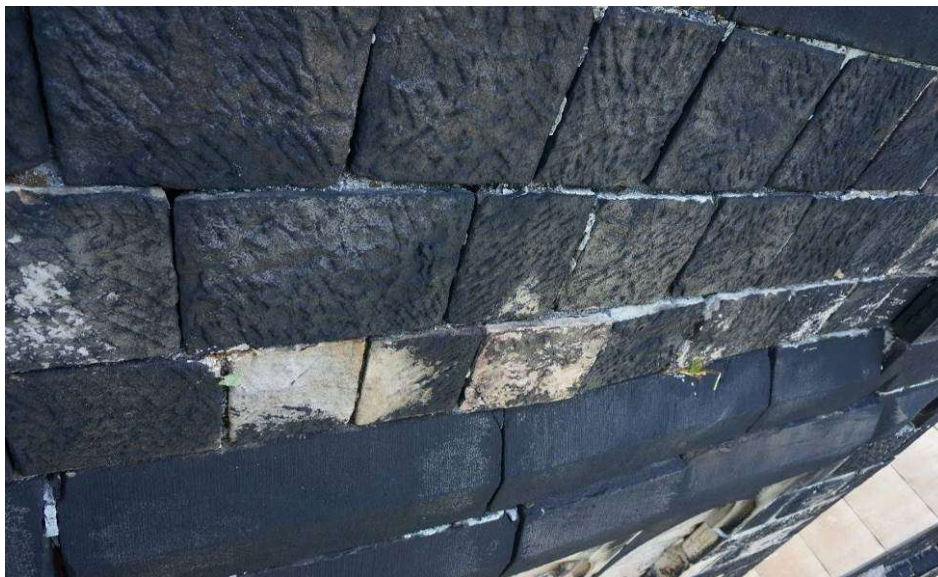
Insect nests were found in both towers, in the spandrel area, in the wall crevices. Bees nested were in the south tower, and wasps nested in the north tower. After the damage to the front wall, the fire service removed the loose masonry units and mortar from the debonding zone on 3 July, 2016. The area around both towers was fenced. The loose masonry units were removed, and temporary centering of the wall facing was performed where debonding was noticed (Fig. 13). The inspection of the second tower indicated significant debonding of the wall facing and high probability of the occurrence of the similar situation (Fig. 14).

Fig. 14. North tower. Loss in joints, cracks in stone works, bumps in masonry units and the cornice

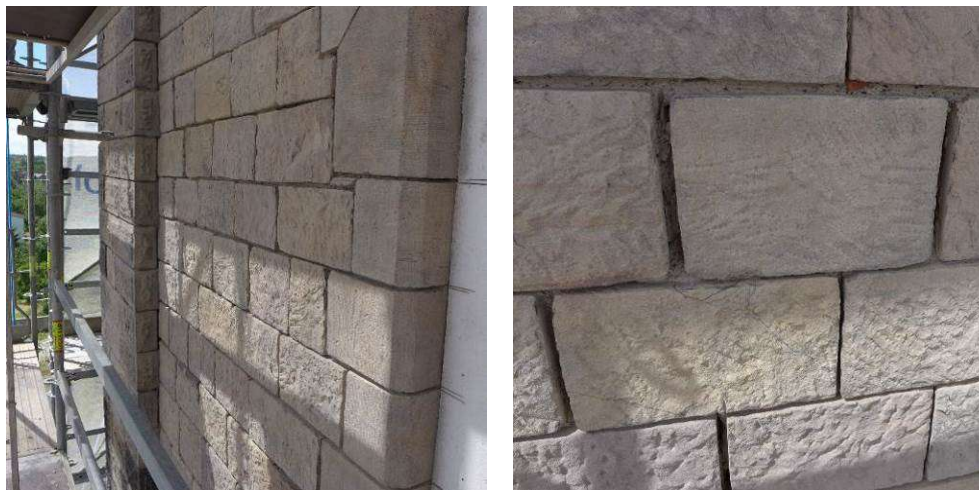
Fig. 17. Cleaned elevation and removed secondary pointing

- Removal of secondary pointing with cement mortar.
- Cleaning of the wall face. The wall was cleaned using the mixed method, that is, manual and blast cleaning.

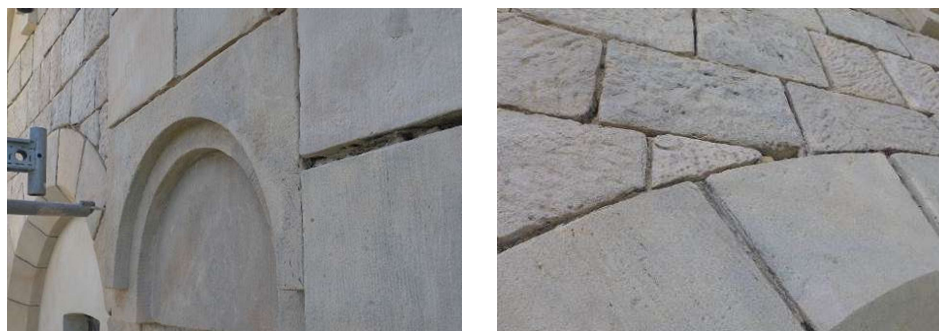
Fig. 18. Cleaned elevation and removed secondary pointing

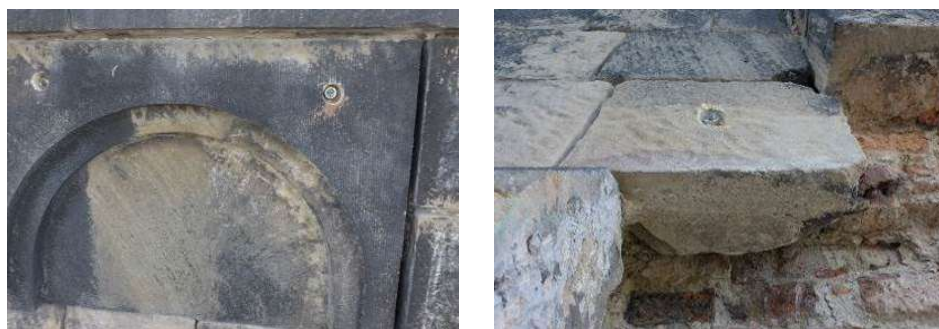
Fig. 19. Anchorage of loose elements

- Masonry anchorage. All stone blocks with the arch ornament were anchored to the brick masonry using stainless steel anchors based on chemical anchors. Two anchors were used per one unit. Additionally, selected elements of the cornice and walls were anchored. Over 400 anchors were used in each tower.

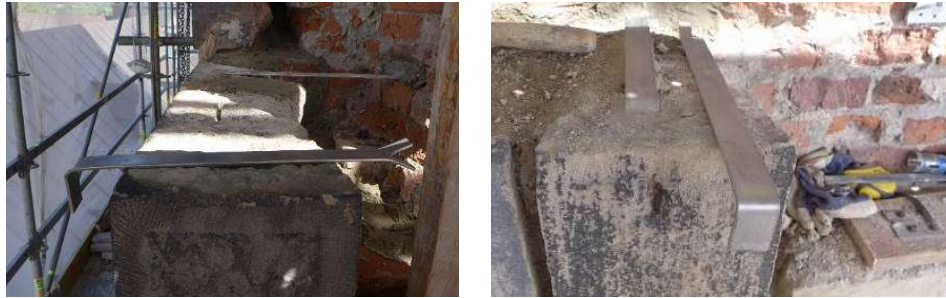
Fig. 20. Anchors for bed joints

- Crack repairs in the tower masonry. The cracks were stitched with stainless steel anchors placed in bed joints. Mineral injections were applied to the cracks.

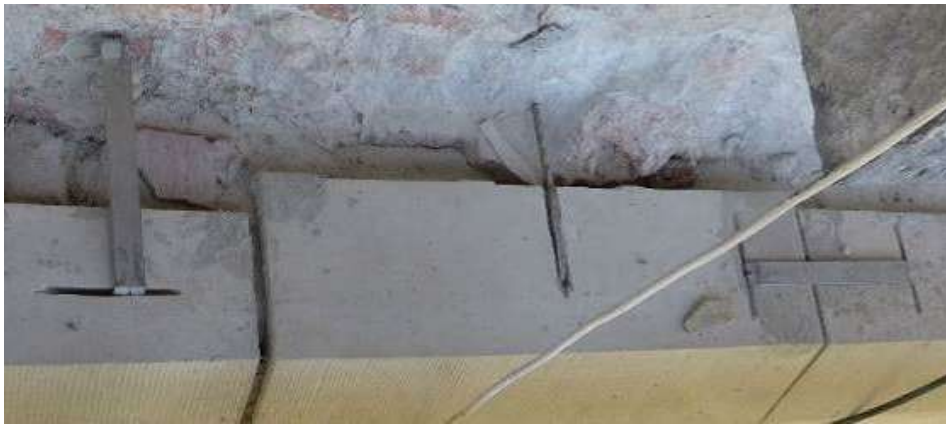
Fig. 21. Anchorage of new cornice elements in the failure zone

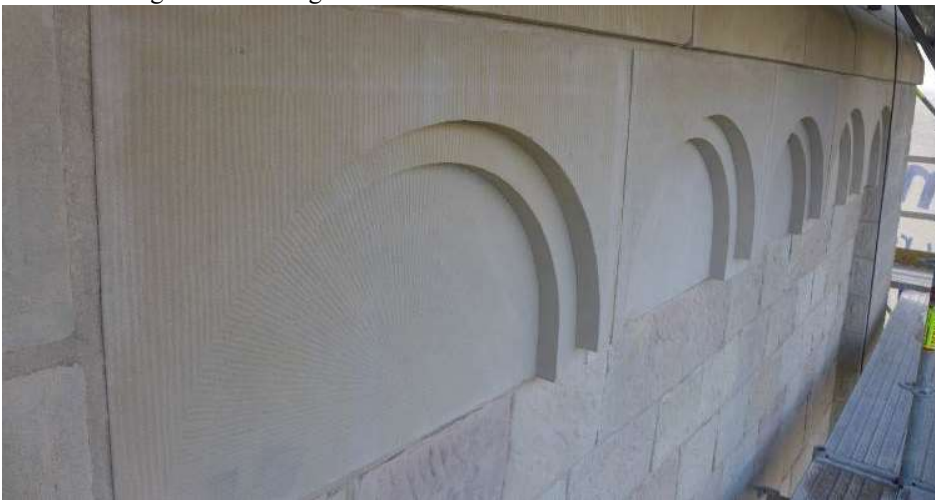
Fig. 22. Restored failure zone in the south tower

- Damage repair in the failure zone. The repair works consisted of rebricking of the wall facing and the parts of the remaining wall. They aimed at keeping as many original masonry units as possible. Unfortunately, the stone blocks with the arch ornament broke into pieces. Thus, they had to be copied. The new stone elements were selected regarding the colour, the size, and the strength. The applied mortar was the system mortar for the historic buildings, similar to the original one.
