## ANALYSIS OF EROSION CONTROL CONSTRUCTIONS EFFECTIVENESS. THE CASE OF A ROAD GULLY IN WIELKOPOLE (LUBLIN UPLAND)

The paper contains analysis of the anti-erosion system in the road gully in Wielkopole, Lublin Upland. The solution implemented in the gully's bottom is effective against line erosion – there is no gully deepening. Lack of protection of slopes results in an intense earthmass movements. At the brim zone of the gully suffosion processes occur leading to the gully widening. The eroded material is accumulated on the road and colmatage drainage system of voivodship road no. 842, what is dangerous to traffic and generates expenses. That is why anti-erosion systems should be implemented comprehensively, protecting both the slopes and the bottom of gullies. Projects of such systems should be consulted with specialist.

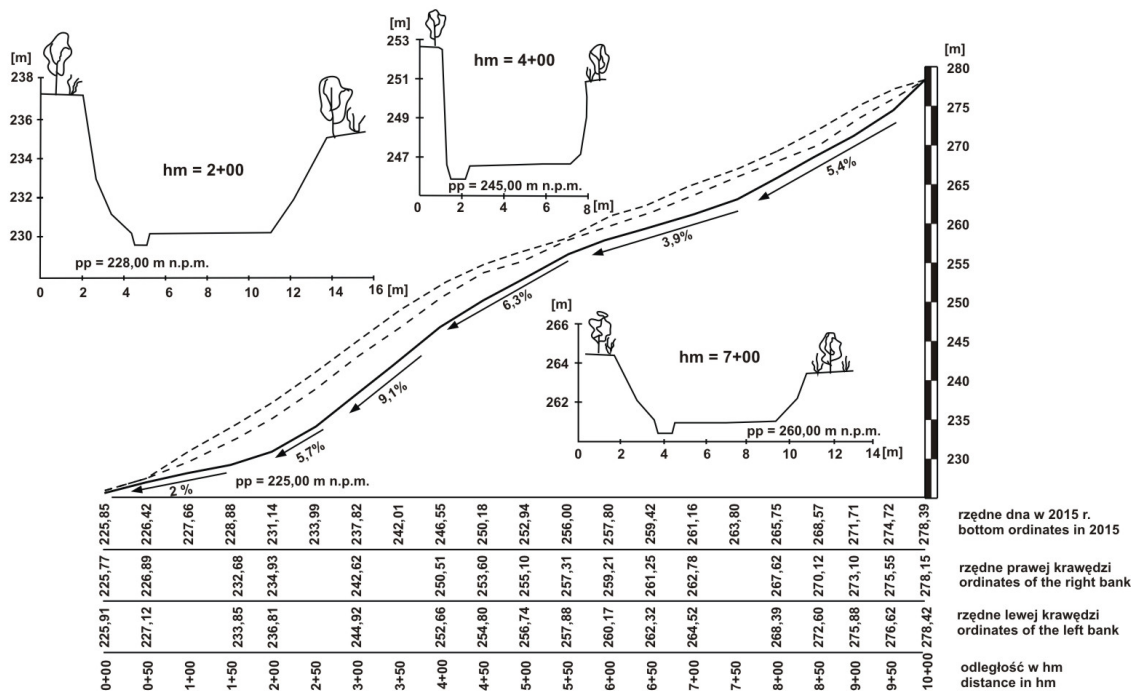
The analysed gully (fig. 1) developed on loess-based soils on a south-east slope, where a rural road led to fields [Mazur 2008]. Its area reaches 1.8 ha, it is 900 meters long and 6 to 14 meters deep, with the left slope being 1 to 2 meters higher than the right one. Both slopes are steep, with a gradient of 1:0.5 in a lower part, 1:1.5 in

an upper and vertical in most of a middle part. The width of a gully bottom is from 5 in a lower part to 7 meters in a middle part with an average of 5.5 meters. The maximum gradient of the bottom is 9.1% with an average equal to 5.3%. In the lower part, on a section of about 3 hm, the gully direction is coincident with a slope direction, while in an upper part it is oblique. It resulted in a 3.5 ha catchment area in an upper part of the gully. The water from a catchment runs-off on a left slope of the gully into a middle and a lower part of it. The run-offs caused by a spring thaw or storm rainfalls activated erosion processes in the gully, resulting in high loss [Mazur 2008]. These were reasons for the commune of Gorzów authorities to protect the gully. Works were done during 2009–2010 and a concrete covering of a field road at the bottom of the gully was laid. Its thickness is about 20 cm, width – 4 m and length reaches 800 meters. The bottom part of a right slope was additionally secured with a concrete openwork plates while on the left slope there was a channel constructed, made of concrete prefabricated trapezium-shaped elements and designed for directing the run-off water out of the gully.

Figure 1. A longitudinal profile and cross-sections of the road gully

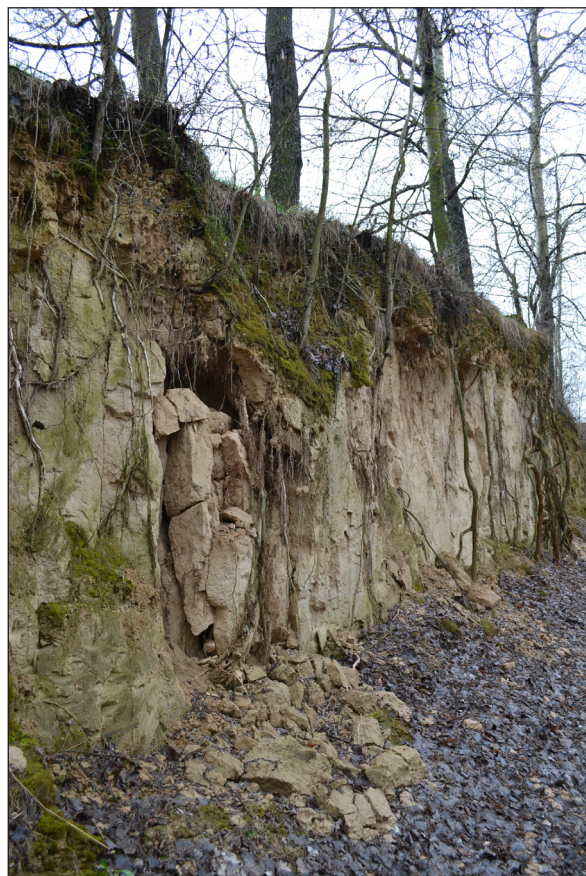
Figure 2. Loess falling off vertical slopes of the gully

Earthmass movements were particularly active on steep slopes of the gully. Solifluction were also noted there, especially on parts with no plants. The influence of this factor on relief forming is small because of a limited occurrence of the phenomenon. A falling off is often seen form of erosion on vertical, non-covered with vegetation slopes in a lower and a middle part of the gully (Fig. 2). The total area of occurrence of this process was about 900 square metres of slopes. As the result, sediment cones of total volume of about 22 cubic metres developed at the foot of the slope. The creep processes were shaping the gully in its upper part too, what was accompanied by movements of earthmass with shrubs and herbaceous plants. They formed numerous shallow slump up to 0.4 metres deep and of total area of 12 square metres.

To prevent development of the gully and protect the road no. 842 and its draining system against colmatation, left slope of the gully has to have water inflow cut off or the water has to be directed to the gully's bottom with a hardened channel. A solution of this kind should eliminate under-surface erosion seen at the foot of the left slope. Trees by the brink of the gully should be removed as well, as they increase loess fragmentation with their weight and their roots penetrating the rock. As a next step, steep and vertical slopes should be transformed to have a gradient of 1:1 and should be technically and biologically protected to eliminate earthmass movements.
