## Proposal of new measures for risk assessment in navigation – a case study of the M/V *Cosco Busan* accident

Rino Bošnjak<sup>1</sup>, Mihaela Bukljaš<sup>2</sup>, Dario Medić<sup>3</sup>, Srđan Vukša<sup>4</sup>✉

<sup>1,3,4</sup> University of Split, Faculty of Maritime Studies

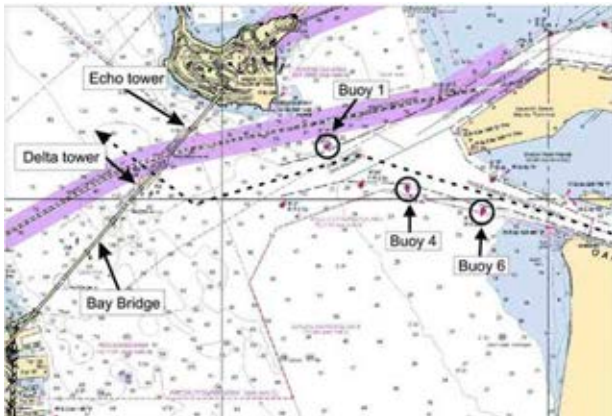
On the 7<sup>th</sup> of November 2007, the container ship M/V *Cosco Busan* allied with the fendering system at the base of the San Francisco–Oakland Bay Bridge. The contact with the bridge tower created a 212-foot-long by 10-foot-high by 8-foot-deep gash in the forward port side of the ship and breached the Nos. 3 and 4 port fuel tanks and the No. 2 port ballast tank. There were no injuries or fatalities that resulted from the accident, but the fuel spill contaminated about 26 NM of shoreline (NM – nautical mile, 1 NM = 1852 m). Total damages were estimated to be \$2.1 million for the ship, \$1.5 million for the bridge, and more than \$70 million for environmental clean-up. The ship cargo consisted of 2529 container units. At 0637, the pilot informed the Vessel Traffic Service (VTS) that he planned to leave berth and pass through the Delta-Echo span, the 2200-foot-long span between towers D and E of the Bay Bridge (pilot – expert in navigating local waters, provided guidance and professional advice to the master for safe navigation in ports, straits, and access to ports). The VTS operator informed him about the reduced visibility due to fog, ranging from 1/8 to 1/4 NM. At 0810, the ship left berth. The black dotted line in Figure 2 shows the ship’s intended course (National Transportation Safety Board, 2009).

Figure 2. Intended course of the *Cosco Busan* (National Transportation Safety Board, 2009)

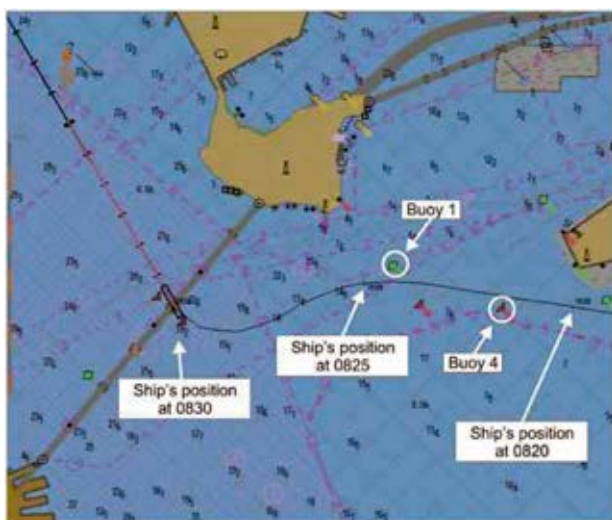
The accident took place at 0830. At 0825, the vessel's heading was 253°, and the pilot ordered rudder to mid-ships (centred), then requested a heading of 250°, followed by 245°. Less than 1 minute later, contrary to his previous instructions, the pilot ordered 10° starboard rudders, then starboard 20°, and the engine to full-ahead to increase thrust over the rudder and achieve greater manoeuvrability. On the loaded *Cosco Busan*, a full-ahead engine would have resulted in an eventual speed of about 17 knots (knot – unit of speed at sea (abbreviation = kn), 1 kn = 1 NM/h). At that moment, the ship's heading was 241°, almost parallel to the bridge. When starboard rudder was applied, the ship's course over ground continued southwest. Figure 3 presents the situation when the pilot ordered 10° starboard rudders, then starboard 20°. At around 0827, the ship's heading

Figure 3. *Cosco Busan*'s record of movement (National Transportation Safety Board, 2009)

was 247°, while her course over ground (her real direction of movement, including leeway) was 236°. The leeway is the angle between the vessel's heading (as indicated by the compass) and the real course over ground, due to the effects of sea currents and wind. A few seconds later, the *Cosco Busan*'s heading was increased to 261°, but the course over ground was 235°. The speed remained constant at about 10 knots. The ship was about 1/3 NM (around 620 m) from the bridge. The VTS operator noticed that the vessel deviated from its intended route and was out of position to make an approach to the bridge's Delta–Echo span, and informed the pilot of this. Figure 3 shows the VTS record of the *Cosco Busan* (National Transportation Safety Board, 2009).

The “black box” of the voyage, i.e. the Voyage Data Recorder (VDR) showed that when the pilot reported to VTS that he was “steering 280”, the ship's actual heading was 262°. The VTS operator did not communicate further with the pilot, as the communication equipment had a time delay. Over the next 2 minutes, the pilot gave rudder orders of hard starboard, mid-ships, starboard 20, and hard starboard. About 10 seconds later, the pilot ordered the rudder to mid-ships. After another 5 seconds, the pilot ordered a hard port rudder. The forward port side of the vessel struck the corner of the fendering system at the base of the Delta tower at 0830. It was later determined that contact with the bridge breached the ship's No. 2 water ballast tank and the Nos. 3 and 4 port fuel tanks (National Transportation Safety Board, 2009).

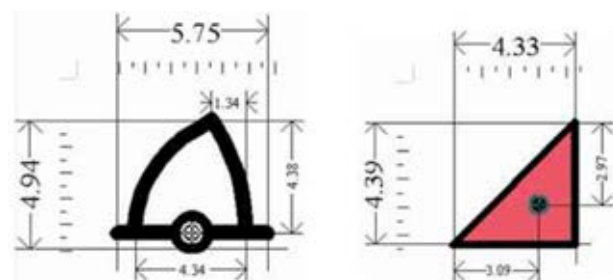
According to the VDR, the pilot was not familiar with the symbols on the electronic chart display – he was using the electronic navigation chart but was not sure what the red triangles represented. They were standard International Hydrographic Organization symbols that indicate a conical buoy (Figure 4).

Figure 4. Standard conical buoy symbols: paper chart (left), electronic chart (right) (National Transportation Safety Board, 2009)

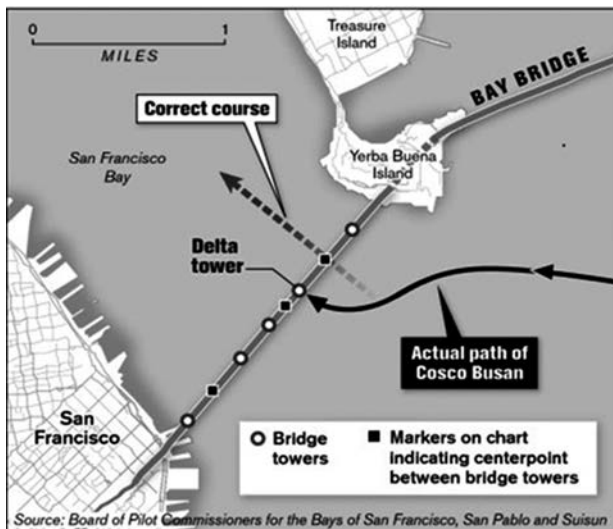
Figure 5. Correct course for passage under the Bay Bridge (National Transportation Safety Board, 2009)

If the coloured zones presented in Table 4 are applied to Figure 5, then the following can be applied: the green colour zone is the correct course, the yellow zone is the area between the correct course and the actual path, and the red colour is the actual path. This should be considered in voyage plans despite marking safety depth, safety margins, shallow, and deep contours.

Based on the risk assessment, the correct course of the ship should have been plotted as in Figure 5.
