RENOVATION OF LARGE-PANEL BUILDINGS IN CONTEXT OF URBAN RENEWAL

Abstract

The article presents issues connected with renovating multi-storey precast concrete buildings, resulting from the consequences of construction defects occurring over the course of the building process and use of the buildings, as well as design flaws and construction defects when insulating external partitions. Analyses and conclusions which stem from them cover issues of renovation in the light of: damage in the vertical and horizontal joints, damage to the connection of layers in three-layer load-bearing and curtain walls, the effect of the damage on the possibilities of carrying out functional modernization of residential units, the effect of the damage on the effectiveness of thermo-modernization - new problems related to faulty insulation.

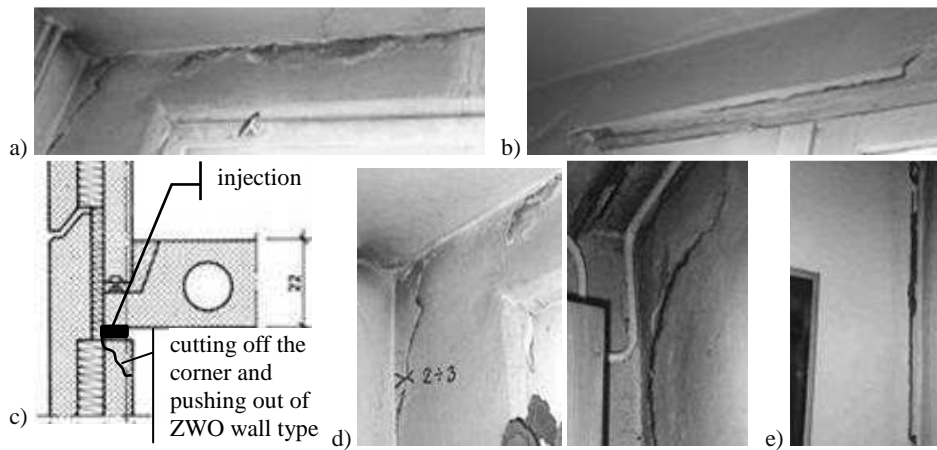
Fig. 6. Examples of damage in horizontal ZWO-S-ZWO wall type joints due to an in-service defect (injection of the gap beneath the floor): a), b), c) cutting off the upper corner of the load-bearing layer of wall and pushing out of ZWO type wall, d) inclination of wall and associated cracking in joints, e) gap with thickness of 5-8 mm between the ZWO type wall and partition wall

When cracks in vertical joints are structural or reveal a tendency to progress (active cracks), or when inclination of the curtain wall has taken place as a result of injecting the expansion gap underneath the ceiling (Fig. 6), it is necessary to remove the source of the cracking and then apply reinforcement in order for the building to meet safety requirements [10, 18]. Reinforcements should be made from the outside (from scaffolding) and should not infringe on

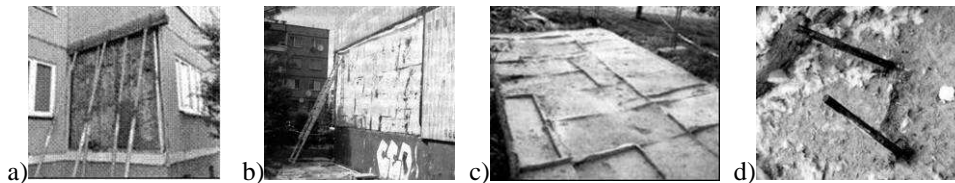
vapor-control layer (with technological defects) increases with added load of an additional heat-insulation layer.

Fig. 12. Effects of the "hidden" construction defects in the joining of the layers: a), b) view of ZWS type walls after separation of texture layer [21, 26], c) view of inside surface of separated texture layer following the removal of mineral wool insulation [21], d) broken bars of hanger anchored within the texture layer [21]

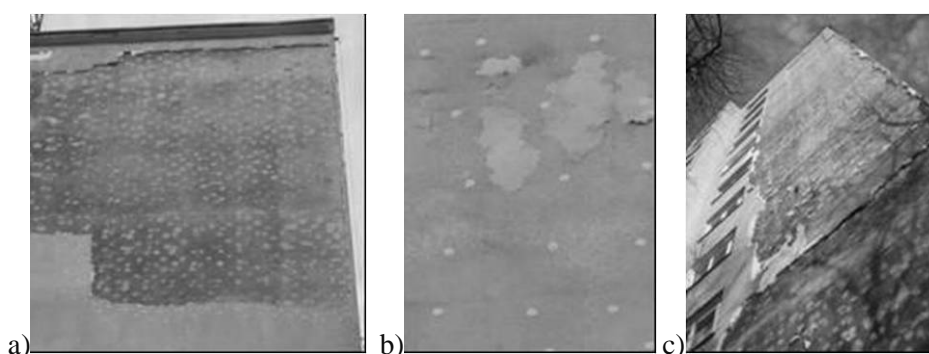
The author's own studies as well as findings reported in literature unfortunately indicate there to be numerous cases of the quick destruction of heating insulation caused by not adhering to the technical and technological conditions of carrying out insulation work. The result of construction defects, described among others in chapter 6 of this the work [15], is damage to the elevation of the building which occurs as soon as after a few years: cracking and destruction of the plaster coating and reinforced adhesive layer (Fig. 14), progression of biological corrosion and sporadically occurring separation of entire heat insulation (Fig. 15).

Fig. 15. Effects of faulty insulation of two 11-storey buildings - view following the separation of the insulation layer: a) at the level of the top three floors, b) secondary dowelling of the remaining insulation, c) along the entire height of the building
