# ASSESSMENT OF STRUCTURE OF PLATE IMPLANTS USED IN MANDIBULAR OSTEOSYNTHESSES

Agnieszka Szust\*, Włodzimierz Dudziński, Marta Szalkowska

Politechnika Wrocławska, Wydział Mechaniczny, 50-370 Wrocław, Smoluchowskiego 25

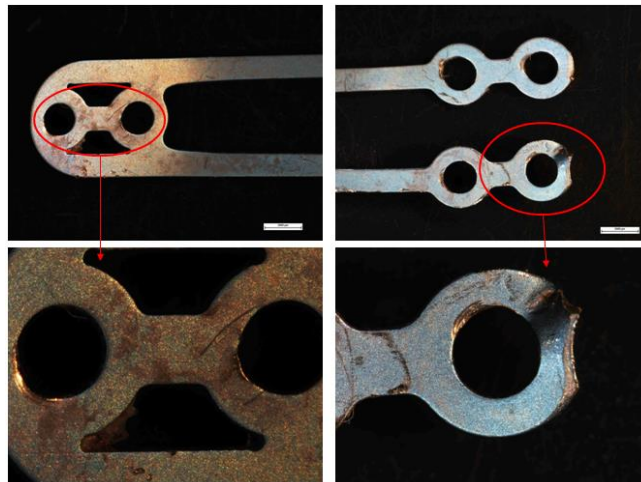
Fig. 4. Inner side of plate 2

The macroscopic examinations revealed extensive mechanical damage. The damage on the outer side of the plate implants was much more extensive, probably resulting from the implantation operations. Whereas on the inner side, which had been in contact with the bone, the damage to the material was slight. The miniplates also showed damage resulting from the interaction between the plate and the fixing screws.

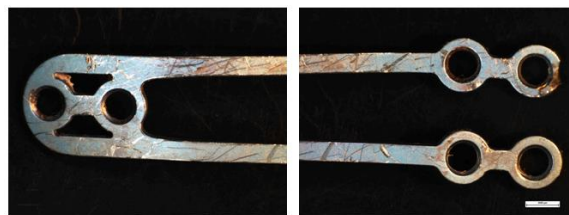
Fig. 5. Outer side of plate 1

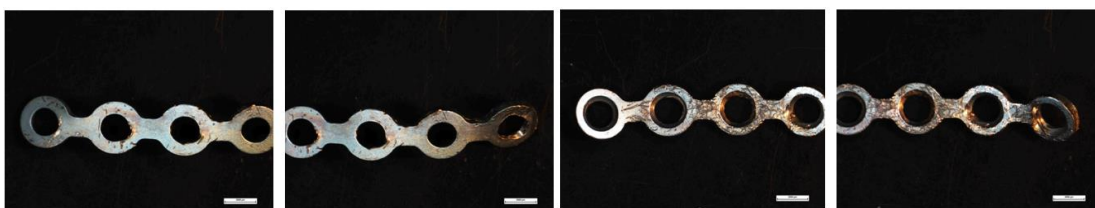
Fig. 6. Inner (A) and outer (B) side of straight plate

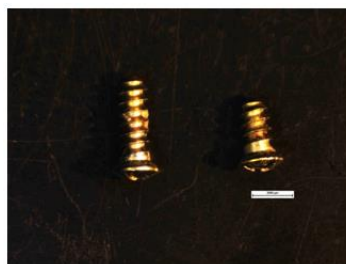
Fig. 7. Plate fixing screws

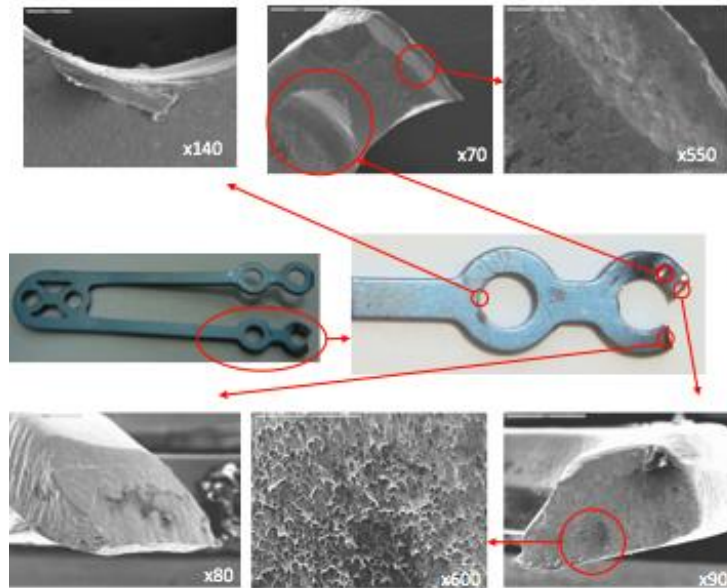
Fig. 8. Image of plate fractured surfaces; damage to surface having contact with patient

The surfaces of the plates and the fractures were also examined using a scanning electron microscope. The image of the fractured surfaces suggests that the fracture occurred as a result of mechanical damage caused by a cut with a sharp tool and subsequently propagated. The result is shown in the photographs (see fig. 8, 9, 10). A plastic fracture, a parting shear fracture and a surface defect (probably caused by either an improper implant manufacturing process or by plastic deformations of the material (resulting in microcracks on the implant surface) are visible.

The macroscopic examinations of the surfaces show that the plates used in mandible osteosynthesis underwent extensive mechanical damage, probably during implantation. The use of the product not in conformity with the manufacturer instructions, such as multiple bending of the plates or their mechanical damage, can result in defects in the material's structure or on its surface, leading to cracking and ultimately to the failure of the element. Small pitting corrosion centres were noticed on the plate implants acquired for the investigation. But since the implants were subsequently sterilized, the analysis of the corrosion sites became impossible. Plate damage in the form of marks left by screw heads near the holes indicates improper interaction between the screws and the implants or errors made during the implantation of the plates. The photographs of the plate implant fractures show that the fracture was not a progressive process. It occurred abruptly as a result of the overloading of the improperly preoperatively prepared element.

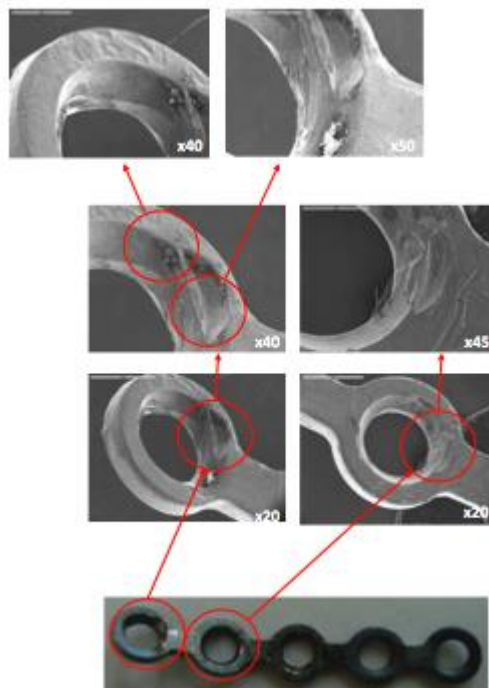
Fig. 9. Deformations of plate outer surface

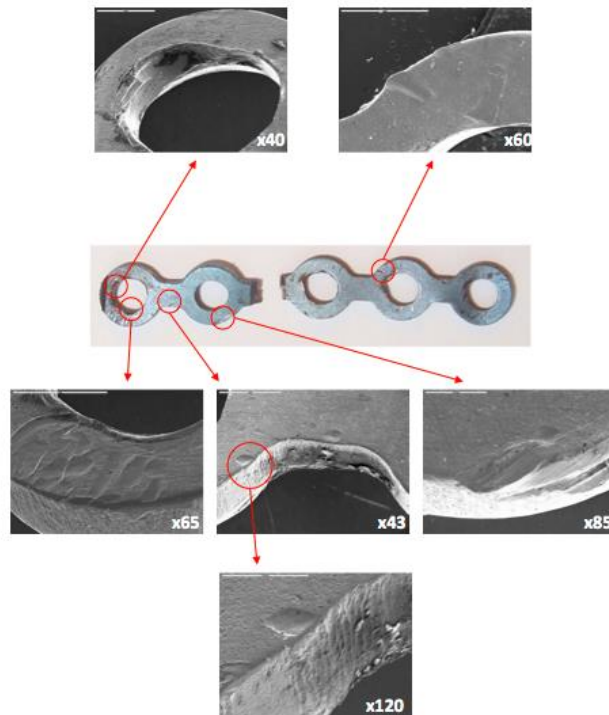
Fig. 10. Deformations of inner surface of straight plate

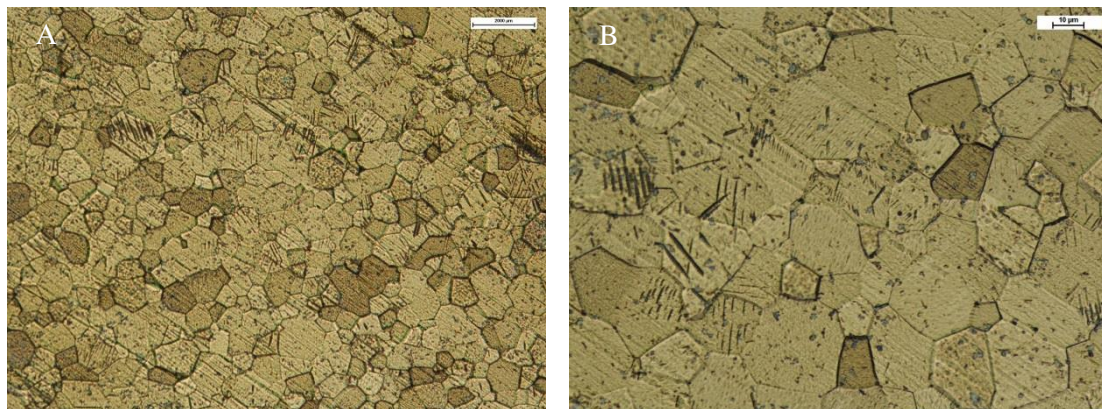
Because of the considerable mechanical damage visible on the outer surface of the plates, the inner surface of the implants, which was in contact with the patient's bone, was subjected to microstructural examinations. Both the areas deformed by bending the plate and the undeformed areas were examined. Figure 11 shows the structure of the implant area fitted to the shape of the patient's bone, with marked microtwins representing a dislocation mechanism of plastic deformation. Twinning is visible inside grains as rectilinear boundaries. Microtwins occur more numerous in places subjected to greater plastic strains [12]. No twins were found to be present in the areas in which the plates had not been shaped.

Fig. 11. Deformed area of plate implant, magnification: A – x200 and B – x500, LM, visible microtwins

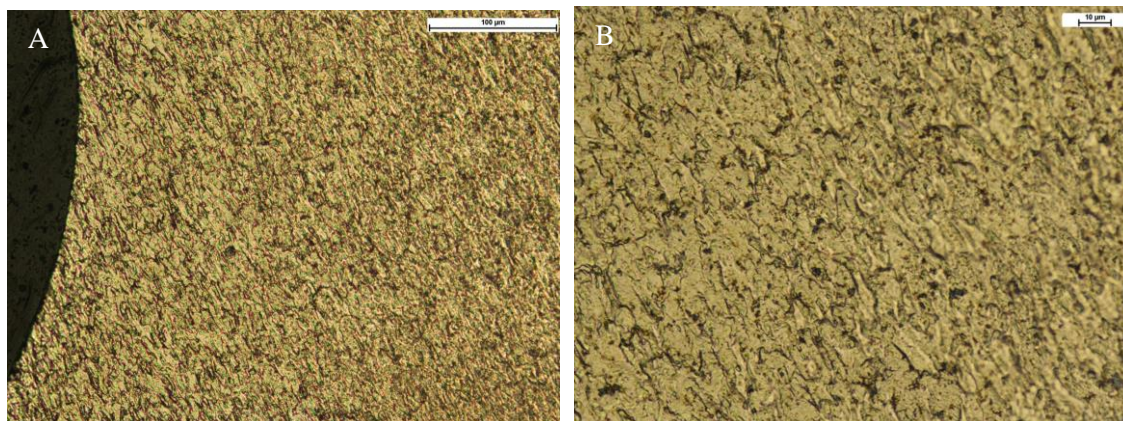
Fig. 12. Microstructure of screw made of commercial titanium in magnification (A) x200 and (B) x500, LM.

Despite the manufacturer assurances, the microstructure of the fractures of the screws (see fig. 10) does not resemble the typical microstructures of commercial titanium. A comparison of this microstructure with the titanium microstructures found in the literature suggests that the structure of the screws resembles the microstructure of titanium alloys containing molybdenum [13]. However, the chemical composition analysis did not clearly corroborate this suggestion.
