Arkadiusz RYCHLIK\*, Krzysztof LIGIER\*, Władysław KOZUBEL\*\*

## EFFECT OF HOLE-FORMING TECHNOLOGY ON THE DESTRUCTION OF MATERIAL DD11 USED TO MANUFACTURE WHEEL DISCS

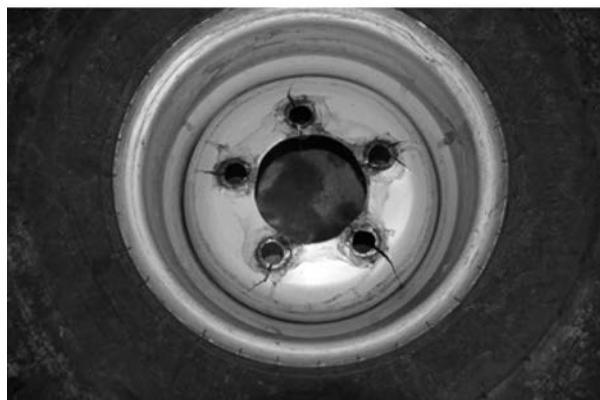
Based on the analysis of warranty and post-warranty complaints conducted at the enterprise Polkar Warmia, a rather considerable percentage of damage to wheel rims was noted within the areas around the mounting holes, as presented in Fig. 1. Some of them probably resulted from the improper process of wheel operation, yet a significant percentage of the damage was not associated with it, as indicated by a visual inspection. In the technology of wheel disc manufacturing at the enterprise Polkar Warmia, the process of hole piercing in the semi-finished wheel disc is applied. Therefore, as part of the research work carried out, an attempt was made to determine the causes of the formation of such defects and to specify measures to prevent them.

**Fig. 1. A view of a wheel rim with cracks formed on the mounting holes in the wheel disc**

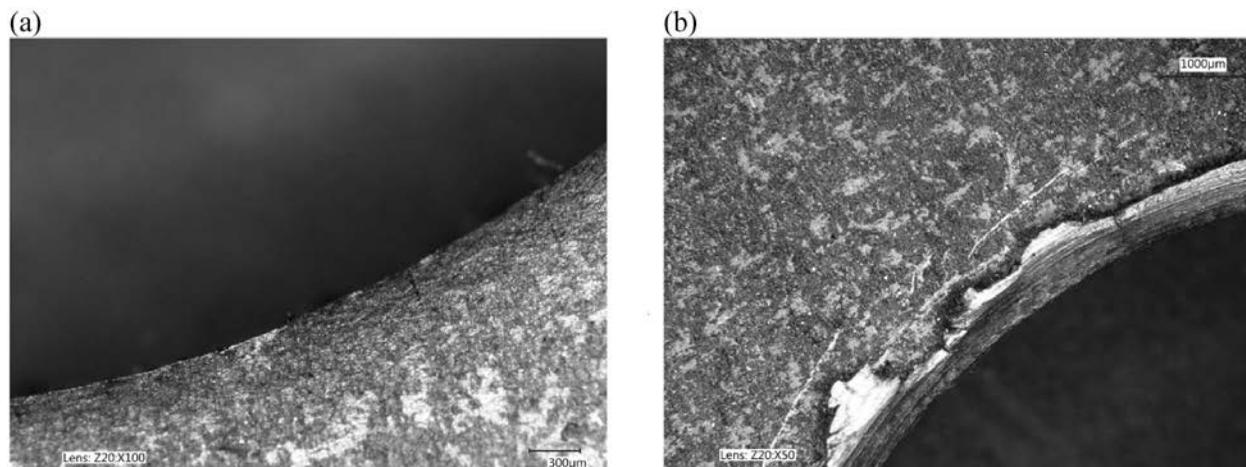
Figure 5 shows a micro-image of the surface of specimens pierced (a) and drilled (b) within the edge area of the hole. In both specimens, a crack is visible which initiates at the edge of the hole and propagates perpendicularly to the specimen's axis.

**Fig. 5.** A view of the specimen surface with a hole pierced (a) and drilled (b) at the stage of cracking initiation  
 Rys. 5. Widok powierzchni próbki z otworem wykrawanym (a) i wierconym (b) w fazie początku pęknięcia

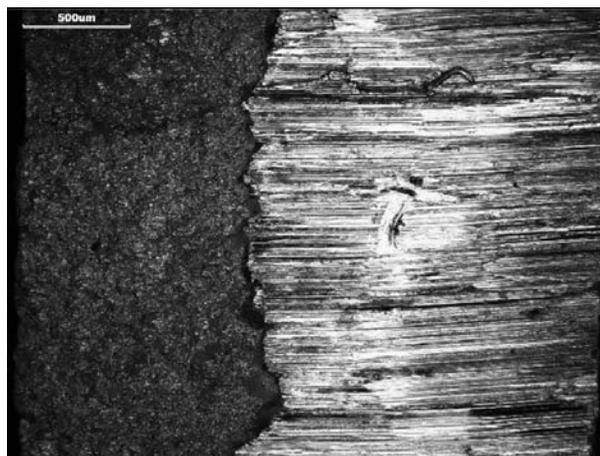
In order to determine the location of the initiation of the cracking of specimens with pierced holes, the internal surfaces of holes were visually inspected. A view of the internal surface of a pierced specimen is presented in **Fig. 6**. On the internal surface of the hole, two areas associated with the hole-making technology can be observed. The area of material shearing at the first stage of piercing, where signs of the action of a punch

**Fig. 6.** A view of the internal surface of a pierced hole  
 Rys. 6. Widok wewnętrznej powierzchni otworu wykrawanego

directed in accordance with its operating motion can be clearly seen, along with the area where the specimen's material has been torn off and pushed out of the hole being made. In turn, this area is characterised by the lack of surface orientation and by the presence of breaches. All of the observed cracks were initiated in the area where the material is torn off and pushed out. These cracks are initiated in these deep breaches (**Fig. 7**) and in locations where the material has been torn off (**Figs. 8** and **9**).

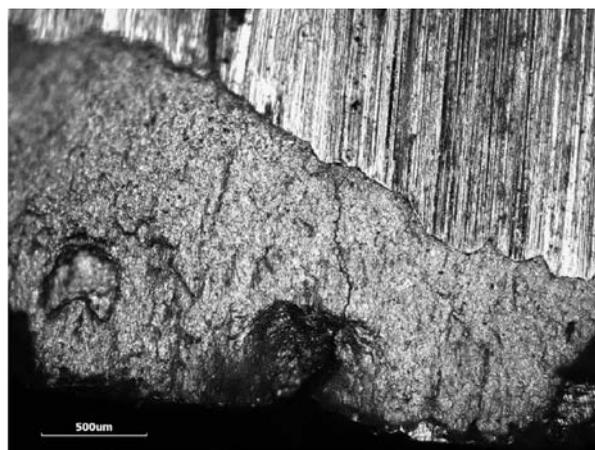
**Fig. 7.** The initiation of a crack in a deep breach formed within the area where the material has been pushed out and torn off

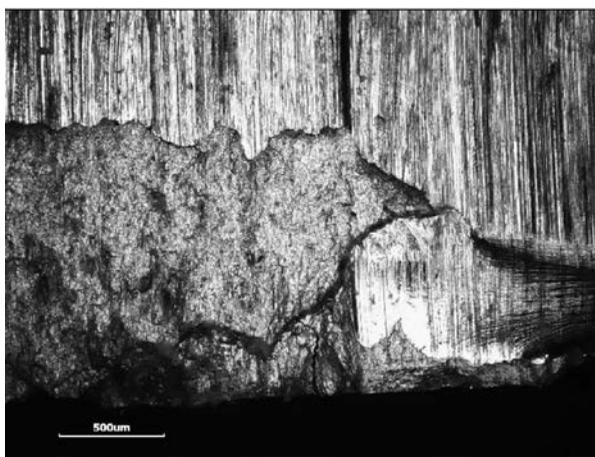
**Fig. 8.** The initiation of a crack in the location where the material has been peeled off

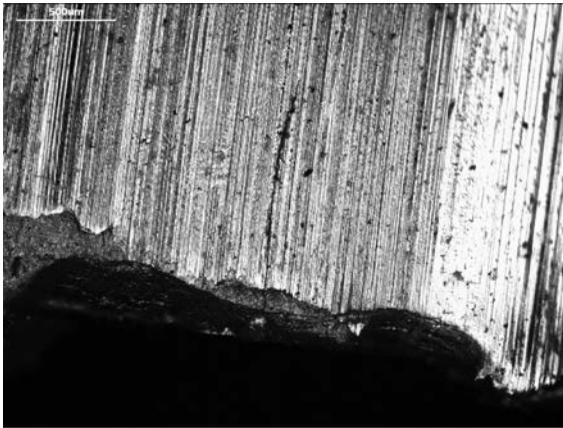
**Fig. 9. Crack propagation from the initiation area to the material shearing area**

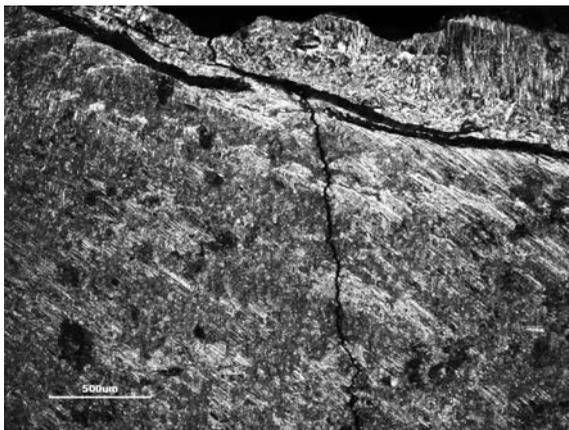
The technology of hole-making through piercing results in sharp burrs and material flashes. Failure to remove these processing residues promotes crack initiation, from where they spread deep into the material, which is presented in **Fig. 10**. The initiation of a crack always occurs near the edge of a hole on the hole-making tool exit side.

**Fig. 10. A crack initiated on the unremoved burr after piercing the hole**
