## Analysis of the end-of-life the front suspension beam of a vehicle

Sławomir Kowalski<sup>a</sup>, Kazimierz Opoka<sup>a</sup>, Józef Ciuła<sup>a</sup>

<sup>a</sup>State University of Applied Sciences in Nowy Sącz, ul. Zamenhofska 1a, 33-300 Nowy Sącz, Poland

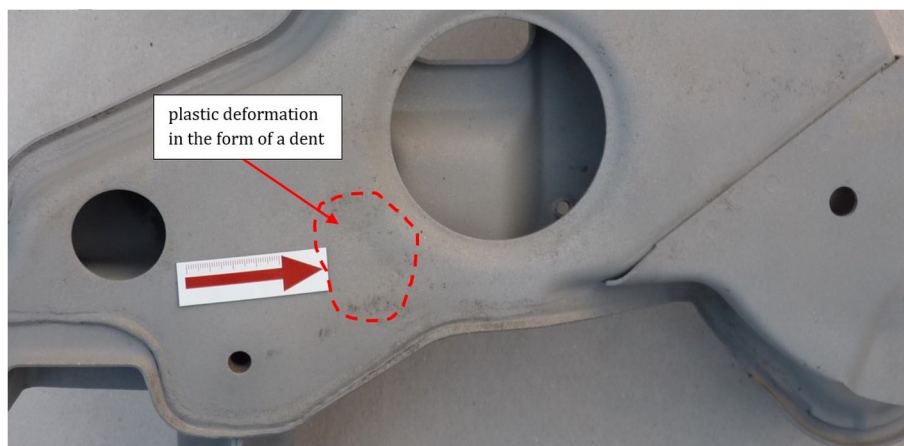
The macrographic observations of the beam plating demonstrated wear in the form of plastic deformations of a peculiar arched shape (Fig. 4). The range of those deformations was insignificant and had no influence on the change of the original beam shape. Linear scratches of the plating as well as hairline cracks of the minimum depth in the beam plating were also noted. The cause of that kind of damage is sought in the contact of that element of the chassis with items making the road dirty, such as sand particles, stones etc., which may have fallen down from aggregate-carrying vehicles. Such items may have also been brought onto the road by vehicles joining the traffic from a construction area or aggregate collection points. Damage described above was located at the lower beam plating, where friction or impact contact with obstacles present on the road may take place.

Fig. 4. Beam damage in the form of plastic deformation

That damage, consisting in plastic deformations, did not affect driving safety and was easy to locate during technical inspections, that is why a detailed analysis of that damage is omitted in the further part of this article. The main focus was on the wear following from the natural operation process, which cannot be verified and removed during diagnostic tests.

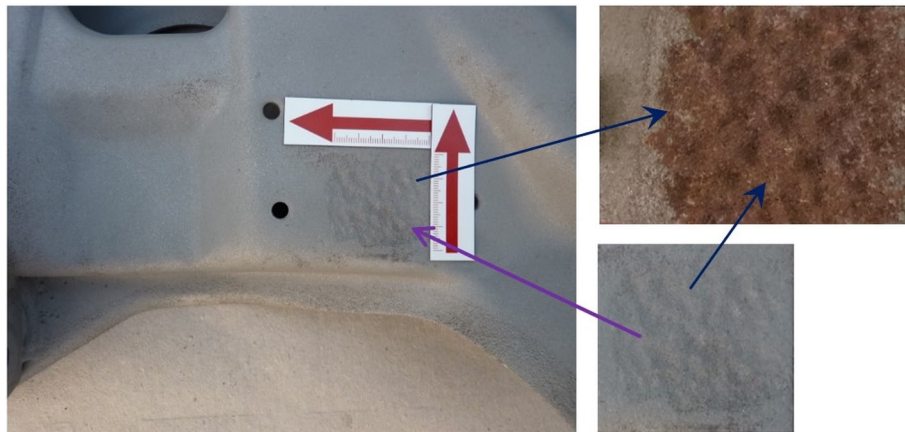
The detailed macrographic observations of the beam surface demonstrated peculiar changes of the surface profile at the point of connection of the stabiliser rod (Fig. 5). Visible wear traces occupy a square area of 16 cm<sup>2</sup>. The wear-affected area is distinguished by high waviness and a change of the top layer structure.

Fig. 5. Front suspension beam fragment with visible wear traces

It is appropriate to think that fretting is highly likely to be noticeable at the point of connection of the stabiliser with the front suspension beam. To confirm that theory, however, further tests and analyses are necessary. The required condition for the development of fretting wear in the case of the front suspension beam and stabiliser rod tribological kinematic pair was fulfilled.

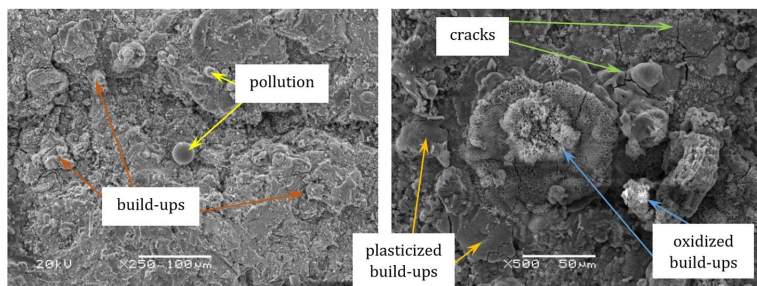
The microscopic observations confirmed the macroscopic observations suggesting that the main damage of the beam at the point of mounting the stabilisers rod is constituted by corrosion or fretting wear. The following features were observed: fatigue crack, corrosion pits, hairline cracks and material build-ups, which become plasticised and crumbled.

Fig. 6. Sample SEM images of the wear products on the front suspension beam surface

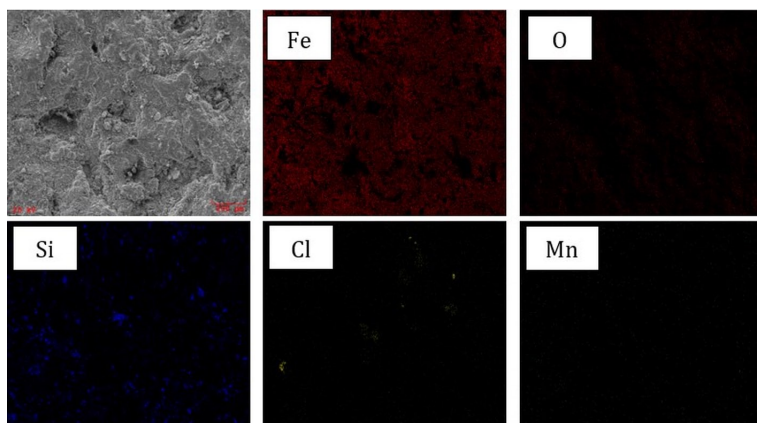
Fig. 7. Surface analysis of the chemical composition of the front suspension beam wear products

ence of iron, oxygen, silicon, chlorine and manganese atoms. The spot analysis of the chemical composition at another place also demonstrated the presence of the same elements. Iron and oxygen atoms prevail in the chemical composition of wear products. Such a result is the evidence of the penetration of oxygen in between the mating surfaces, which leads to surface oxidation and to the initiation of a phenomenon similar to corrosion. In the case of fretting wear, iron and oxygen atoms are the prevailing components of the wear products, too [1, 21, 29]. Thus, the thesis that the suspension system elements may be exposed to fretting confirmed in this case as well.

The analysis of the chemical composition of wear products demonstrated the presence of silicon and chlorine atoms. Silicon is the evidence of the presence of sand or other impurities from the road in the space between the beam and stabiliser rod mounting. This also proves the fact that the vehicles were moving on sand or unpaved roads. During vehicle operation, sand grains trapped in the space between the mating elements move in various directions thus causing, with the passage of time, the development of friction wear and surface scratches on the micro scale, which may also initiate the development of fatigue cracks. The presence of chlorine atoms confirms that the vehicles were moving on roads at which slipperiness was reduced by means of road salt. During suspension system deflection, salt present on the road would penetrate into the space between the beam and stabiliser rod mounting. Road salt which will not be removed from that space, will accelerate wear processes.

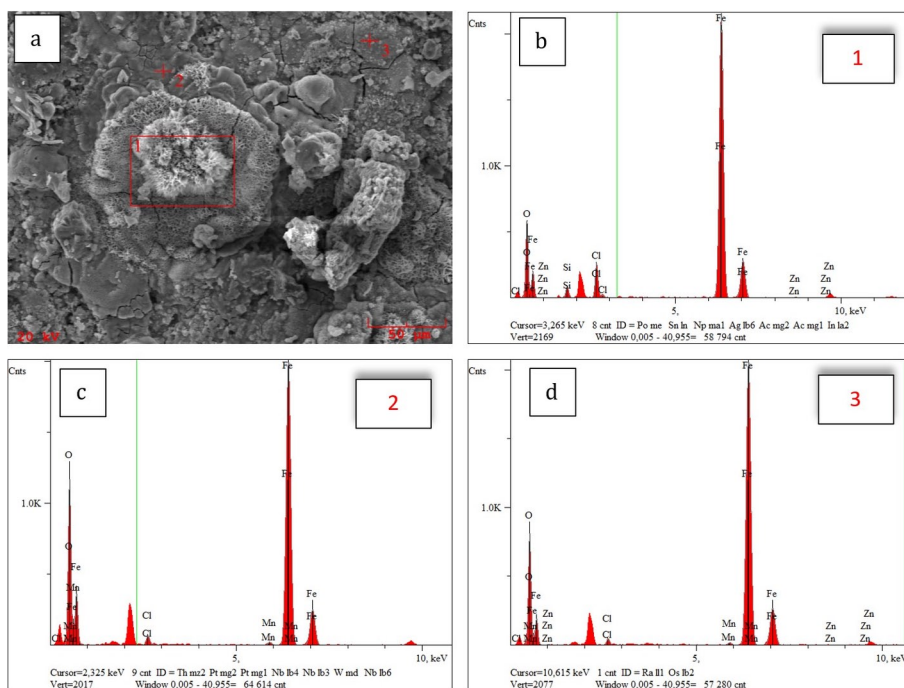
Fig. 8. Spot analysis of the chemical composition: a) SEM image, b) radiation spectrum peculiar for point 1, c) radiation spectrum peculiar for point 2, d) radiation spectrum peculiar for point 3

Chemical element	Line	Chemical composition of wear products			Unit
		Area 1	Point 2	Point 3	
Fe	Ka	62,582	77,679	60,096	wt.%
O	Ka	30,688	47,519	38,245	wt.%
Cl	Ka	4,086	0,993	0,768	wt.%
Si	Ka	2,166	-	-	wt.%
Zn	Ka	0,478	-	0,446	wt.%
Mn	Ka	-	0,434	0,603	wt.%

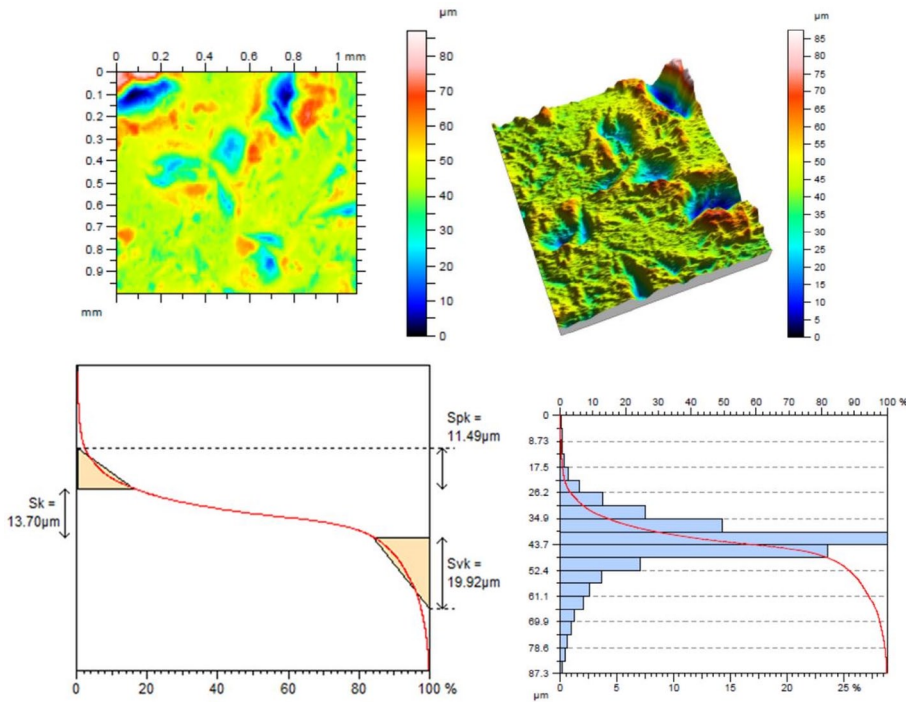
Fig. 9. The area without wear traces in profilometrical analysis

When analysing the obtained values of the parameters for the area not affected by wear, it may be noticed that the maximum surface height  $S_z$  is  $85.60 \mu\text{m}$ , the arithmetic mean surface height  $S_a=6.496 \mu\text{m}$ , the maximum peak height  $S_p=41.98 \mu\text{m}$ , the maximum valley depth  $S_v=43.63 \mu\text{m}$  and the root mean square height  $S_q=9.709 \mu\text{m}$ . Quite quick fading of the ACF function (the  $S_{al}$  parameter) is the evidence of the dominant share of the random component in the surface geometry structure. The distribution of the data for the local summits is the normal distribution with high kurtosis  $S_{ku}=6.022$  and insignificant negative skewness  $S_{sk}=-0.7271$ , which points out to the surface with a plateau shape.

The uniform structure of the top layer was evidenced in the regions without damages. This was confirmed by the value of the texture aspect ratio which takes  $S_{tr}=0.7015$  (the isotropy level 70.15%).

When analysing hybrid parameters, attention should be paid to the high local summit density ( $S_{ds}=1088 \text{ 1/mm}^2$ ) and the large fractal dimension ( $S_{fd}=2.481$ ). The surface has the smallest core fluid retention index ( $S_{ci}=1.33$ ) and the highest valley fluid retention index ( $S_{vi}=0.197$ ) given the bearing index  $S_{bi}=0.3539$  compared to the surfaces affected by corrosion.

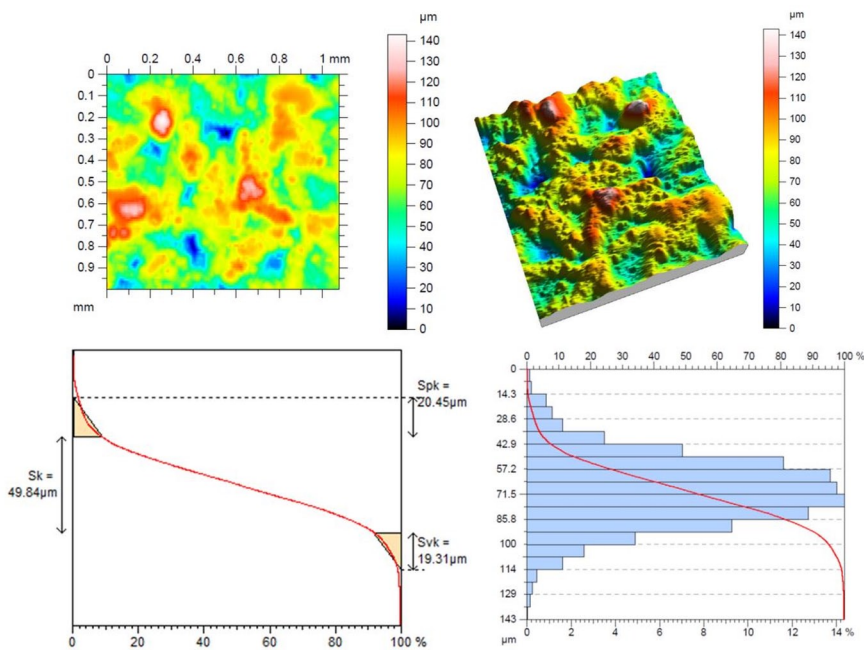
In the case the area affected by wear, it may be noticed that the maximum surface height  $S_z$  is  $143.2 \mu\text{m}$ , the arithmetic mean surface height  $S_a=15.04 \mu\text{m}$ , the maximum peak height  $S_p=69.68 \mu\text{m}$ , the maximum valley depth  $S_v=73.52 \mu\text{m}$  and the root mean square height  $S_q=18.93 \mu\text{m}$ .

All the height parameters even doubled in comparison with the surface not affected by corrosion. The quickly diminishing autocorrelation function ( $S_{al}=0.10691 \text{ mm}$ ) is peculiar to random structures.

The surface affected by corrosion has a random isotropic structure, as evidenced by the value of the texture aspect ratio  $S_{tr}=0.8574$  (the isotropy level 85.74%).

The local summit density decreased by the factor of two compared to the surface not affected by corrosion ( $S_{ds}=531.13 \text{ 1/mm}^2$ ). A large fractal dimension ( $S_{fd}=2.382$ ) was also obtained. The root mean square gradient was equal to  $S_{dq}=0.664$ , the arithmetic mean summit curvature reached  $S_{sc}=93.03 \text{ 1/mm}$  and the developed interfacial area ratio obtained  $S_{dr}=20.20\%$  doubled, confirming greater surface roughness.

Fig. 10. The area affected by wear in profilometrical analysis

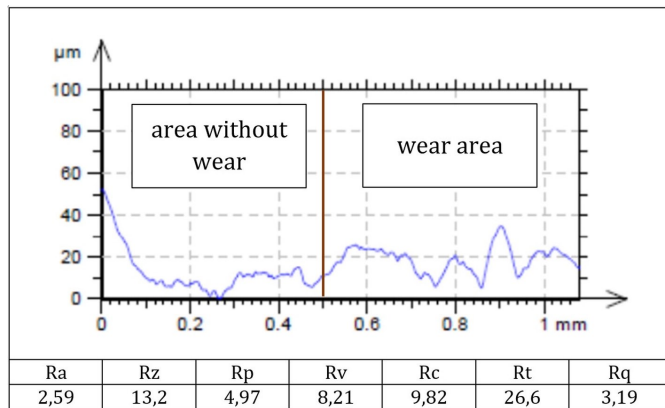
The 2D course of the profile of the beam surface comprising the area with and without wear (Fig. 11) confirms the loss of the material as a result of cyclical loading, the continuous generation of wear products in the tribological kinematic pair (the joint between the suspension beam and the stabiliser rod mounting), which products, during vehicle operation, move over the entire joint length thus causing surface scratches or the formation of micropits and microabrasion. Those phenomena are conducive to fretting wear development.

Fig. 11. 2D roughness parameters of the surface comprising the area with and without wear

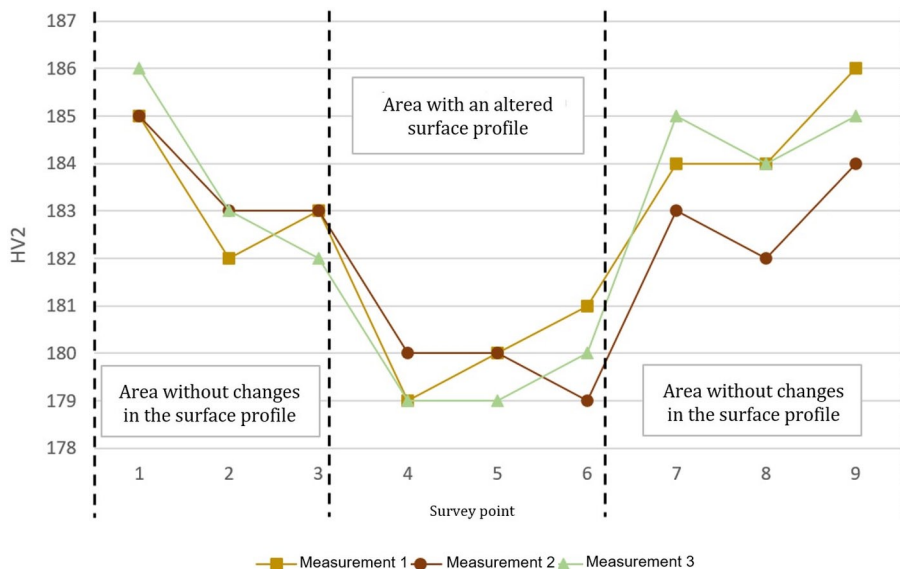
The measured beam surface hardness varies from 179 to 186 HV2. Following the analysis of the beam hardness results, the decrease of surface hardness in the area affected by wear can be noticed. In that area, surface hardness was equal to 179-181 HV2. Steel hardness reduction may be the cause of the reduced resistance of the element to friction wear and plastic deformations, which are conducive to adhesion processes. Those factors create a suitable environment for the development of fretting wear, whose consequence is the development of fatigue wear and the cracking of the element.

Fig. 12. Suspension beam hardness measurement results

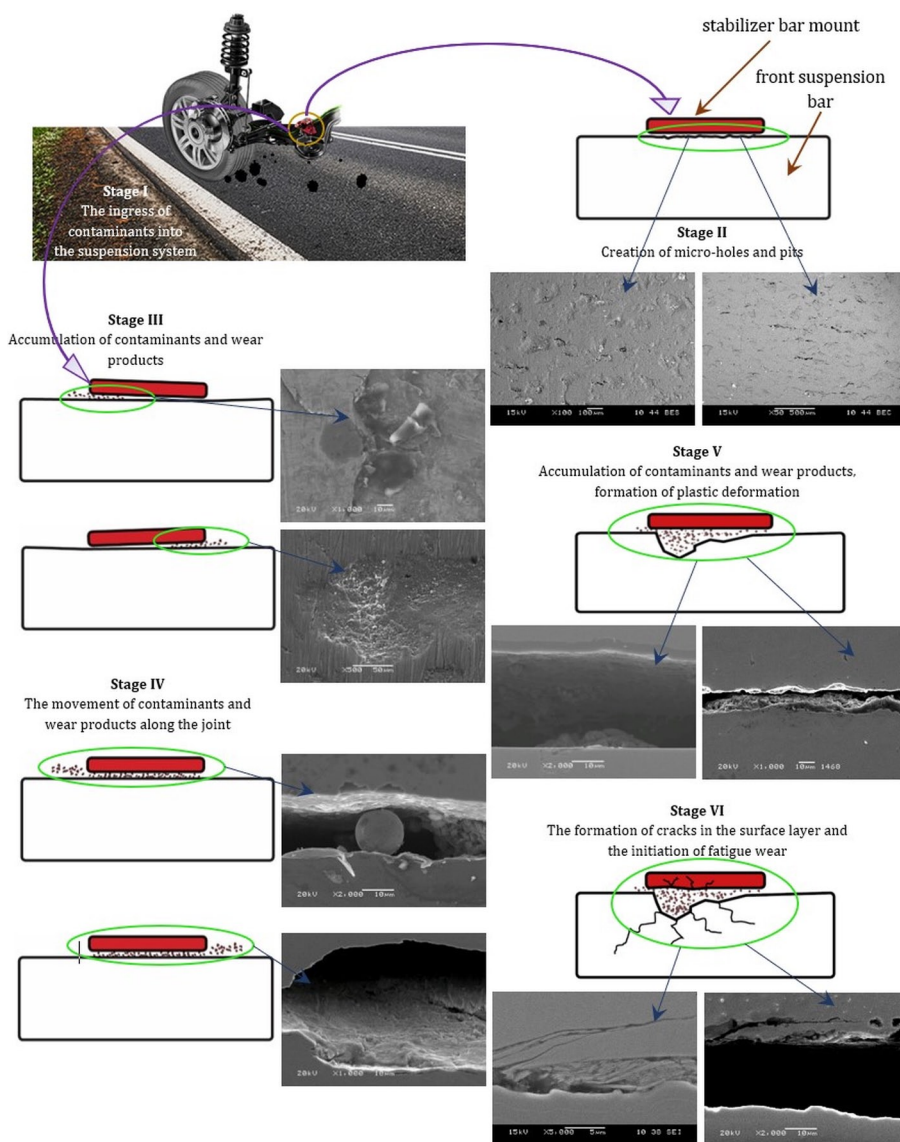
Factors related to the loading from the vehicle weight as well as dynamic factors connected with road conditions act on the beam and on the remaining elements of the suspension system of a moving vehicle. Due to the cyclical activity of those factors, the microdeflection of the mating elements and, at the same time, their static microdisplacement, takes place. This situation is conducive to a change of the profile of the elements' surface and, as a result of friction, surface micropullouts, microholes and micropits will come into being at the beam surface.

Trapped impurities will move along the joint and cause the degradation of the elements of the tribological kinematic pair as a result of abrasion. As a result of that activity, microholes and micropits become deeper and abrasion traces appear. In the deeper microholes, more impurities and surface abrasion products will accumulate thus leading to the plastic deformation of the top layer of the elements.

Further vehicle operation will result in the rise of microcracks, which will expand in the direction of the interior of the element's top layer thus causing the development of fatigue wear and, as a consequence, the cracking of the element. Road salt and water present in the space between the elements will be conducive to the formation of corrosion centres, which are an additional burden for the tribological kinematic pair.

Fig. 13. Development mechanism of the tribological wear in the suspension beam and stabiliser tribological kinematic pair
