BOŠNJAK S, ARSIĆ M, SAVIĆEVIĆ S, MILOJEVIĆ G, ARSIĆ D. Fracture analysis of the pulley of a bucket wheel boom hoist system. *Eksploatacja i Niezawodność – Maintenance and Reliability* 2016; 18 (2): 155–163, <http://dx.doi.org/10.17531/ein.2016.2.1>.

FRACTURE ANALYSIS OF THE PULLEY OF A BUCKET WHEEL BOOM HOIST SYSTEM

This paper presents the results of the pulley fracture analysis. Experimental investigations confirmed that the chemical composition and basic mechanical properties of the pulley material, except the impact energy at a temperature of -20°C , meet the requirements of the corresponding standard. The impact energy value at the temperature of -20°C is for $\approx 45\%$ lower than the prescribed value which has considerable influence on the appearance of the brittle fracture, especially having in mind the fact that the bucket wheel excavators operate at low temperatures. Metallographic examinations as well as magnetic particle inspections indicated that initial cracks in the welded joints occurred during the manufacture of the pulleys. Characteristic levels of the rope load cycle are obtained by using in-house software which includes the dynamic effects of the resistance-

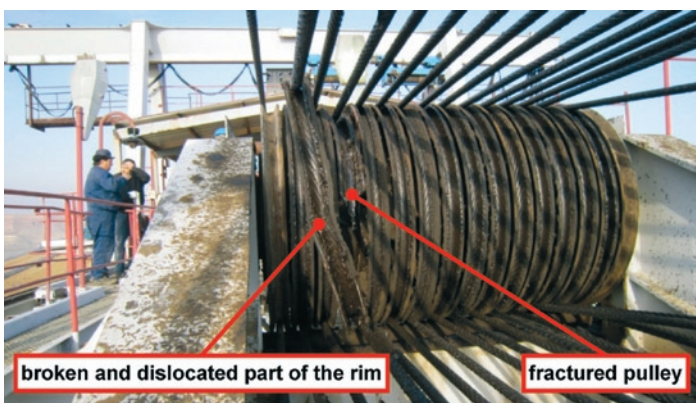
Fig. 2. Fracture of the pulley of the fixed pulley bloc

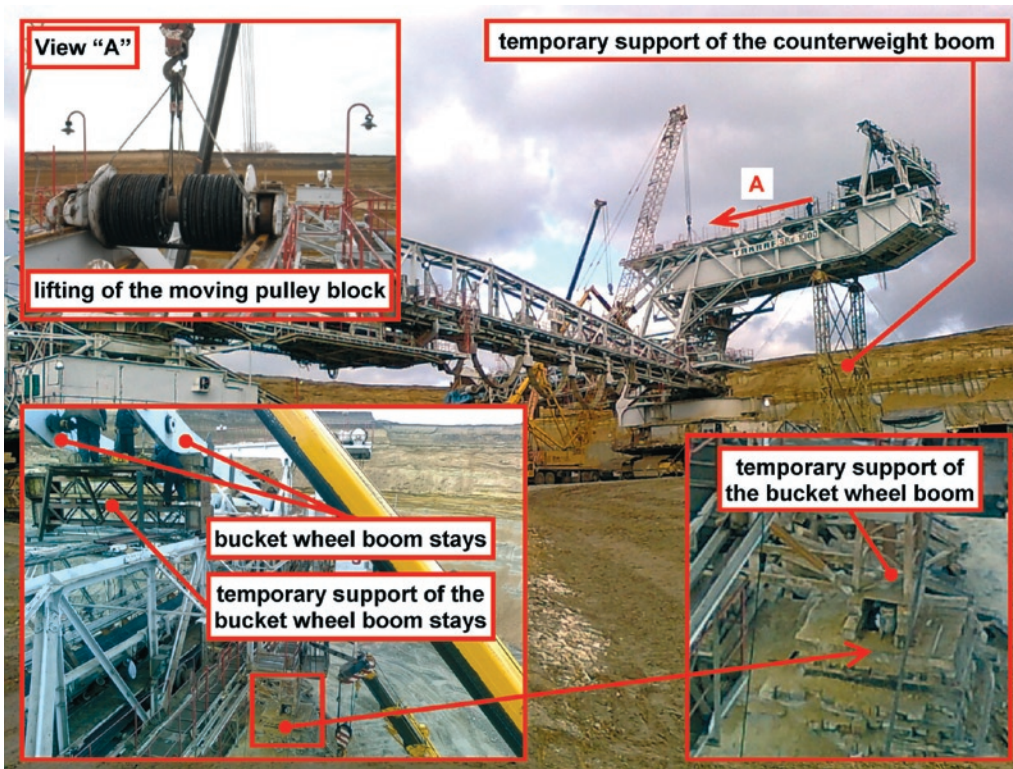
Fig. 3. Details of the BWE temporary supports and the dismantling of the BWB hoist system

supporting of the machine, dismantling of the BWE hoist system, testing and repair of the failed pulleys, testing of the rope and reassembling the BWE hoist system (Fig. 3, Table 1).

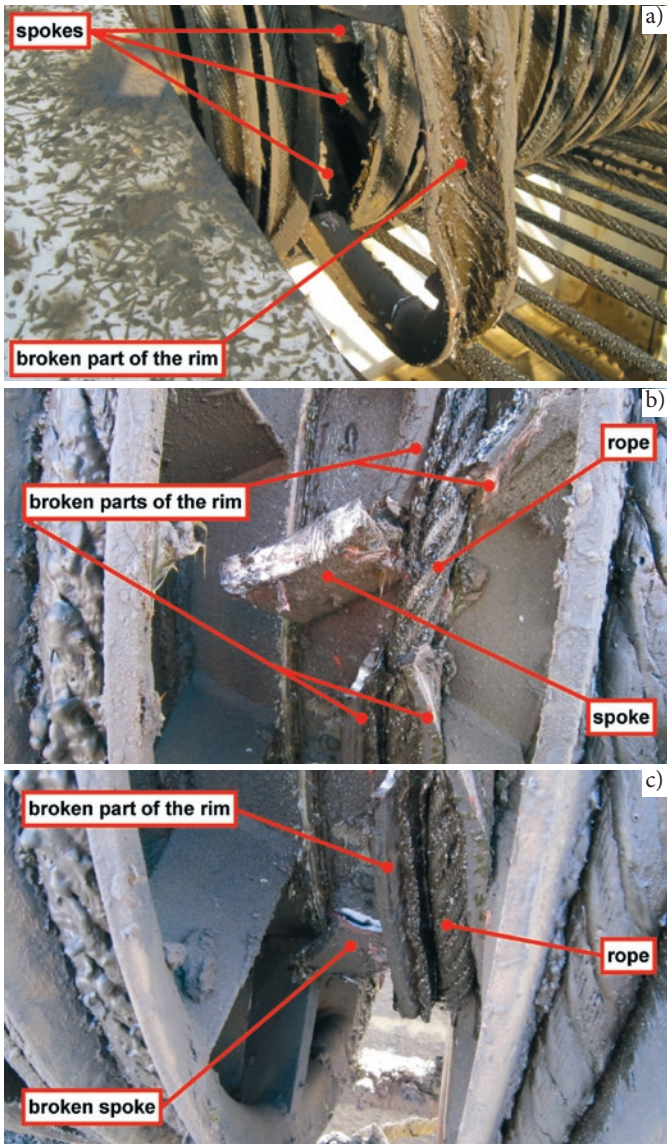
During BWE exploitation a failure of the welded joints of the spokes and rim occurred, which led to the plastic deformation and fracture of the rim (Figs 4a, b). Apart from that, plastic deformations of the spokes are observed (Fig. 4c) as well as fractures of their welded joints with the hub.

Fig. 4. Details of the fractured pulley: (a) front view; (b) back view; (c) view from below

Based on the presented results, it was concluded that the pulley fracture was caused by the ‘manufacturing-in’ defects. That is why it was decided to carry out the repairs of the pulley spokes’ welded joints, without modifying their design.

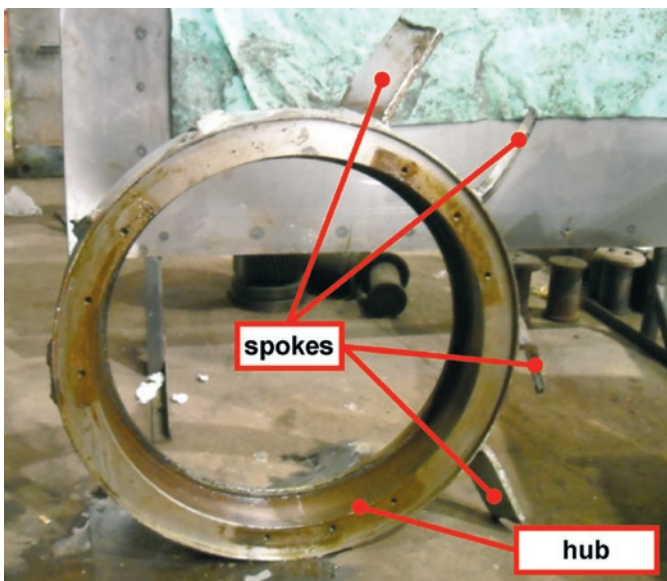
Fig. 5. A part of the damaged pulley used for sampling

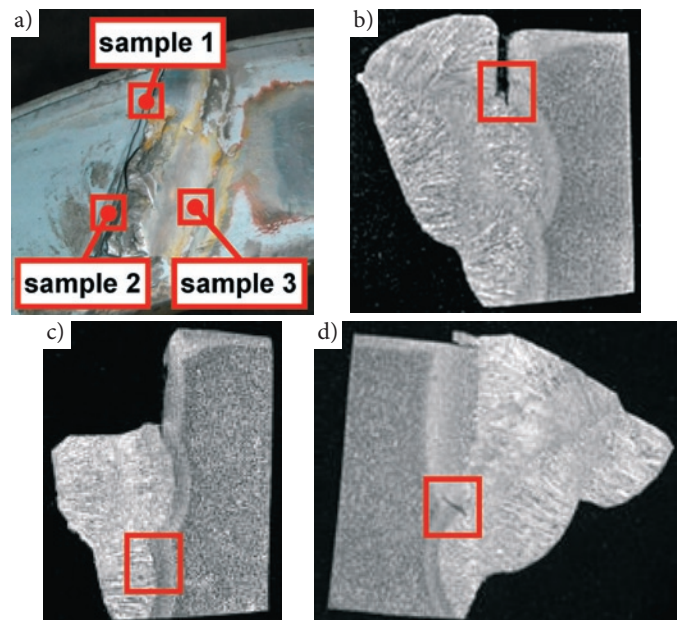
Fig. 6. Sampling zones (a) and samples: 1 – (b), 2 – (c), 3 – (d)

taken from the welded joint of the spoke and hub (Fig. 6). Grain sizes were determined using the standard [19], and the content of the non-metallic inclusions according to the code [20] (Figs. 7, 8).

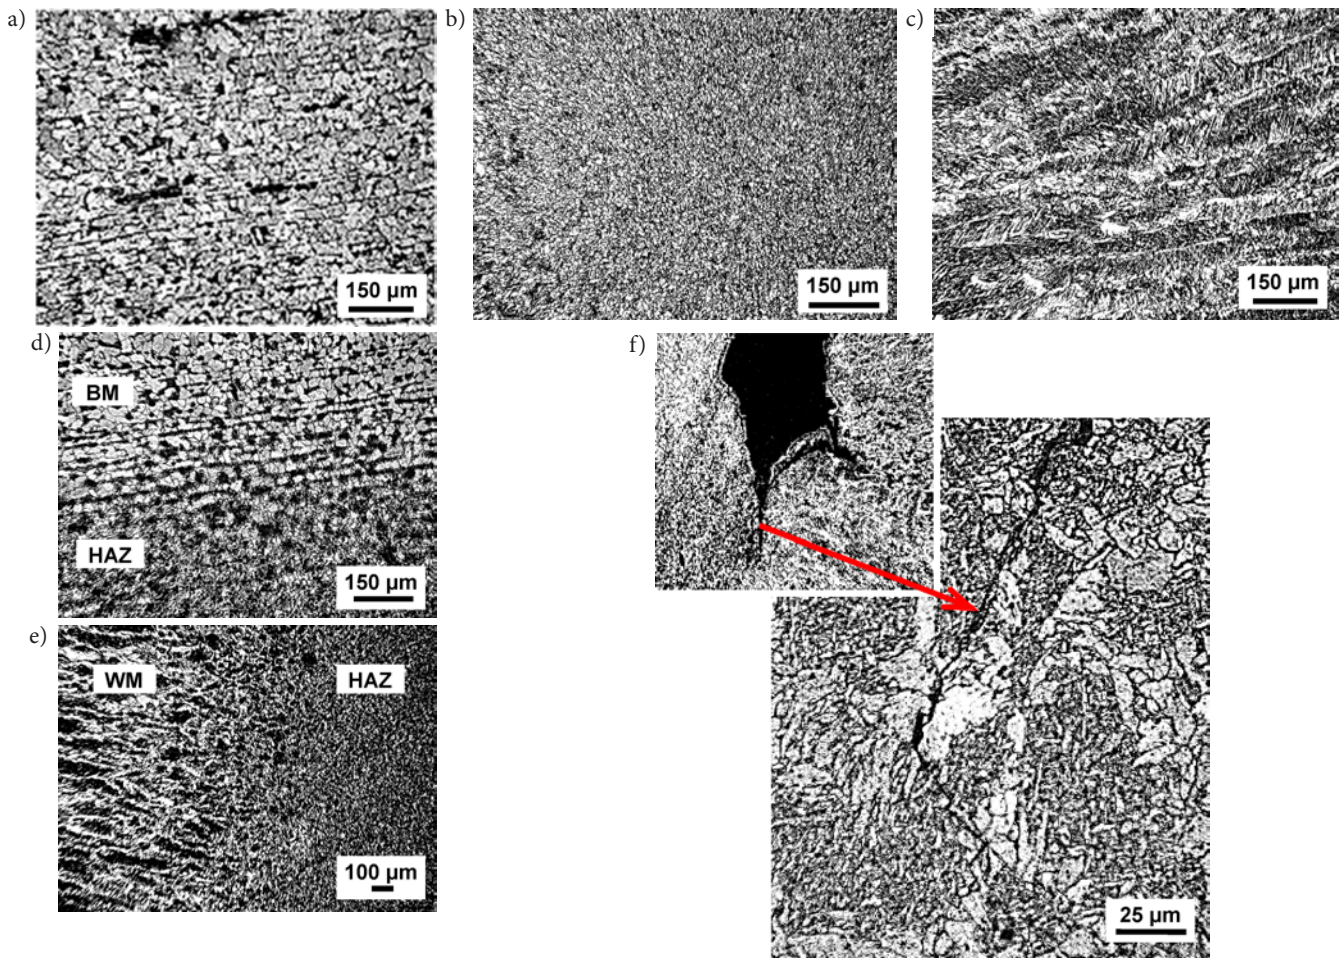
Fig. 7. Sample 1 (etched with 3% nital): (a) strip-type ferrite-pearlite microstructure of the BM, microhardness of 140–144 HV1 [27]; (b) fine-grained ferrite-pearlite microstructure in HAZ, microhardness of about 159 HV1; (c) casting dendritic microstructure of the WM, microhardness of 172–197 HV1; (d) microstructure on the verge of the BM and HAZ; (e) microstructure on the verge of the WM and HAZ; (f) tip of the crack (depth ≈ 4 mm, width ≈ 0.5 mm) and its propagation

Micrographic testing indicates the notably structural heterogeneity of the welds. BM has the strip-type ferrite-pearlite microstructure with non-metallic inclusions of both oxide and sulfide type (Fig. 7a). The microstructure in HAZ (Fig. 7b) is fine-grained ferrite-pearlite with fine-grained oxide type non-metallic inclusions. WM has the casting dendritic microstructure (Fig. 7c) because the appropriate heat treatment of the pulley welded structure was not carried out. Under fatigue loading the non-metallic inclusions in BM and HAZ may cause the appearance of initial cracks, whilst the dendritic microstructure of the WM indicates the tendency towards the brittle fracture. Poor manufacturing practice led to multiple welding defects – incomplete welding (Fig. 6b). Those defects significantly accelerate premature crack initiation by playing a role, from the welding point of view, as the local HAZ based weak link.

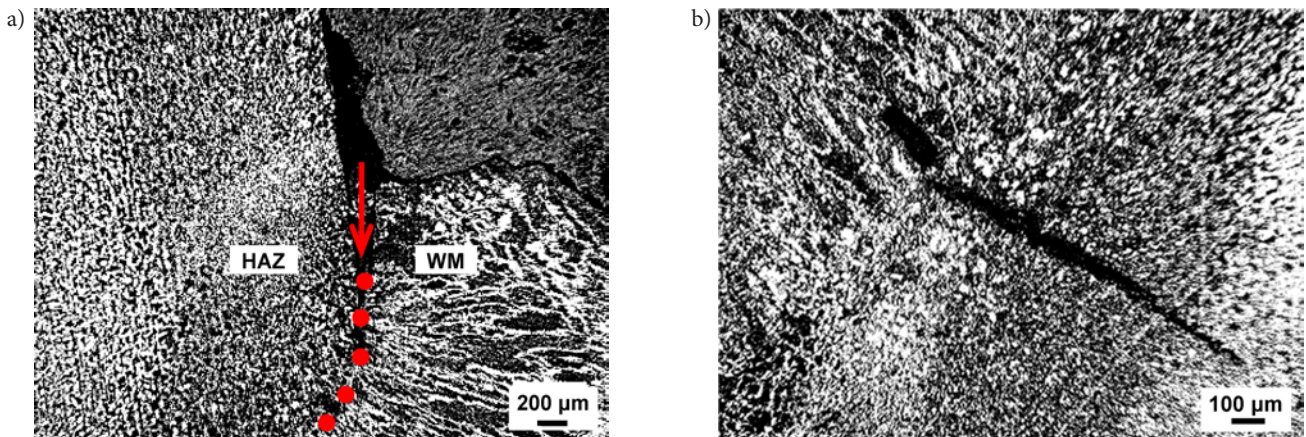
Fig. 8. (a) Crack propagation alongside the verge of the WM and HAZ, sample 2 (framed detail in Fig. 6c); macrocrack (total length of ≈ 1.5 mm) initiated in WM and its propagation through HAZ and BM, sample 3 (framed detail in Fig. 6d)

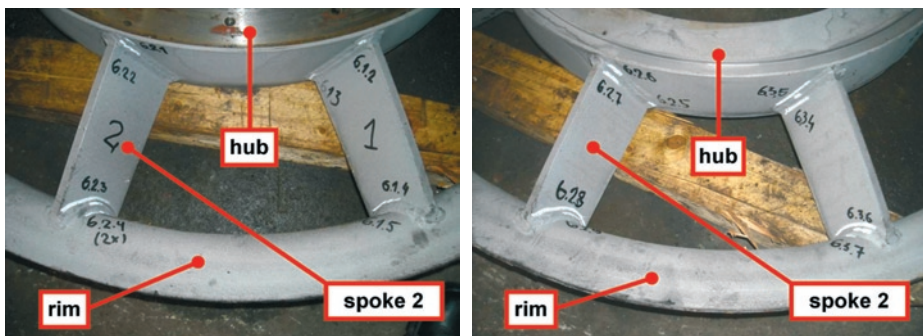
observed on all pulleys. They are considerably more pronounced on the welded joints of the spokes and rim than the welded joints of the spokes and hub.

Fig. 9. Typical MPI indications – pulley 6, spoke 2: (a) left side; (b) right side

Designation (a.b.c*)	6.2.1	6.2.2	6.2.3	6.2.4	6.2.5	6.2.6	6.2.7	6.2.8	6.2.9
Figure	9a				9b				
Length (mm)	15	30	80	20;30	25	30	40	100	55

The considerably more pronounced presence of the MPI crack indications at welded joints of the spokes and rim is the consequence of their geometry being more complex than the geometry of the welded joints of the spokes and hub.

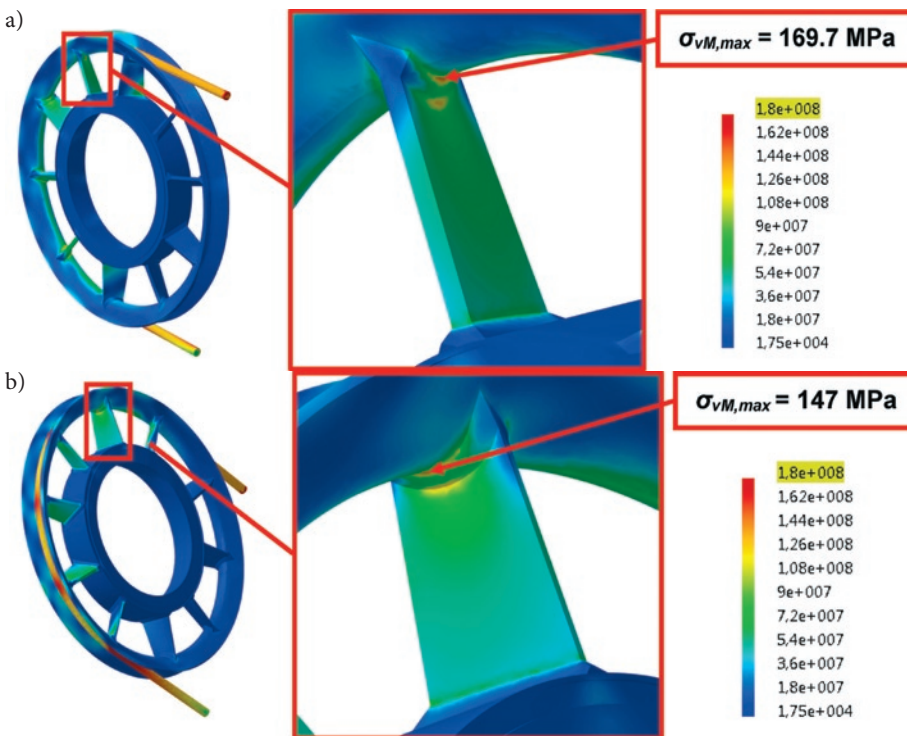
rope and the pulley was simulated by contact connection. Maximum values of von Mises stresses are obtained in the T-fillet welded connections of the rim (Fig. 15). The characteristic stress levels of the pulley load cycle during excavation for both considered LCs are presented in Table 7. For the maximum rope force (209.1 kN, Fig. 11) ob-

Fig. 15. The von Mises stress field obtained for $F_R = 191$ kN (the maximum rope force in LC HZ, Fig. 12)

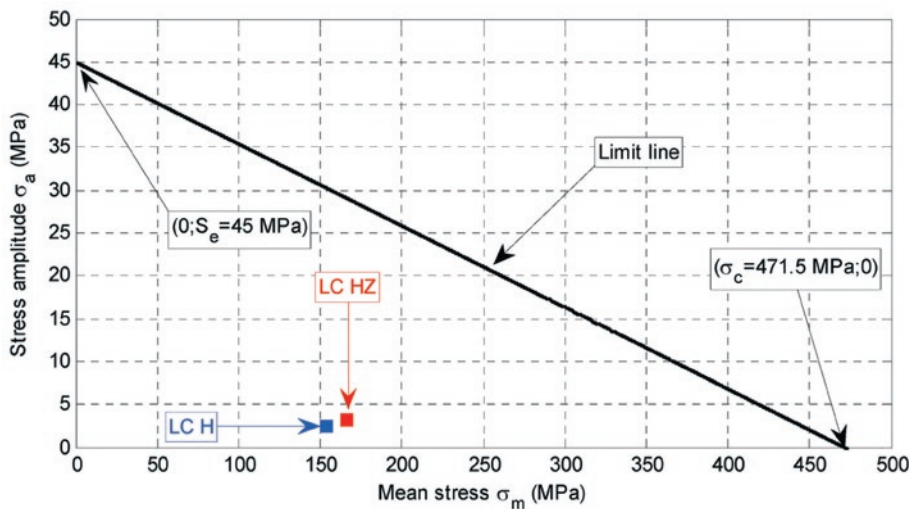
Fig. 17. The modified Goodman diagram

It is obvious (Fig. 17) that in both representative LCs the combinations of the mean stress and the alternating stress in the critical zone (Table 7) lie considerably below the limit line connecting the fatigue limit S_e and the tensile strength of the weld metal σ_c . Besides that, in the case of the maximum rope force obtained by using code [12], the maximum von Mises stress value ($\sigma_{vMmax,[12]}$) is 2.5 times lower than the tensile strength of the weld metal (σ_c , Eq. (1)).
