## Problem of Damage to Curved Switch Rails in Ordinary Turnouts

Marcin CZARNECKI<sup>1</sup>, Robert BIŃKOWSKI<sup>2</sup>

### Summary

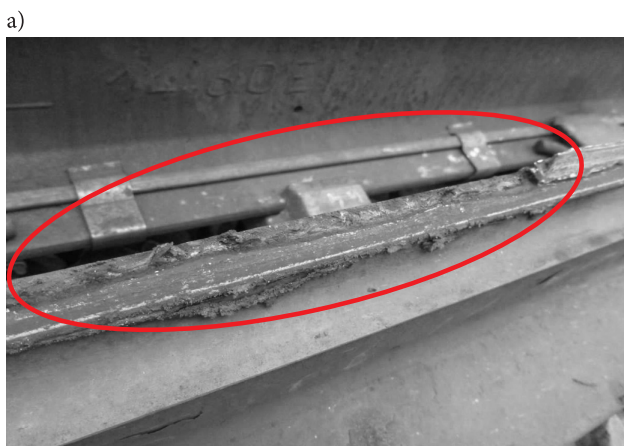
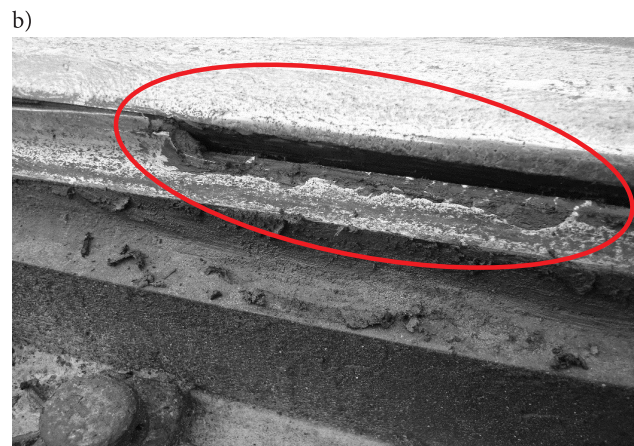
As already mentioned above, similar switch rail damage is a common feature of the analysed turnouts. In each of the three cases, such damage was characterised by spallings of material near the tip of the switch rail, which has arisen in each case at the same height from the foot of the switch rail profile (see Figure 3). In a zone adjacent to the decrement of material, propagating and developing cracks were spotted (see Figure 4). These cracks, in the case of further exploitation, would probably lead to expansion of the spallings of material near the tip of the switch rail. As there is no data about the load transferred by turnouts, the respective factor influence on the switch rail degradation rate cannot be determined. The found spall material (see Figure 5) constituted part of a switch rail, which broke away from the switch rail profile. However, the preserved spall surfaces indicated normal wear peculiar to interaction with rolling stock wheels.

Fig. 3. Damage to switch rails in the form of spallings of material a) and b) [photo. M. Czarnecki]

Existing spalls created a real hazard that the wheel flange would climb over the switch rail onto the stock rail and that the switch rail would be broken, consequently possibly leading to rolling stock derailment.

To avoid similar cases in the future, it is reasonable to use material with better mechanical properties than R260 steel, e.g. R350HT grade of steel, for the turnout switch rails for diverging tracks carrying high loads with high speeds of rolling stock. R350HT has a yield strength on the level of 700 MPa, which may cause a lowering of excessive wear and damages of the curved switch rails in ordinary turnouts. Moreover, precise fabrication and turnout assembling in the track, especially precise fabrication of the switch panel as well as continuous monitoring of the relative positioning of movable parts within turnouts, shall enable the switch rail damage hazard to be reduced.

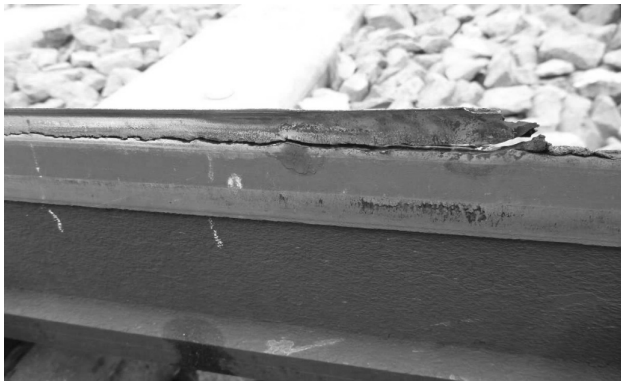
Fig. 4. Crack propagating near spallings of material of the switch rail [photo. M. Czarnecki]

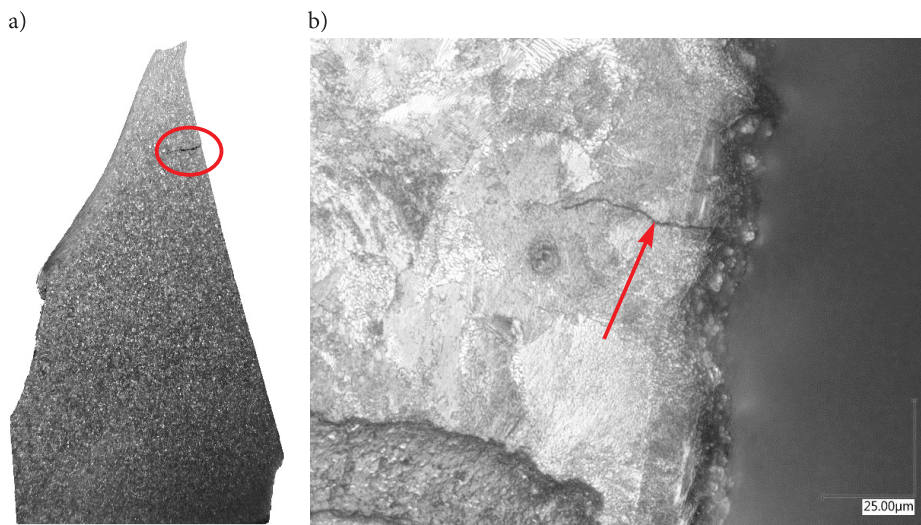
During microscopic tests, on samples which were taken near the damage, it was seen that the main crack was initiated on the switch rail and stock rail contact surface, then propagated deeper into the material (see

Figure 6a). Smaller cracks were spotted near the main crack. Smaller cracks, similarly to the main one, were initiated on the surface (see Figure 6b). This fact was also proven by magnetic particle inspection, which showed that discontinuities set themselves in a row located on one height (see Figure 7). Non-metallic inclusions located on the switch rail and stock rail contact surface could constitute places where cracks are initiated. They form potential structural indents where, in the point of contact between the inclusion and metallic body (rapid change in material properties), micro-cracks could arise, which as a result of further exploitation could merge together into one big crack. This can then lead to spallings of material and damage of the turnout switch rail. An example of the potential centre of material micro-cracks on non-metallic inclusions is shown in Figure 8.

Fig. 6. Part of the switch rail with a propagating crack (a), a small crack near the main one (b) [photo. M. Czarnecki]
