Research paper

Building condition ratings using infrared thermography: a preliminary study

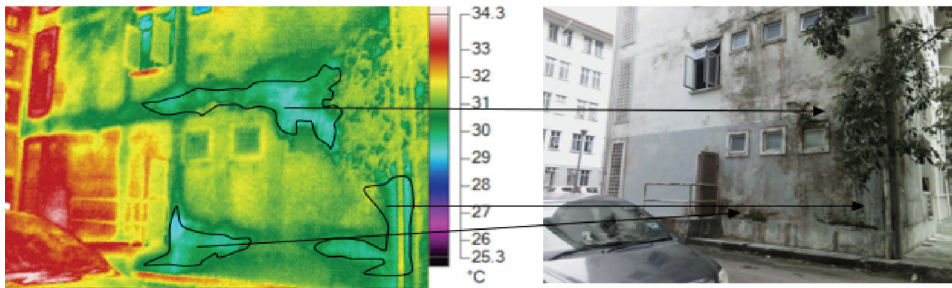
(a) Bathroom location

Figure 4 shows an example of the IRT findings that were obtained from the AA1 block of the case study. It shows a surface with temperature variations, where defects can be detected from the temperature difference. All 51 spots were analysed to determine their temperature

difference and their associated IRT rating. Meanwhile, Table 4 shows the overall results for the IRT method and visual inspection for the AA1 block of case study. From the results, IRT gave $\Delta T = 0^\circ\text{C}$ for 23 spots that gave no rating to the building envelopes. However, the visual inspection gives a score of 1, which indicates that there is an existence of a defect, which is the chipping paint and staining surface. It shows that the IRT cannot detect the chipping and staining surface defect as part of the temperature difference. However, it is believed that the defect, while observable, will not risk the building's functions. From the 51 spots, 28 spots were rated as having a rating of 1, which indicates a temperature difference of $4^\circ\text{C} \leq \Delta T \leq 6^\circ\text{C}$. Further verification was carried out, and it was discovered that there were defects of moisture, pigmentation and shrinkage cracking on the surface, resulting in a rating of 1. In addition, a rating of 2 was assigned to the spots due to shrinkage cracking with joint crack and dampness.

Fig. 4. Examples of IRT findings at the respective block AA1

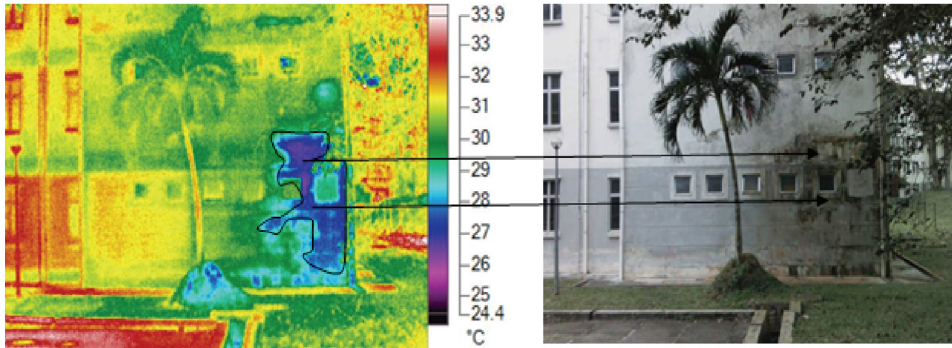
(a) Bathroom location

Figure 5 shows an example of the IRT findings that were obtained from the BB2 block of the case study. All 67 spots were analysed to determine their temperature difference and their associated IRT rating. From the results, IRT gave $\Delta T = 0^\circ\text{C}$ for 27 spots that gave no rating to the building envelopes. However, the visual inspection gives a score of 1, which indicates the existence of a defect, which is the flaking paint. It shows that the IRT cannot detect the flaking defect as part of the temperature difference. However, it is believed that the defect will not affect the building's functions as it is still observable and will not impair its functions. From the 67 spots, 40 spots were rated as having a rating of 1, which indicates a temperature difference of $4^\circ\text{C} \leq \Delta T \leq 7^\circ\text{C}$. Further verification was carried out, and it was discovered that there were defects as a staining surface and dampness, resulting in a rating of 2 but only shrinkage cracks, which were indicated as a rating of 1. Therefore, it shows that the IRT method still underestimates the defect rating. However, it shows a maximum temperature difference of $\Delta T = 7^\circ\text{C}$, approaching 10°C .

Fig. 5. Examples of IRT findings at the respective block BB2
