TOMASZ SIOSTRZONEK
PIOTR TRÓJCA
JAKUB WÓJCIK

Winding machine additional overload state indication as supporting solution for mine shaft hoist operators

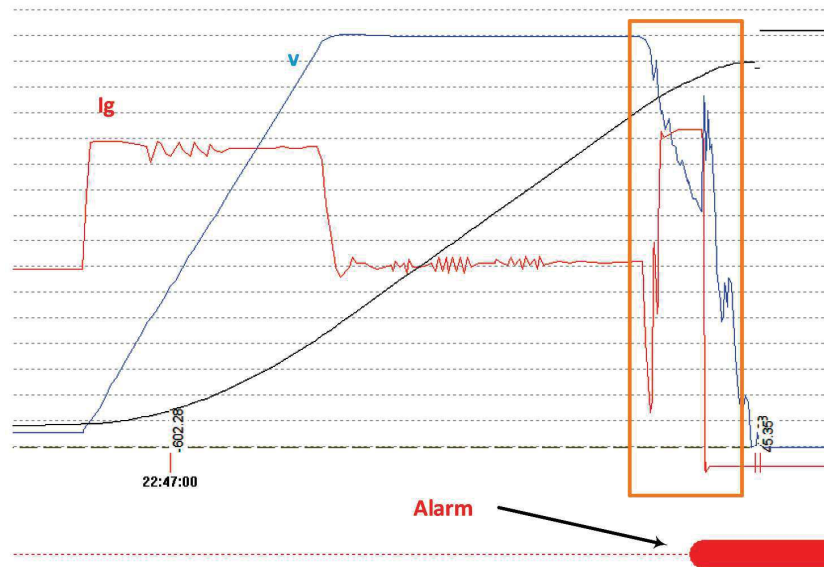
Fig. 4. Logger data during incident

In the case of stopping Vessel No. 2 by the construction of the spill bunker, the load torque suddenly decreased.

The regulation system behaved properly. The current value dropped down to rise to its maximum value limited by regulator settings. At this point, the machine became a single-end machine. After this, the second vessel release skip went into a freefall. This caused its speed to rise above the permissible value and the machine to be switched off due to exceeding the maximum limit.

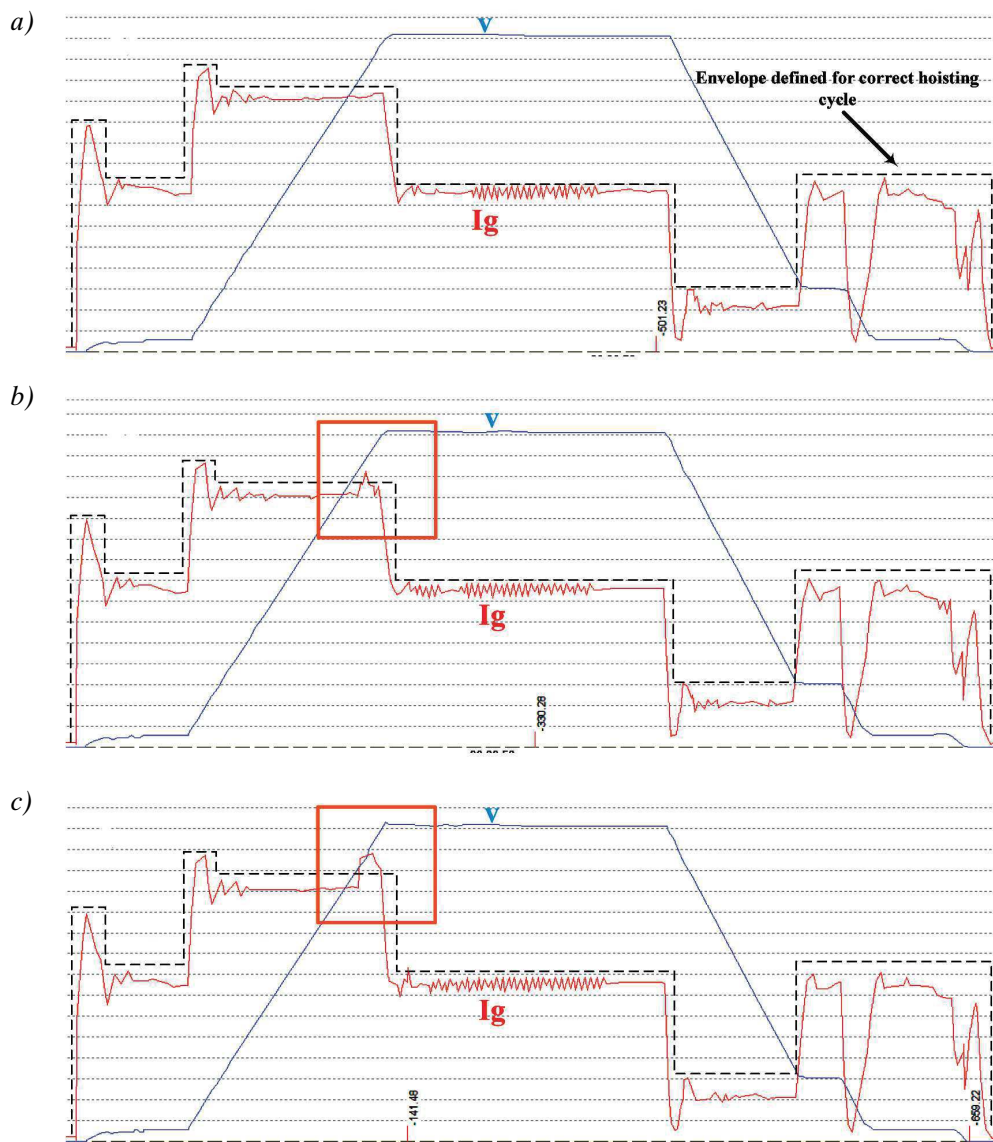
Fig. 5. Main circuit current I_g and vessel speed v waveforms – data acquired from AR-3c logger: a) no disturbances visible (correct waveforms); b) three cycles before incident; c) cycle directly before incident

The ten cycles preceding the incident were analyzed. Further than three cycles before the event, no disturbing changes in either the current or speed can be observed (Fig. 5a). For each form of the current waveforms in Figure 5, the envelope was applied on the basis of the normal course, which is information regarding whether there was an anomaly in the system. Three cycles before the occurrence of the event, an increase of approx. 500A in the main circuit current is visible above the value set for this fragment of the hoisting cycle. The full Vessel 2 was ascending during this time. It can be concluded that the vessel was already in contact with a deviated design of the adjacent compartment tank. The operation of the shaft station devices suggested that disturbing noises were heard in the mining shaft. In the cycle preceding the event, the increase in current when passing the vessel in the vicinity of the tank was already at 900 A and lasted much longer (Fig. 5c).

On the basis of the analysis of the winding machine logger data, it can be stated that it was possible to detect the symptoms of an impending threat earlier. For several cycles before the incident, it was possible to observe anomalies in the course of the main circuit current. The current changes were caused by a variable load torque resulting from the appearance of an additional obstacle to Vessel 2.

It is not possible to detect this type of anomaly only by observing the current waveforms on the driver's desk or in the logger. To properly respond to such irregularities, it would be necessary to place an addi-

tional indicator of such a state on the driver's desk as well as appropriate changes in the regulations [5].

In the form of a visual signal (a glowing lamp) placed on the driver's desk, this indicator would be activated when the permissible value of the current is exceeded by the assumed value for a given fragment of the driving diagram. If established in double-compartment shafts with different levels of extraction, it would require the service staff to take control actions in case of its activation.
