# Reinforcement of cracked hollow-core slabs during the construction of the building

Romuald SZELAĞ<sup>\*1</sup>,

<sup>1</sup> Faculty of Civil Engineering and Environmental Sciences, Białystok University of Technology, Białystok, Poland

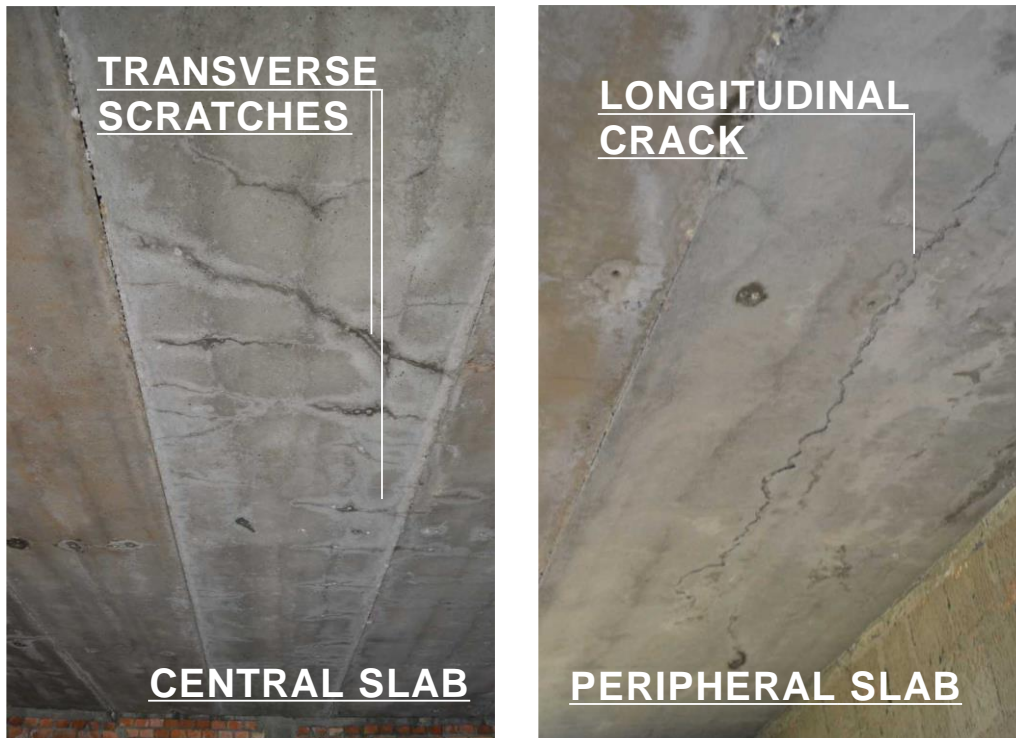
The occurrence of damage to hollow core slabs in newly erected buildings becomes a problem due to the reliable determination of their causes. A typical picture of damage observed in the area of prefabricated hollow-core slabs included their lower surfaces in the form of scratches and cracks. The defects took a course perpendicular or parallel to the length of the boards and may cover only the middle zones of the boards or their entire surface. Examples of damage that properly illustrate the described damage pattern are shown in Fig. 1.

Figure 1. Examples of defects (cracks and scratches) on the bottom surfaces

The most common damages are scratches with a course similar to transverse, covering more than a single element. The width of the cracks is varied and it is difficult to clearly indicate their border, however, in most cases it was in the range of  $0.1 \div 0.3$  mm, and in some ceilings it was up to 0.5 mm. Scratches are often clearly visible due to moisture accompanying the penetration of rainwater through the surface of the ceiling. Longitudinal scratches have a different course because they cause a crack which may be accompanied by a shift of adjacent fragments resulting from different permanent deflections.

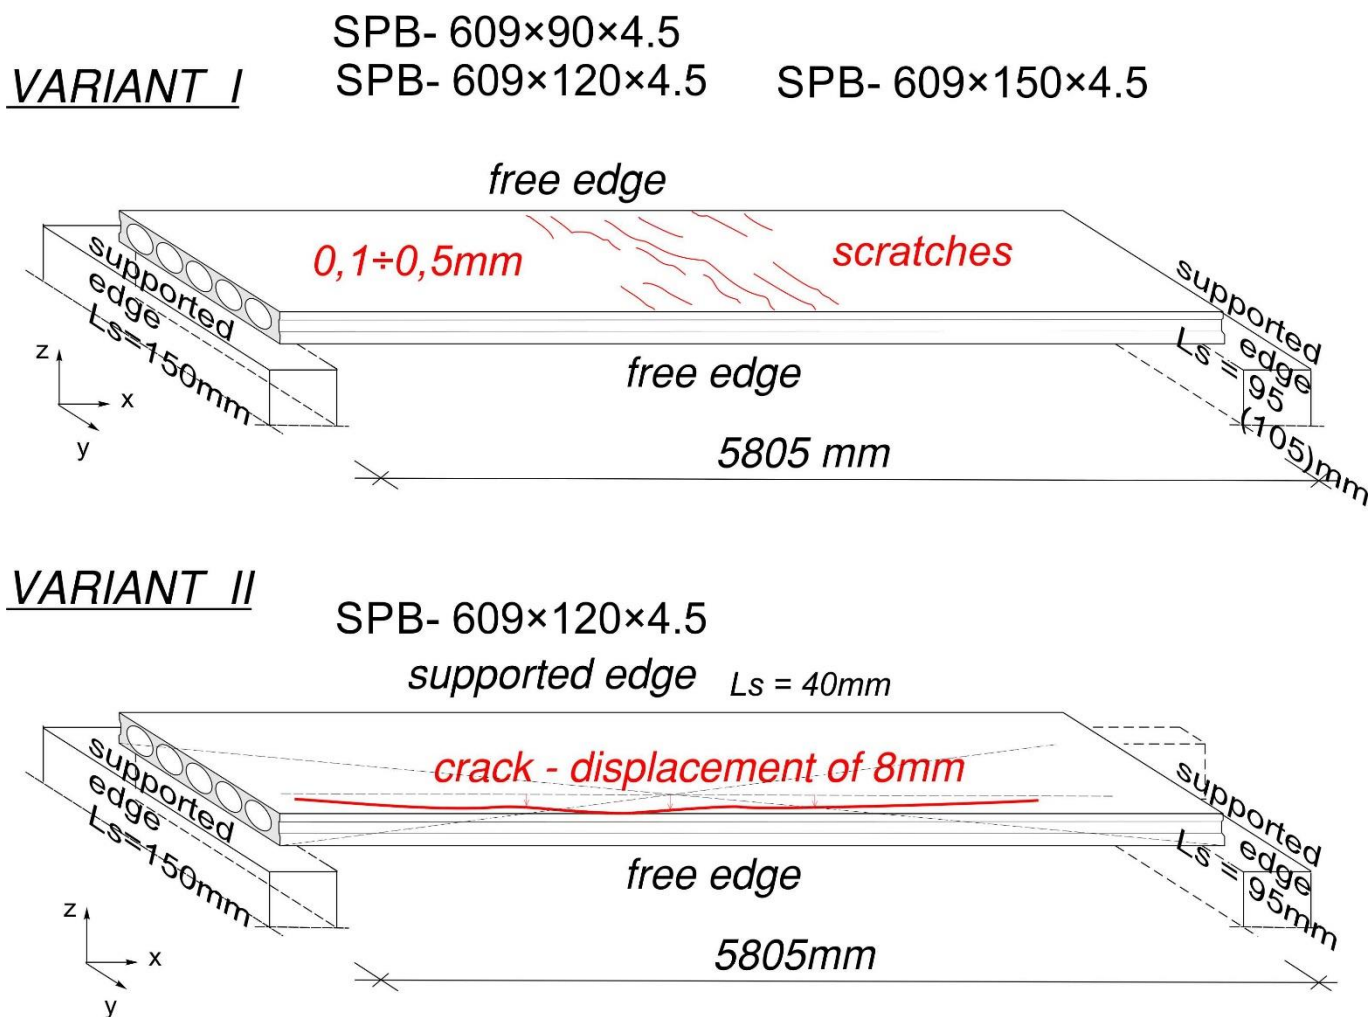
In order to assess the load-bearing capacity of the slabs, it is necessary to carry out tests and measurements to obtain the necessary technical parameters. The analyzes begin with determining the depth of the slab supports on the structural walls constituting the supports. The depth of the panel supports on the wall should be greater than the minimum value of 50mm, which results from the construction requirements. Prefabricated hollow-core slabs are unidirectional elements, therefore they should have shaped supports on the edges perpendicular to their length. The calculation model is a slab strip corresponding to the width of a single prefabricated element, which, after filling the joints between the slabs, becomes a one-way reinforced ceiling. The nature of the defects is usually related to the shaped schemes of the elements' support. In the conditions of proper implementation of the Variant I backrests, the cracks were located in the central zone, and in the case of an additional support, along the longitudinal edge of Variant II, longitudinal cracks may occur in conditions close to half the width of the element. The global nature of the damage correlated with the boundary conditions is shown in Fig. 2.

Figure 2. Support model and fault location on external surfaces

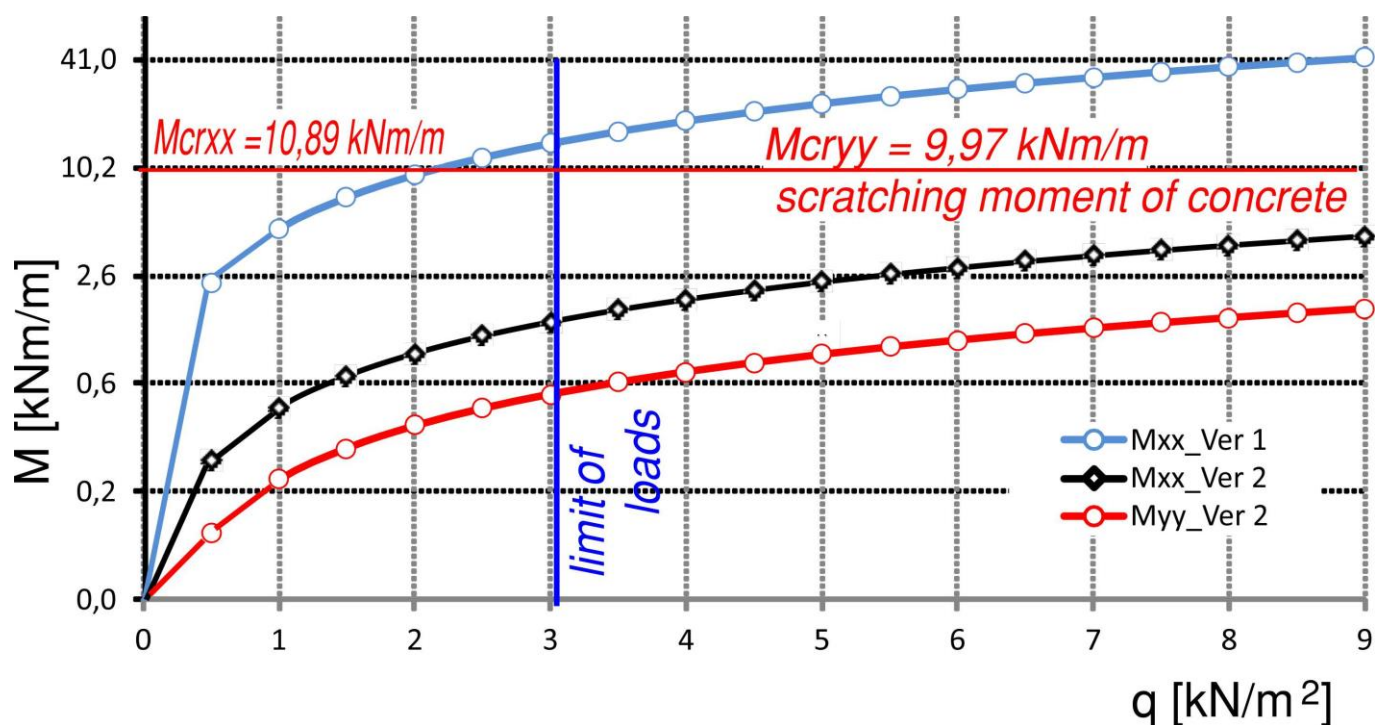
cause of cracks in the conditions of the target load of the ceiling, and not during the construction process. The analysis based on the provisions of the standard [2] of the span bending moments of the slabs, which are responsible for the nature of damage, in two support schemes showed that for the existing load level, the values of internal moments may cause the first cracks in the scheme according to variant 1. On the other hand, cracks, and even more cracks cannot occur in the conditions of supporting the panel on three edges, variant 2. The results of the analysis are presented in Fig. 3.

Figure 3. Slabs bending moments in correlation with external load and drawing moment

An extended analysis for variant 1 showed that the crack width should not exceed 0.1 mm, regardless of the width of the elements, and the distance between them should be about 300 mm. The actual nature of the cracking of the elements and their intensity is different and the performed calculations do not properly explain their causes. Despite the use of an insufficient cross-section of slab reinforcement, the expected damage should be less intense and longitudinal cracking should not occur.

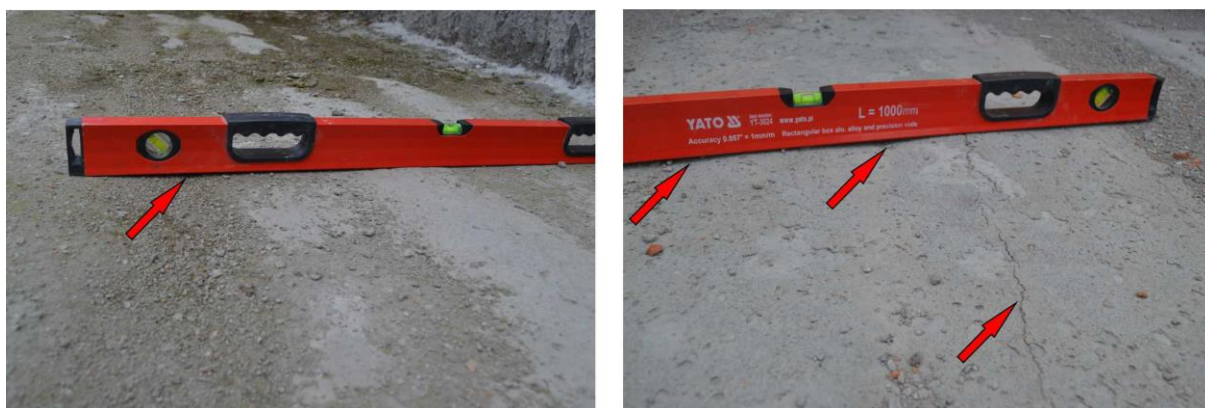
Figure 4. Disadvantages of the process of forming elements, collapse of concrete in the zones of channels and local longitudinal scratches

Defects committed in the technological process additionally weaken the elements, causing a change in the position of the concrete compression zone, which also reduces the load capacity of the elements. The arm of internal forces between the stretched bars of the lower zone and the compressed concrete surface, being reduced due to deformation, causes a drop in the load capacity of the element, which was set at several percent. The identified defects in the process of forming elements also turned out not to be the cause of numerous scratches and cracks observed on the surfaces of the lower plates.

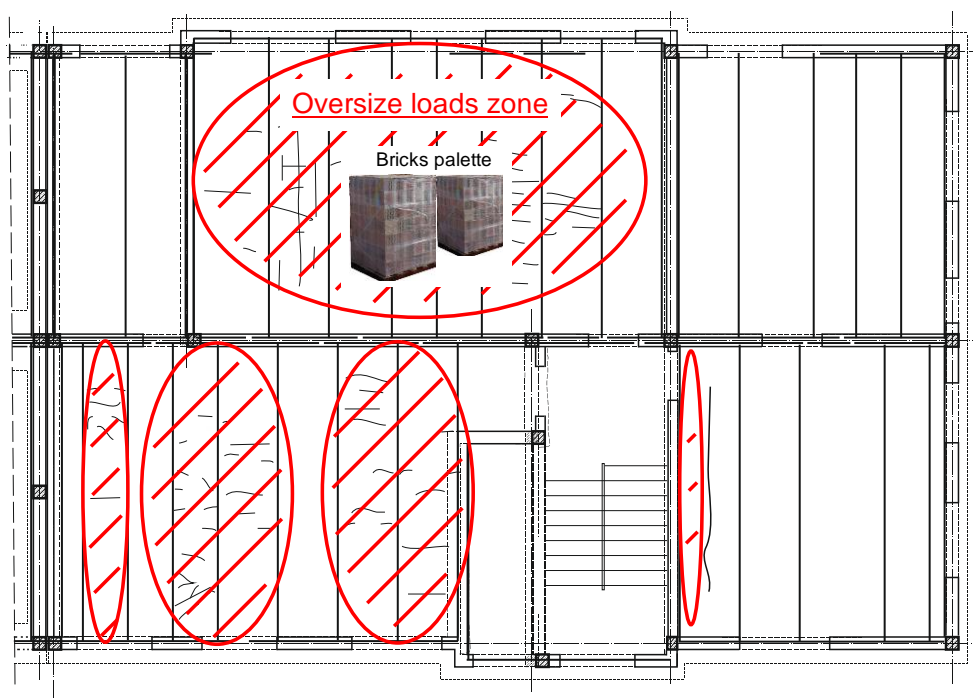
In the analyzed situations, the cause of damage resulted from errors made during the process of erecting the building and storing wall materials directly on the ceilings made of hollow-core slabs. It turned out to be important that after the ceilings were made, the process of continuing construction works on erecting the facilities included the construction of structural walls from small-sized wall elements. If you analyze in detail the process of using materials to make the walls of the next floor, for example from ceramic hollow bricks with dimensions of  $188 \times 250 \times 220$  mm, it will turn out in what quantities they should be delivered directly to the place of laying. To make the walls of the next storey, 2.60 m high, more than 5,000 elements should be used in multi-family housing, which are delivered to the construction site in pallets of 112 pieces. Based on the data of the manufacturer of wall elements, it was determined that the weight of a single pallet is 1050 kg. When erecting buildings, in order to speed up the construction process, pallets are usually placed locally on the ceilings, from which the elements are taken directly to build the walls.

Figure 5. The zone of presumable collection of blocks for erecting walls

The common image of panel damage during the construction of buildings, which could not have been created for other reasons, indicates that the pallets were placed on the ceilings in zones where scratches and cracks occurred, Fig. 5. The one-time number of pallets stored on the ceilings cannot be clearly determined, therefore a simulation was carried out the effect of a single and two pallets placed on the ceiling. Setting one pallet around the center of the span of the hollow-core slab leads to an increase in the crack spacing to about 0.22mm with the distance between them being about 20cm. For two pallets placed next to each other in the area of the middle of the panel span, the crack spacing would increase to a value of approximately 0.56÷0.61mm, depending on the width of the prefabricated panel. The number of damages occurring in the elements proves that once on the surface of the ceilings material was accumulated in an amount exceeding their load-bearing capacity, which consequently led to their permanent scratching. Calculation simulations in relation to the scale of defects indicate that in most cases, about half of the number of pallets with the material necessary to make the walls was stored on the ceilings at one time. Longitudinal cracks in the slabs resting on three edges were, in turn, caused by placing two pallets directly next to the erected wall. The result was an increase in bending moments in the perpendicular direction  $M_y$  and in the absence of appropriate reinforcement in this direction, both fragments of the slab element disintegrated.

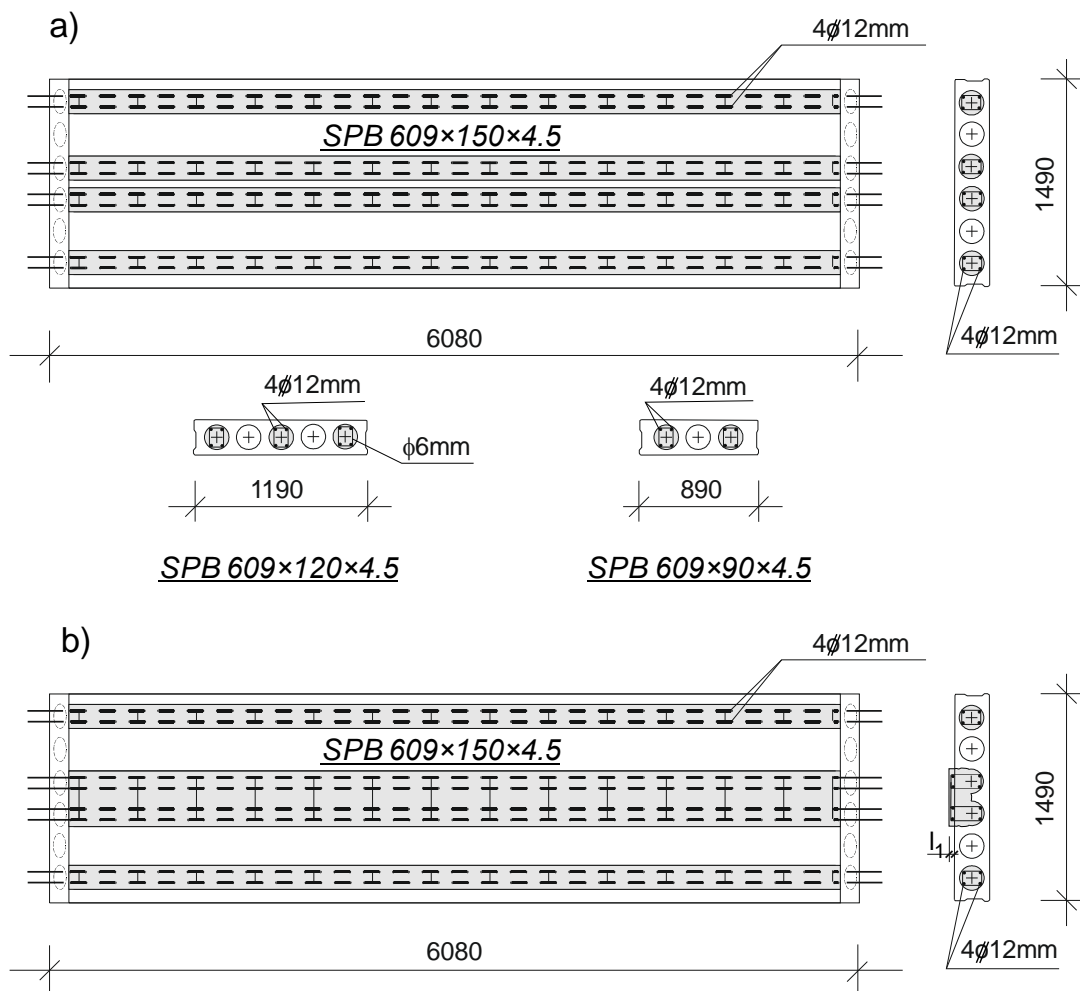
Figure. 6. Reinforcement concept for cracked hollow core slabs.

a) transverse cracks, variant I; b) longitudinal cracks, variant II

the middle of the span exceeded  $a = 10\text{mm}$  was provided. In the process of restoring the original shape, the use of intermediate supports stabilizing the structure of the slabs in a non-deformed position was provided. After the preliminary works prepared in this way, it was planned to open the channels from the top and make reinforced concrete beams in them with a circular cross-section, Fig. 6a, or similar to a rectangular one, Fig. 6b.

Before implementing the reinforcement, the exposed surfaces should be cleaned of contamination and then moistened with water. Reinforced concrete cores reinforcing the cracked prefabricated slabs were made of concrete class C30/37, reinforced with 4 bars  $\phi 12\text{mm}$  in the area of each of the circular fields, exposure class XC3 for environmental conditions [2]. The stirrup bars used in the reinforcement process are  $\phi 8\text{mm}$  in diameter and spaced every 25cm. The dimension of the height of the reinforcement  $h$  in the event of longitudinal cracks depends on the floor surface finish and should be correlated with the designed layers. In typical solutions, when the insulation is placed on ceilings 5 cm thick, this dimension may correspond to the thickness of the insulation.
