Röwekamp, Marina

GRS gGmbH, Köln, Germany

Operating experience with hydrological external hazards and their potential safety significance

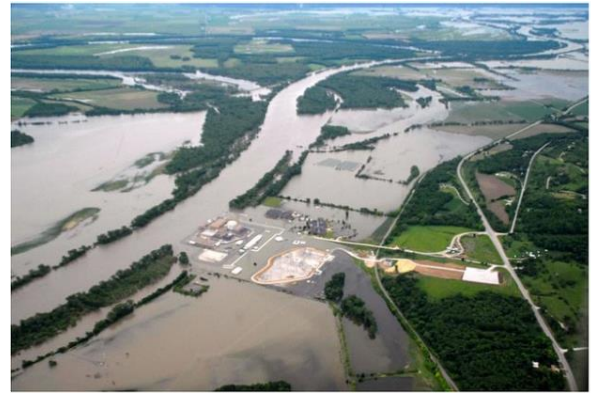
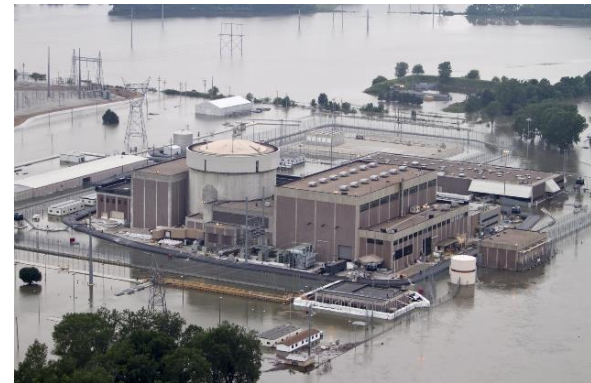
Figure 1. Fort Calhoun NPP site during the Missouri flood in 2011.

Fort Calhoun was designed for floods up to 1014 ft (309 m) above sea level. Berms and temporary AquaDams had been installed around Fort Calhoun's main plant buildings as well as the electrical switchyard and administration area.

On June 26, 2011 one part of an AquaDam suffered a puncture (attributed to work at the plant site) allowing

water to enter and to surround some of the plant buildings as well as the unit transformers. This prompted the staff to disconnect the plant from the offsite grid and to establish the energy supply of the plant safety systems from on-site diesel power by means of the diesel generators. This status remained until all the equipment checks confirmed that it was safe to terminate diesel power operation and to reconnect to the offsite grid. The NRC confirmed that cooling of safety relevant equipment was not impaired and that no water had entered the reactor building. Then, during the following weeks, the plant remained in safe shutdown throughout the event.
