Reinforcement solution of damaged load-bearing frame structure in a coal power plant for additional loads

Abstract: Significant subsoil deformation and additional loads from the new denitrification unit caused a major problem with the load-bearing capacity of the coal power plant. It was necessary to perform an advanced assessment of the technical condition of the structure. Laser scanning (LiDAR) were used to obtain detailed data upon structure. Based on the analysis of the point cloud, the location of the column axes was determined, which allowed to determine the global and local displacements of the structure. Spatial models of the structure were created. Non-linear analyses of the structure were carried out using two types of models: 1) global beam-shell 3D models of the boiler room used to calculate the magnitude of internal forces and deformations of the structure; 2) local beam-shell detailed models of selected structural elements. Based on the results of the calculations, necessary reinforcement of the structure was designed and successfully implemented. Advanced analysis of the structure using laser scanning, subsoil monitoring and complex numerical models made it possibl

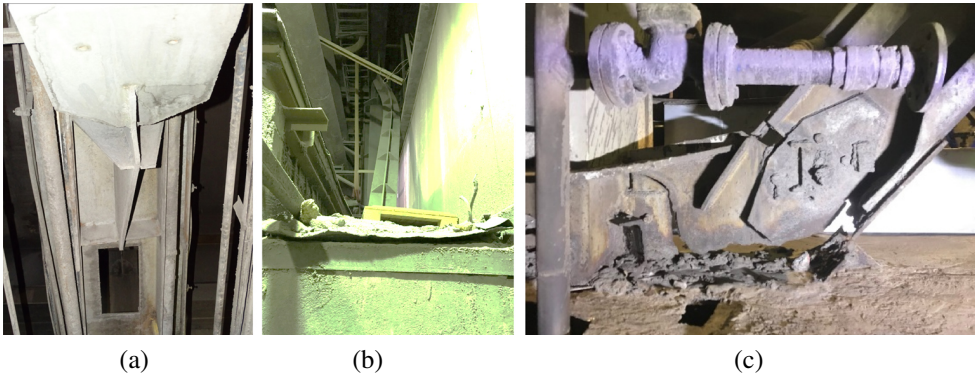
The structural analysis was performed not only due to planned works described in Section 1 but also due to numerous existing structural damages. The damage was particularly evident in the cross-braces of the vertical tie systems. The analysis of existing damages allowed to group them into three categories: (i) local loss of stability of members, (ii) global loss of stability of members and (iii) local damages for example rupture of tension members. Examples of damages are presented in Fig. 4.

Fig. 4. Damages of the steel structure: a) buckling of gusset plate, b) buckling of a bracing member, c) ruptured of bracing at the node

- ruptured bracing connection should be strengthened;
- struts that exhibited buckling should be reinforced or replaced;
- struts that is likely to buckle and whose location means that there is no substitute system capable of supporting the horizontal load must be reinforced. If there are several bracings in the same axis at the same level, the limit state of the bracing system determines the qualification for strengthening. Some members are allowed to buckle if the global stability of the structure is maintained;
- in the bracing of horizontal planes, connections and some members must be reinforced so that the global stability of the structure is maintained;
- overloaded columns should be strengthened by increasing the cross section.

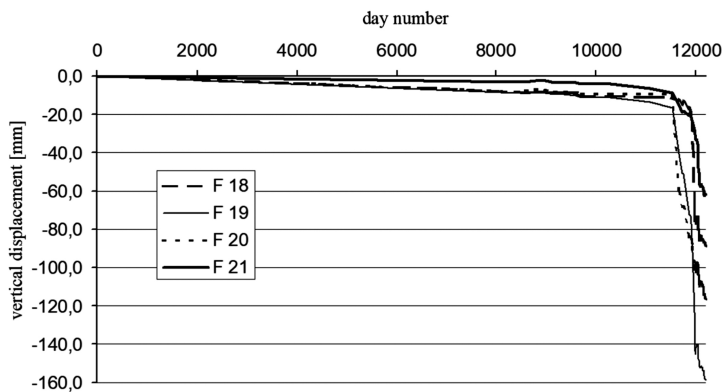
The ground settlement propagation is measured in number of days in reference to the initial state, which is described as day zero. Fig. 5 shows the development of the column settlement in selected row F of block 6 over a period of more than 33 years of operation of the facility. It can be clearly seen that after about 32.5 years of operation, there was an unexpected sharp increase in the displacement of the supports. In the period of two months from day 11907 to 11976, the settlement in some places (e.g. column F19) reached 7 cm [24, 25]. The degree of settlement of the subsoil can be described as sudden. It became the cause of numerous damages to the steel supporting structure and building's equipment.

Fig. 5. Vertical displacement of the F row columns in block 6 from day 0 to 12193

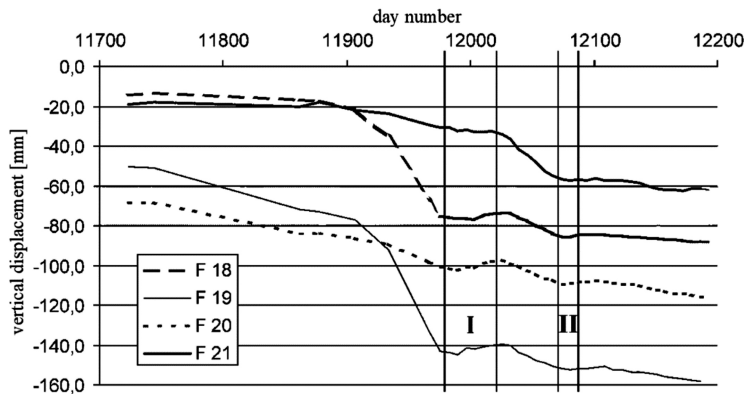
The immediate repair works included stabilizing of the ground and temporary shutdown of the block. The results of these actions are presented in Fig. 6. For the same F row columns, the most intensive settlement is shown compared to two periods when the block was out of operation. Apart from the damage to the building, the boiler system, especially technological pipelines, got significantly deformed. The decision to shut down the boiler was necessary for safety reasons and to repair the deformed system. Additionally, coal mills were also shut down. The coal mills are a major source of vibration generated in the ground near the boiler room. The presence of these vibrations can be attributed to the poorly executed stabilization, which was conducted as soon as signs of settlement were discovered. Only the second shutdown of the boiler led to a significant slowdown of the settlement process. The data collected to date indicate that the uneven settlement continues, but with significantly lower rate.

Fig. 6. Vertical displacement of the F row column in block 6 from day 11739 to 12193 with visible effect of the operation stoppage at period I (days 11982–12019) and period II (days 12072–12086)

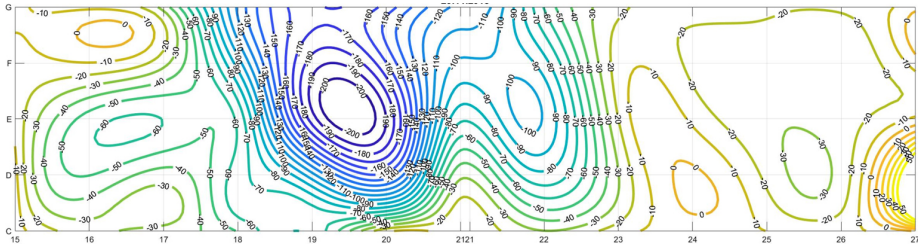
Fig. 7. Contour map of subsoil settlement

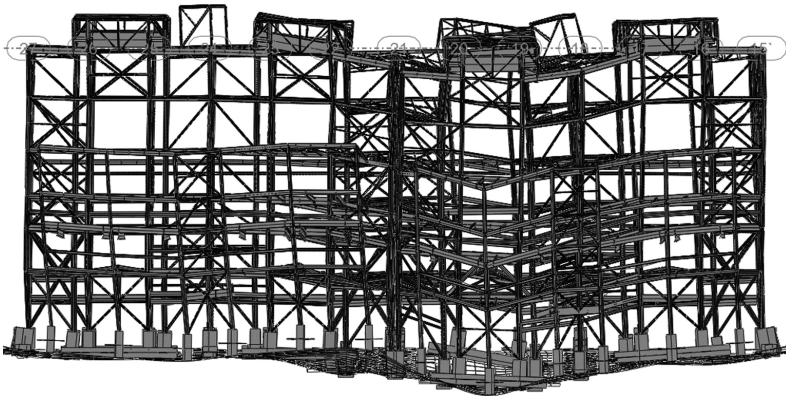
Fig. 8. Deformation of the structure caused by the settlement

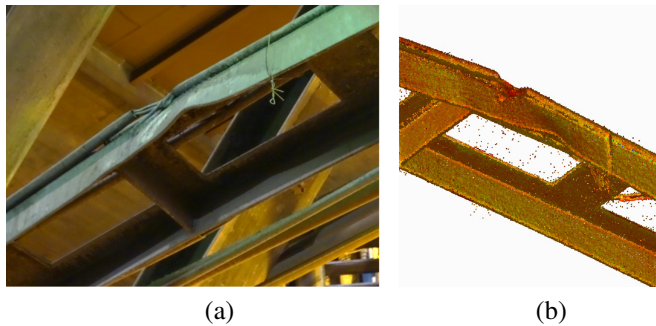
Fig. 9. Comparison of a real-life photo of damaged member with a model from point cloud data: a) photo of a local buckling, b) laser scanning model

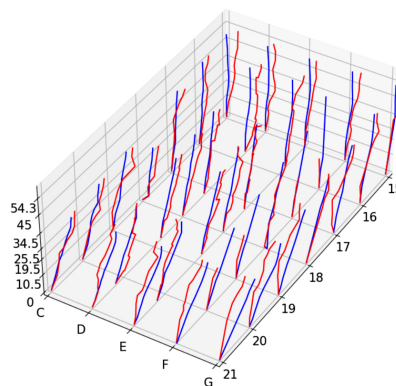
Fig. 10. Comparison of global state of deformation of columns in the area of blocks 5 and 6 obtained by laser scanning with deformations obtained in numerical way (blue – numerical analysis, red – laser scanning)

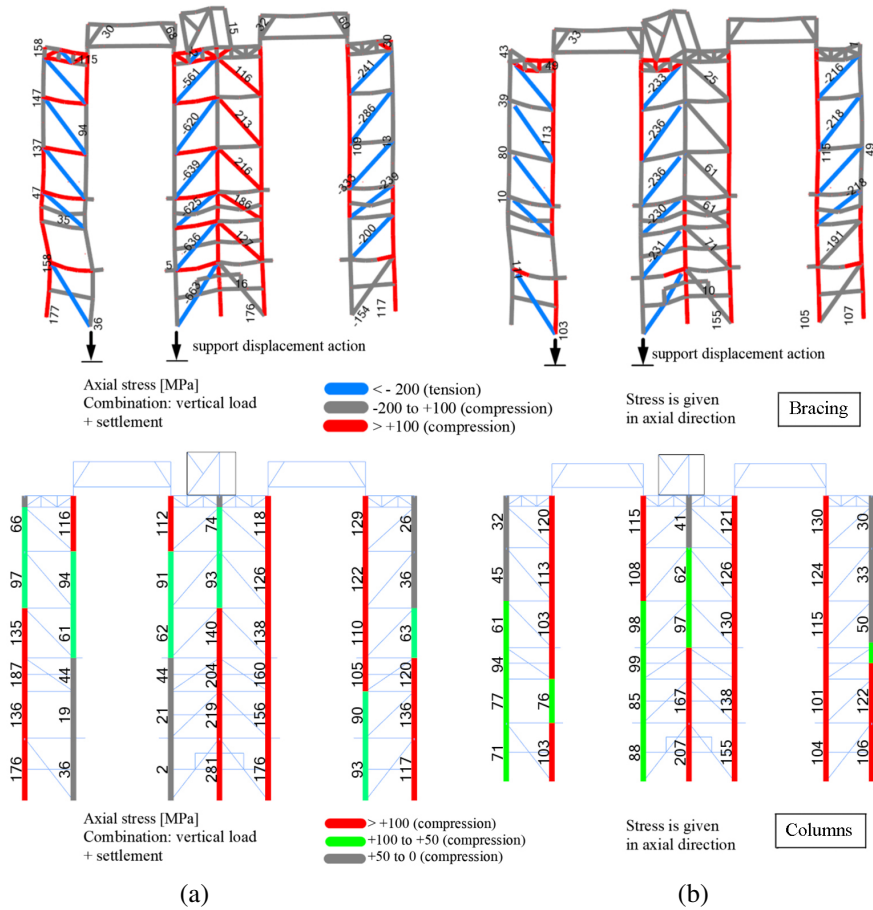
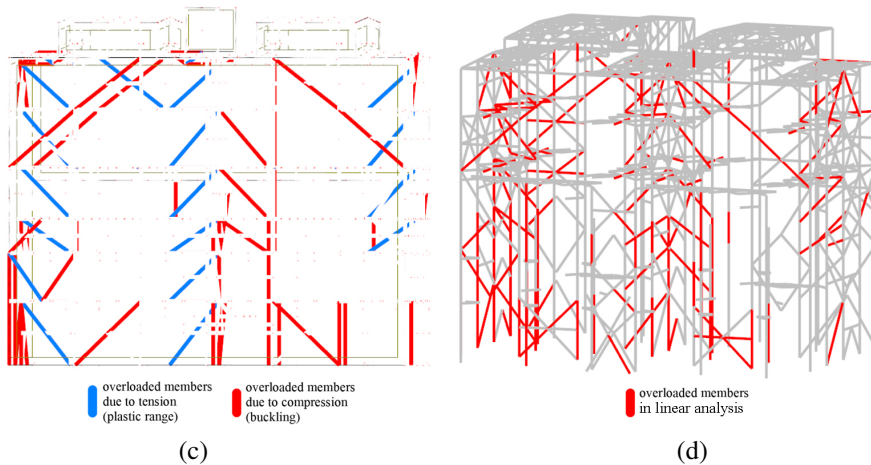
Fig. 11. Comparison of the linear and non-linear analysis: a) linear analysis, b) non-linear analysis, c) linear analysis – overloaded members, d) Members with exceeded load-bearing capacity

elements which show significant exceedances of the load-bearing capacity conditions in the case of linear analysis are presented. The significant exceedances of load-bearing capacity shown in the linear analysis did not reflect the current state of the structure, which proved that the results should be disregarded for the analysis.

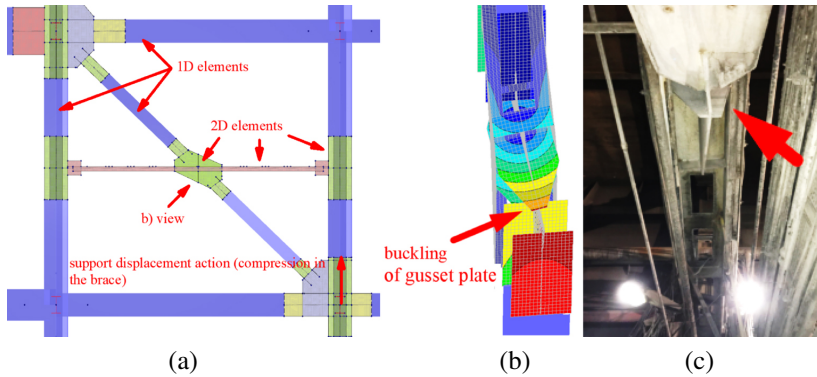
Fig. 14. Part of vertical bracing calculation model – type 1: a) calculation model, b) buckling in num. model, c) buckled member in reality

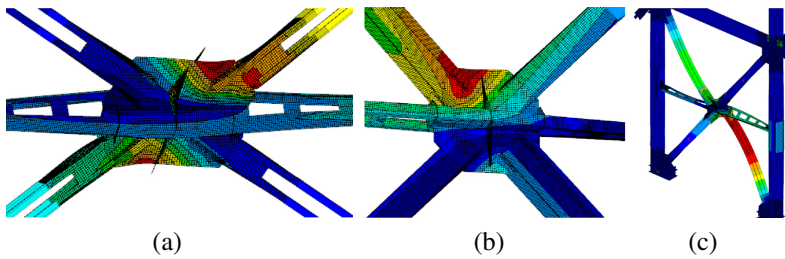
Fig. 15. Buckling of different bracing types: a) type 1, b) type 2, c) type 3

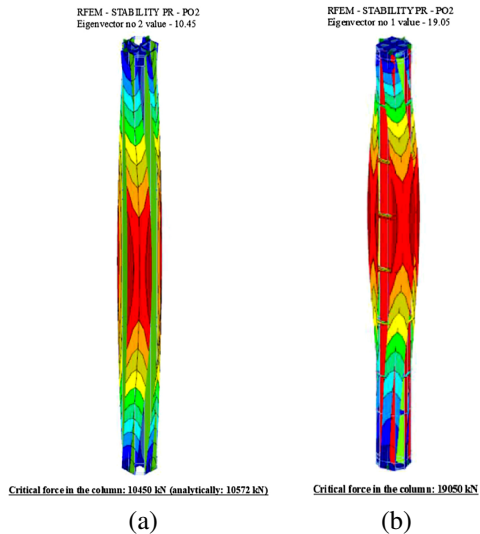
Fig. 16. Buckling analysis of columns with a flanged cross cross-section: a) without horizontal stiffeners, b) with horizontal stiffeners
