CAUSES OF THE CRACKS IN THE PIPELINE MADE OF THE 15HM STEEL

Issues referring to cracks in the pipelines made of the 15HM steel are described. Metallographic specimen of welded joints are provided. The results of impact strength tests, hardness tests and static tensile tests are given. Tests results as well as direct and indirect causes of the pipeline cracks are shown.

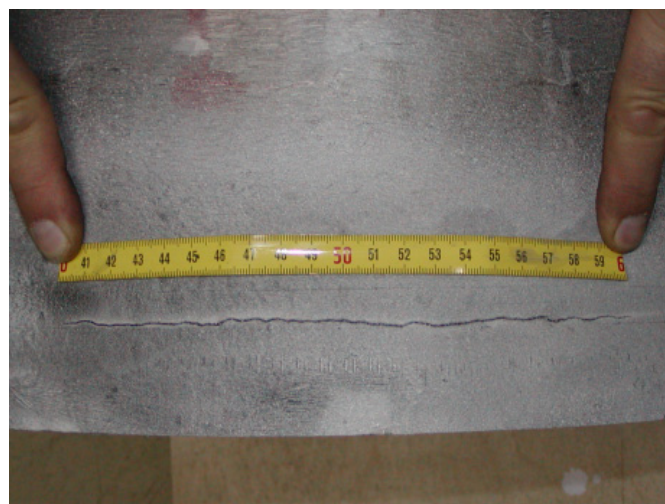
- Crack length of about 210 mm was created from the pipeline's side in the heat affected zone;
- The main crack extends through the entire thickness of the material along the outer border (from the material side) of the heat affected zone. HAZ from the crack's side is much wider than on the side of the collector (Fig. 1);
- The cross-section shows the final phase of the crack. Initiation occurred in the upper part of the weld (the face of the weld) and moves along the outer border of the heat affected zone and then into the zone. Definitely a wider lower part of the HAZ (Fig. 2);

Fig. 1. The main crack - a view from the outer side in the place of the welded joint

- the main crack was formed along the outer boundary of the HAZ (from the side of the material) and extends through the entire thickness of the material – the crack length approx. 210 mm;

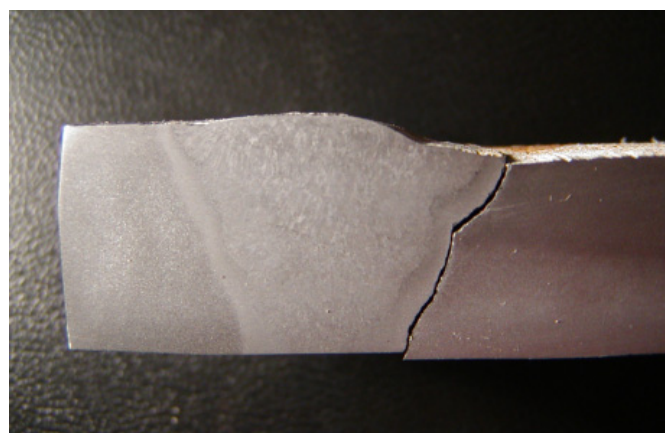
Fig. 2. The main crack from the pipeline's side extending through the HAZ – a cross section

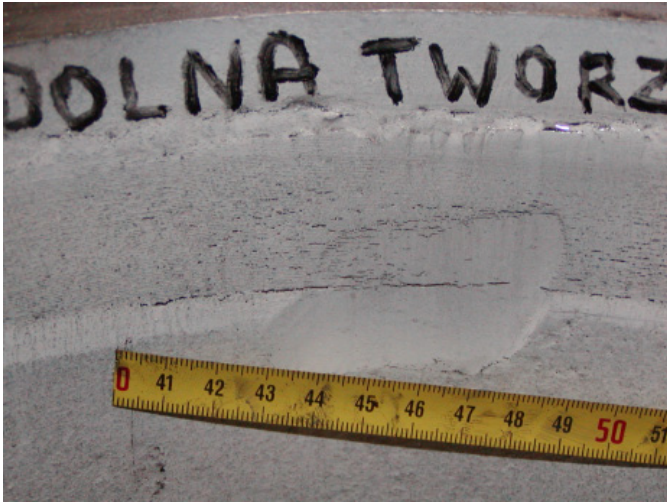
- In the lower generatrix of the pipeline at the place of the change of the thickness of the material are thermal shock cracks with a more visible crack of approximately 70 mm in length (Fig. 3);

Fig. 3. Thermal shock cracks on the inside of the lower generatrix at a distance of 40 mm from an axis of the weld

- in the lower generatrix of the pipeline at the place of changing the thickness thermal shock cracks were observed;
 - There are not any visible cracks from the collector's side in the fusion line

- In addition to the above-mentioned defects there are also fatigue cracks (thermal shock cracks). These are typical cracks for this type of areas of communication pipelines located in the area of the collector of the lower generatrix of the pipeline probably caused by an improper operation of the nozzles or cracked protective T-shirts. The scale of observed fatigue cracks, however, is disproportionately smaller than the cracks that caused damages.

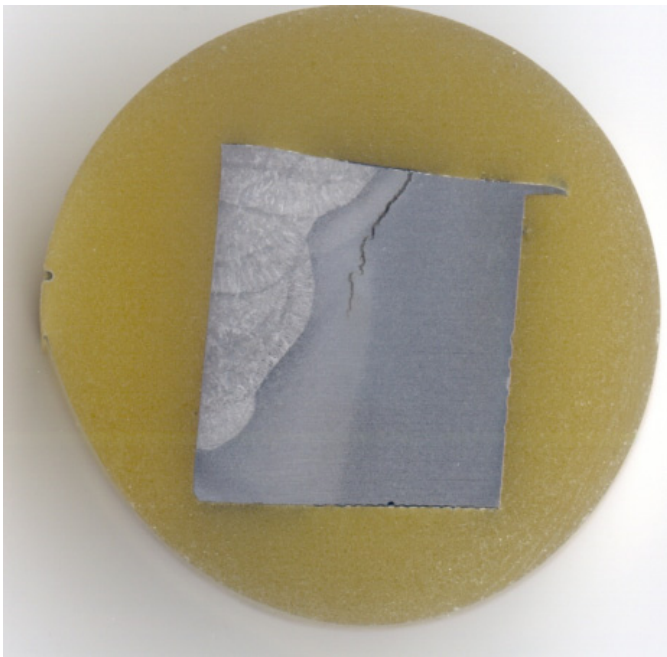
- On the surface of the outer wall is visible the final phase of the crack in the HAZ from the pipeline's side (Fig. 4);

Fig. 4. The main crack from the pipeline's side in the HAZ – a cross section

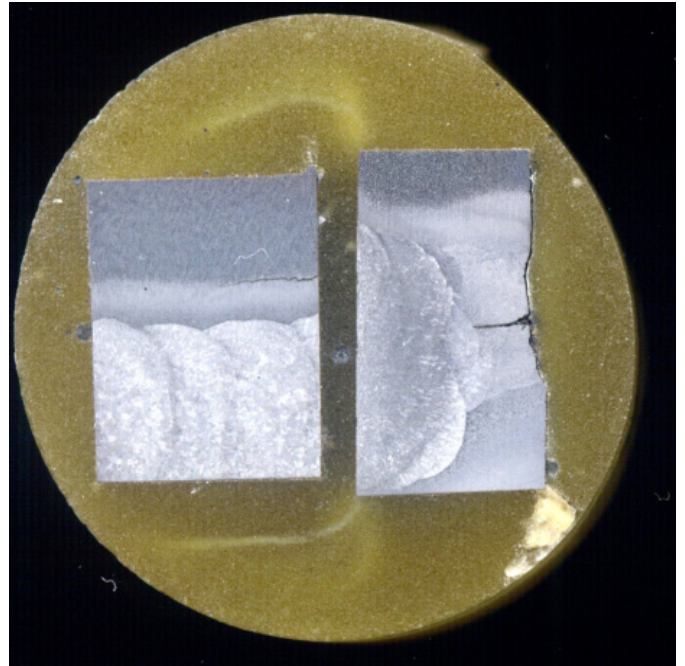
- In the lower generatrix of the pipeline there is a crack of the weld from the root side of the weld in the root pass (Fig. 5);
- In the fusion line there are not any visible cracks. Heat affected zone in the grain layer is much narrower than in the lower part of the joint (Fig. 6)

Fig. 5. The view from the face of the weld, an outer surface – a crack in the HAZ and a cross section – a crack in the weld from the root side of the weld

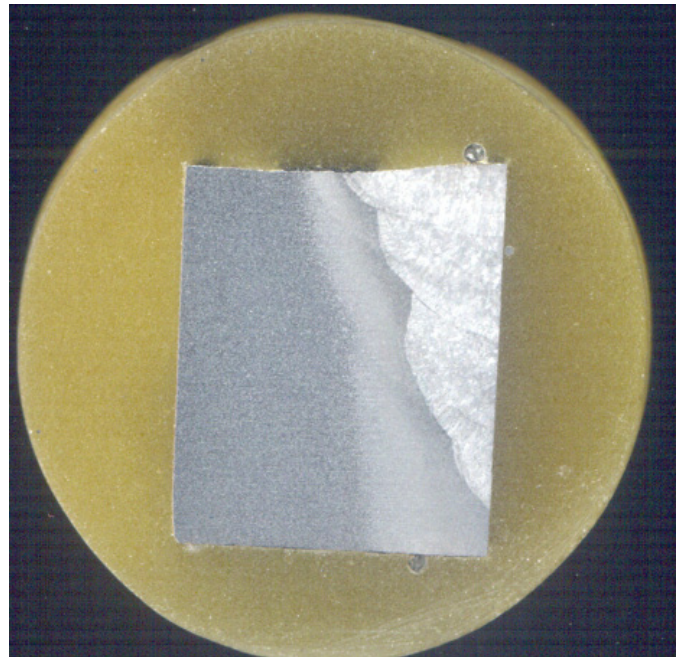
Fig. 6. A fusion line of the weld on the side of the collector – cross-section.

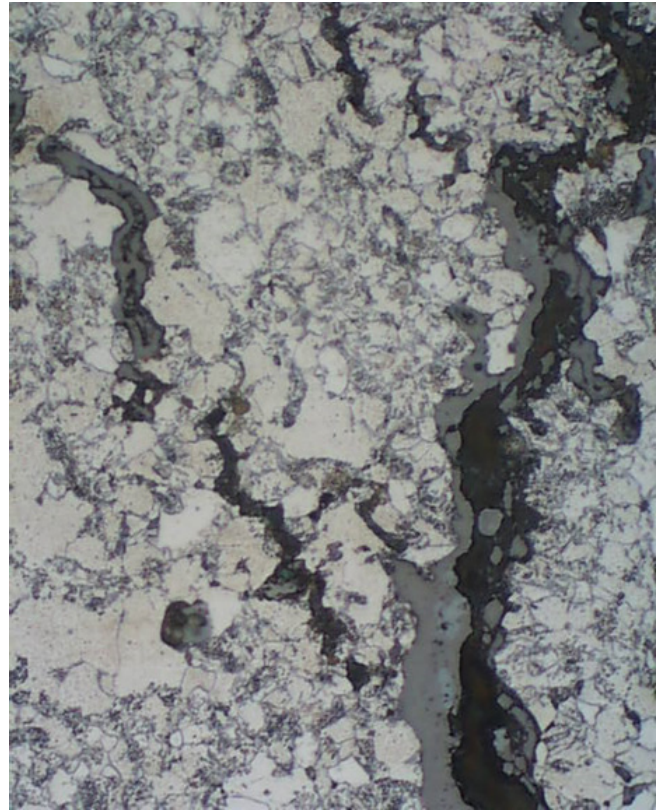
Fig. 8. HAZ – the bainite type of a structure. The disintegration of the primary structure, grids of intercrystalline macro and microcracks, and the chains of creeping micropores on the grain boundaries. Zoom 500×

5. The tests and structural analysis showed that:
 - HAZ from the pipeline's side directly on the main crack corresponds to the structural changes SIII and physical degradation DV class. A degree of exhaustion was determined at 100%;

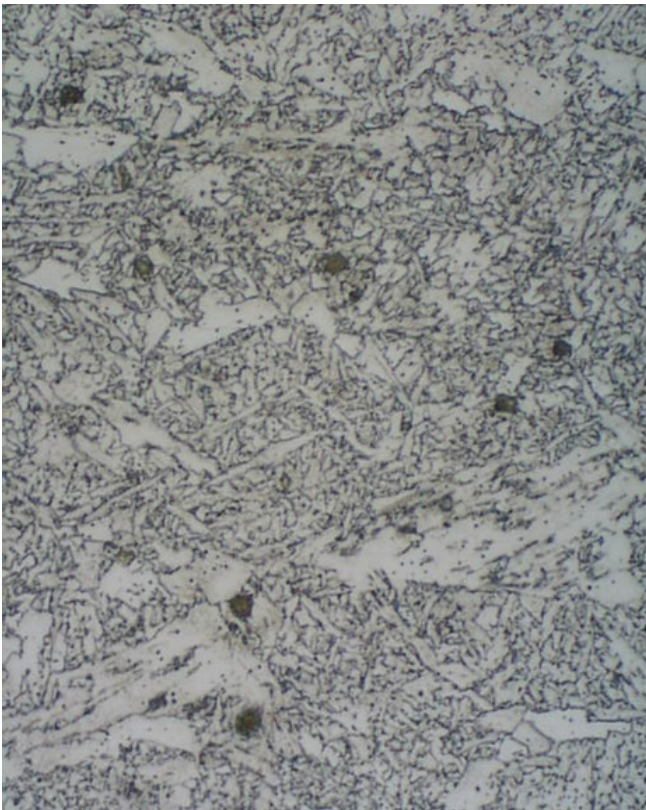
Fig. 9. The weld – a bainite type of a structure with a ferrite grid on the borders of a former austenite. There are visible single creeping micropores. A partial disintegration of the primary structure. Zoom 500×

- a weld corresponds to structural changes SII and physical degradation DII class. A degree of exhaustion was determined at 45%
6. Macroscopic tests showed that:

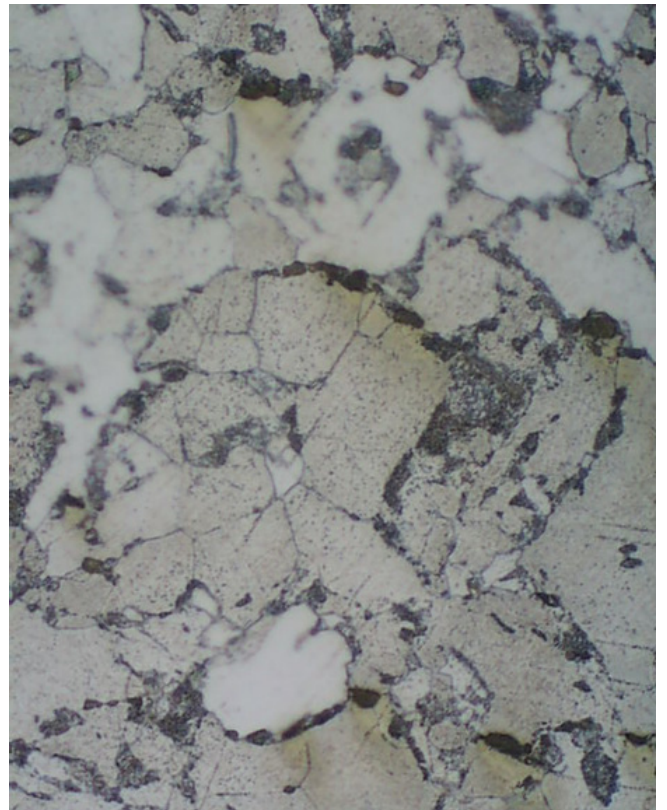
Fig. 10. A base material of the pipeline – a disintegration of the primary structure, grids of intercrystalline macro and microcracks, and the chains of creeping micropores on the grain boundaries. Zoom 500×

- base material in the vicinity of the main crack of the pipeline corresponds to the structural changes class SIII and physical degradation DIV. A degree of exhaustion was determined at 85%;

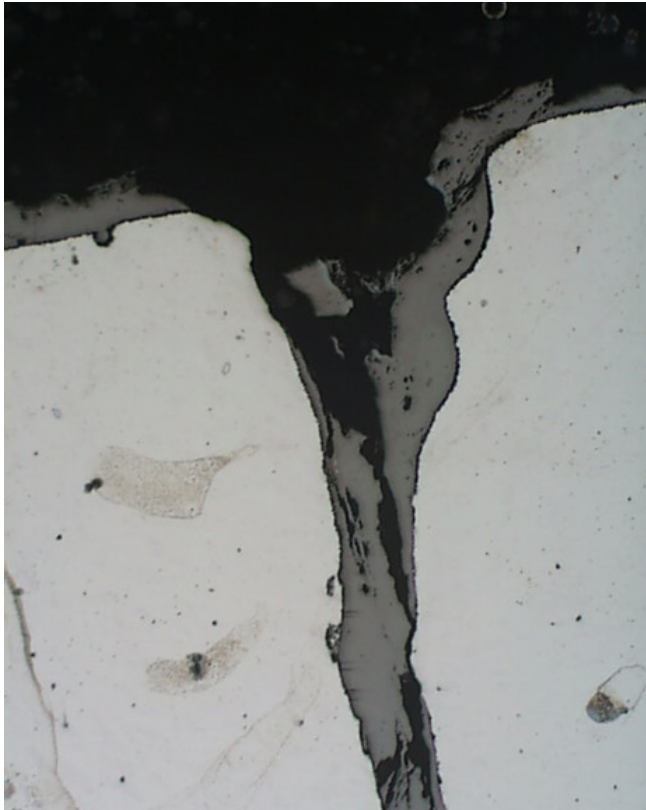
Fig. 11. A material of a welded joint (bottom generatrix – the root of the weld). A visible thermal shock crack with a distinctive wedge shape with the rest of the corrosion products. Unetched metallographic specimen. Zoom 50×
