Renata PAMIĆ, Franc POHLEVEN

PROTECTION THROUGH CONSTRUCTION OF A WOODEN MONUMENT IN RADOMLJE (SLOVENIA)

Biodegradation of the wood, photo-degradation of the coatings and major cracks appeared on a six-metre high oak monument built in 1960. Due to three displacements and exposure to increased moisture and pests, the monument lost its original appearance. Damage due to the fixation elements became so extensive that they threatened its load-bearing capacity. During the renovation work, the monument was subjected to original and specific constructional measures and its original appearance was restored. Restoration of the original details allowed water to flow off the monument easily, hence the wood could dry quickly. The weakened and worn parts of the wood were replaced or consolidated. Dilatation between the wood, metal and stone was stopped and further corrosion processes prevented. Restoration of the cracks prevented the entry and retention of water inside. Where this was not achievable, drainage was installed and aeration of the wood was enabled. By means of a central metal mandrel and a supporting system of adjustable bolts, the bearing capacity was improved and, in the event o

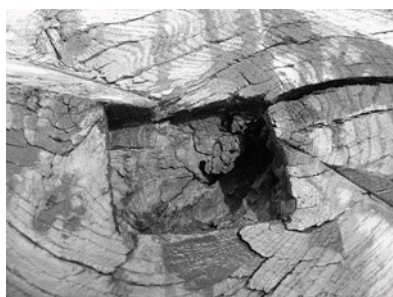
Once the monument was taken down, it was examined in detail and the damage to it documented. The monument was protected by a copper cover, which had caused galvanic corrosion where the metal came in contact with the wood. Flaking, dislodged wooden inserts and rotten wood were documented over the entire surface coating. The multi-layered decorative coatings were cracked and photo-degraded (fig. 1). Cracks, wooden inserts and rotten parts were visible where water had flowed into the wood. The greatest damage was found in the lower part of the monument, in the area of screwing, where radial cracks extended to the bore (fig. 2).

Fig. 1. Detail of photo-degraded surface and rotten area

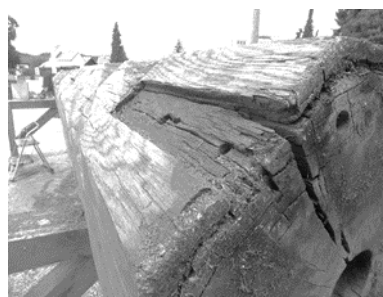
Fig. 2. Damage to monument due to the fastening system

A 10 cm bore in the wood was only 50 cm deep and was badly cracked. The monument was mounted on a metal tube with 9 cm diameter and a height of 50 cm, which was fixed in a granite pedestal and filled with cement mass. The slats were enclosed within a metal ring which did not allow water to run off, therefore it accumulated, saturated the bottom of the monument and caused intense rotting.

At the points where the ring was screwed in place, pronounced tearing of the wood fibres and, to a height of 200 cm, radial and longitudinal cracks of up to 10 cm deep in the direction of the wood fibres were found. Brown rot and white rot, slightly higher above the screws, were found. On account of this, the lower section of the monument was severely damaged.

Due to the inadequate fastening, as well as biotic and abiotic factors, the monument was in an extremely bad condition. The short mandrel and loose screwing points could no longer ensure the bearing capacity of the monument. A new, innovative installation and integrated remediation of the monument was therefore planned.

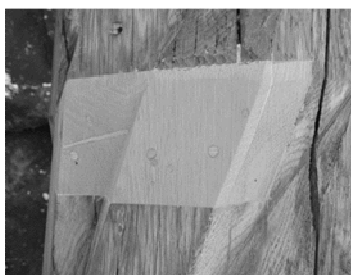
Fig. 3. Insert of new oak wood

The filling places (deepening, niches) and wooden inserts were cut in the direction of the water outflow and reinforced with dowels and urethane glue (fig. 3). The rotten parts were filled with epoxy binder with added wood flour and AR glass fibres. The rotten parts not suitable for the insertion of wooden implants were thoroughly cleaned and strengthened with dowels and Paraloid B-72. In the open parts of the damage, unbound dry wood flour was scattered and the remaining volume was filled with Araldite. When the epoxy mass hardened, the residue of unbound wood flour was blown out through a water drainage duct, drilled at the lowest point of damage. The opening was covered with stainless steel wire wool, allowing drainage and aeration but, at the same time, preventing access for insects (fig. 4).

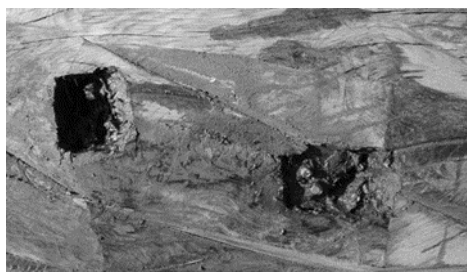
Fig. 4. Reinforcement of rotten parts with dowels and epoxy mass

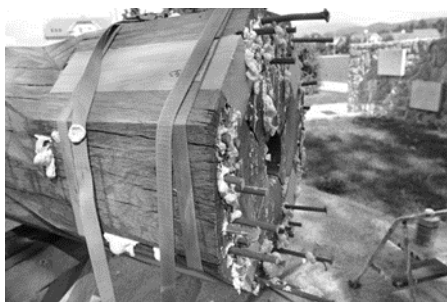
Fig. 5. Reinforcement of lower part of monument with oak dowels and prisms inserted with urethane adhesive

The rotten wood at the site of the previous bolting was removed with a joiner's chisel, the areas were impregnated with Silvanolin and substitutive glued oak prisms measuring $35 \times 10 \times 10$ cm were inserted. The peripheral part of the monument was structurally remediated so that, with the new concept of installation, it could bear the static load. The wood was drilled around the perimeter at a width of 10 cm and to a depth of 40 cm. It was then impregnated with Silvanolin and oak dowels were inserted using urethane adhesive (fig. 5).

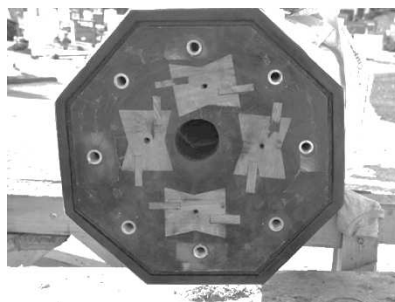
Fig. 6. Arrangement to stainless steel inserts with an internal thread. Drainage of main cracks through wedges

The weakened zone of major radial cracks was fastened together with four butterfly wedges of glued oak wood and additionally secured against extraction. The cracks were cleaned beforehand, cleared by blowing and then impregnated with Silvanolin. In order to prevent the accumulation and retention of water above the wedges, drainage of the main cracks was provided through the wedges. The wedges were glued with urethane glue only at the sides and, on the edge above, the upper surface of the wedges was hollowed out into a funnel-like shape towards the centre, where a hole of 0.8 cm in diameter was drilled and covered with a mesh against insects. At a distance of 1.5 cm from the perimeter, a drip chamfer was also carved on the lower surface of the monument (fig. 6).

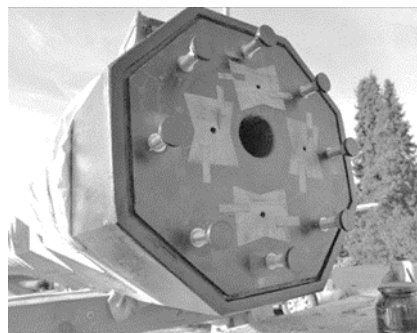
Fig. 8. Adjustable supporting elements of the monument

Since the new tube, with a height of 195 cm (135 cm above the pedestal and 60 cm in the pedestal) was sufficient to bear 60% of the load, eight M20 bolts were inserted on the periphery of the monument, to bear the remaining 40% of the load. They were bolted into stainless steel inserts with an internal thread. Each insert had a diameter of 3 cm and height of 10.5 cm, with a thread depth of 10 cm. The inserts with bolts were installed in a radius of 20 cm, 4 in replacement oak prisms in the original mounting points, and 4 in special oak bushings with a diameter of 5 cm and a height of 15 cm (fig. 8).

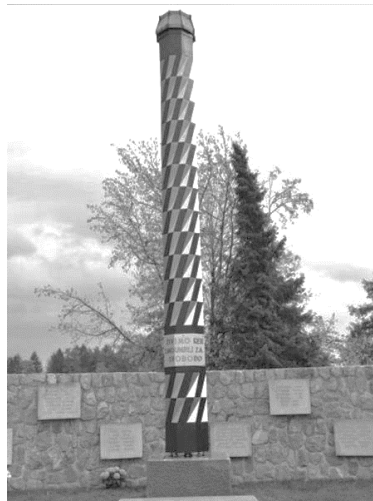
Fig. 9. Monument after restoration

The innovative and statically-verified load-bearing system applied helps shape the architectural appearance of the monument and, at the same time, enables protection through construction (fig. 9).
