INFLUENCE OF GEOTECHNICAL CONDITIONS ON DAMAGE STATES OF GDANSK BAY COAST CLIFF FORMATIONS

ABSTRACT

A geotechnical aspect of destruction processes of seashores was identified based on the case of erosion of Gdansk Bay Coast cliff formations. Causative factors of landslide were described in the context of natural phenomena, land development and its anthropogenic transformations. Possible directions of theoretical analysis of changes in ground-water relations were indicated.

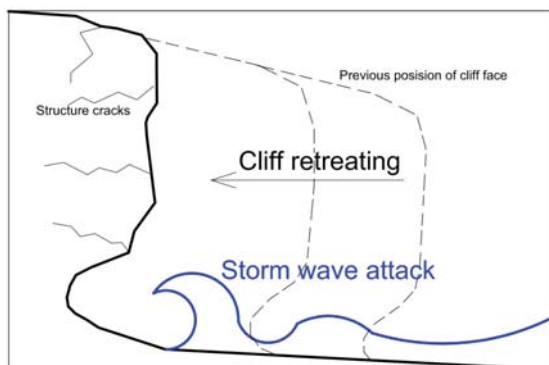
- permanent or periodical attacks of storm sea waves against cliff base [4], as a result of which cliff slope retreats step by step back into the land (Fig. 1),

Fig. 1. Erosion of cliff resulting from storm wave attack

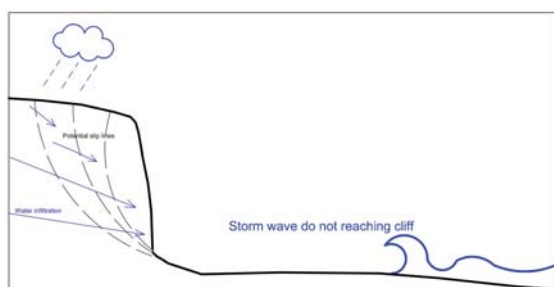
- effects of ground mass forces onto sheer slopes, that results in loss of stability and landslides,
- infiltration and flow of underground water from the side of land towards sea, which liquefies the ground and changes its state (Fig. 2).

Fig. 2. Cliff erosion due to geotechnical effects from the side of land

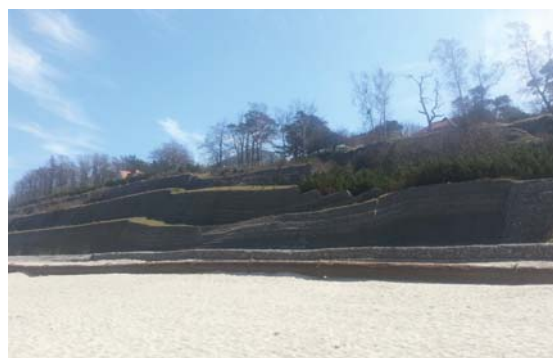
Landslide effects usually cause also destructions of shore protection structures, for instance such as the damage of cliff protection gabion structure shown in Fig. 3.

The deformations could not be caused by storm waves in view of that the beach is a dozen or so meters wide [11]; their causes should be searched in periodical changes in ground-water relations within the cliff itself.

Fig. 3. Deformations of the cliff protection structure made of reinforced ground and gabions (2014) [8]

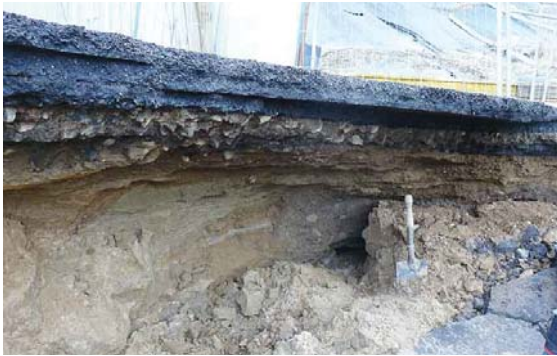
As a result of the critical water pressure produced in pores of the ground, the hydraulic piping flow and its significant pressure occurred, that caused washing away the road embankment and liquefying the ground. This is a frequent cause of building damages associated with changes in ground-water relations, that is described in the geotechnical literature [2]. In the photographic documentation there are visible a hydraulic piping flow canal and a cavern formed as a result of the washing out of

anthropogenic ground layers placed under the roadway (Fig. 4, Fig. 5a, Fig. 5b, Fig. 5c).

Fig. 4. A cavern and hydraulic piping flow canal revealed after the damage [10]

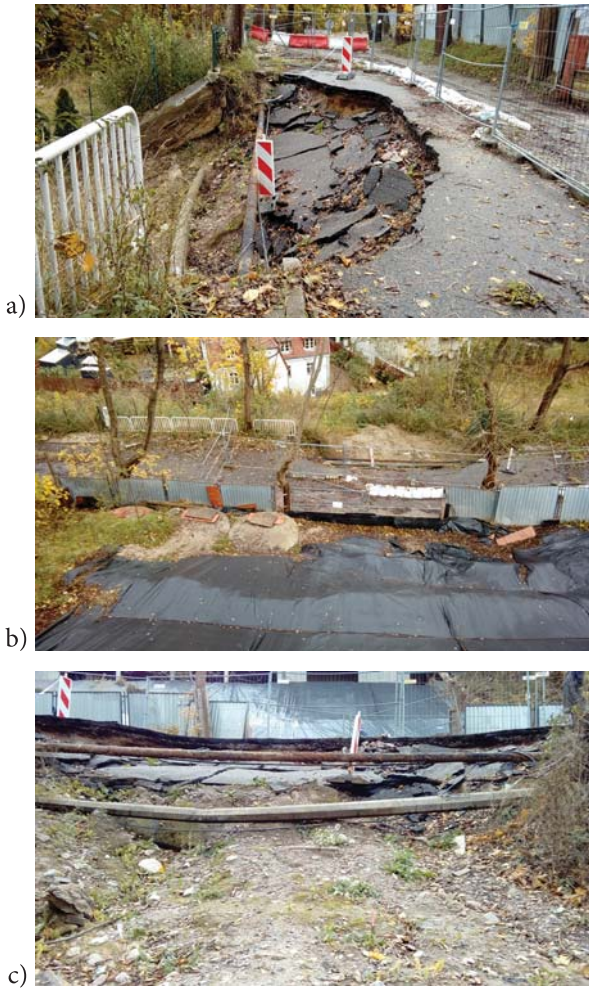
Fig. 5. State of the landslide 8 months after the damage

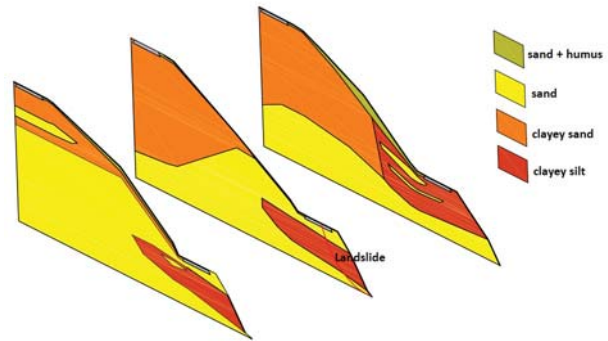
The geotechnical cross-sections in the line of the landslide have confirmed possible water accumulation in ground lens (Fig. 6). On this basis it is possible to conclude that the geological structure of the base in which ground layers of a higher and lower water permeability alternately appear, helps in forming privileged ways of water filtration in the ground and underground water flows concentrated within a rather small space. In the base there are ashy ground layers

which are characteristic of substantially decreased strength parameters in case of watering.

Fig. 6. The geological cross-sections showing stratified grounds of variable filtration ratio within the landslide

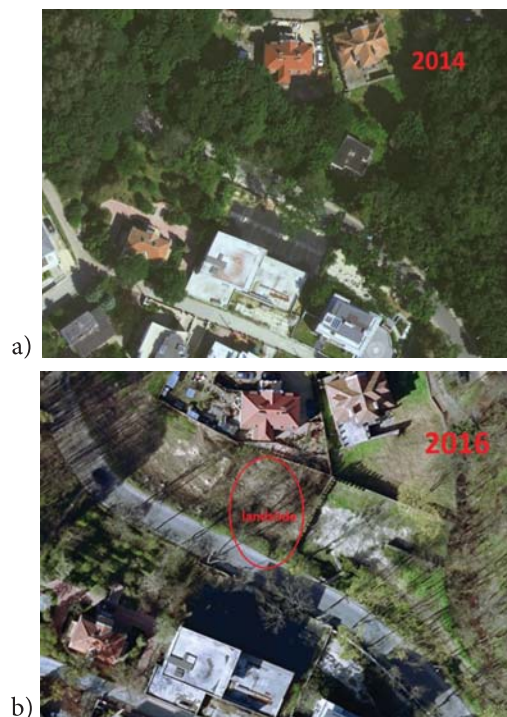
For several years before the landslide event, a devastation of the existing stand of trees has been observed. As a result, a lack of the natural factor holding the ground on the slope has been introduced. The attached photographs reveal a wastage of the stand of trees in this area (Fig. 7a, Fig. 7b).

Fig. 7. Changes in the stand of trees within the landslide, which occurred between the years 2014 and 2016, (Aerial photographs shot by MGGP AERO)

The removal of flora from the escarpment area of the plot in question and neighbouring plots exposed the terrain to intensive surface erosion and increased infiltration of rainfall water into the ground, that resulted in the ground strength lowering. Additionally, a lack of transpiration causes that water is not taken up by the plant root system and in the surrounding ground there do not exist respective compression stresses resulting from sucking the water by plants.

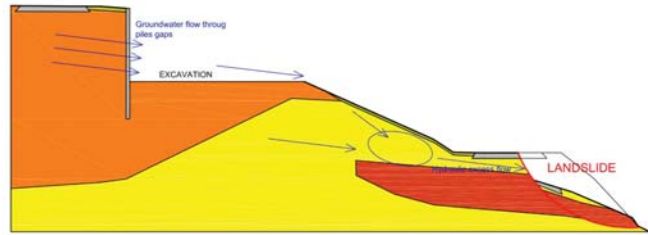
Fig. 8. Direction of hydraulic excess flow under the road of Sienkiewicz street.

Over the entire cliff area there is legally forbidden to discharge the rainfall water off the buildings and hardened surface areas directly into the ground because the terrain is deemed susceptible to landslides [10]. Till the occurrence of slope damage, the rainfall waters were discharged directly into the ground. It resulted in a degradation of its strength parameters in the analyzed area, especially in places where ashy ground layers were present. The damage mechanism is highlighted in Fig. 8.

The break in the building works, which was introduced without completing realization of the drainage system, resulted in penetration of the taken-in rainfall water deep into the slope and its accumulation over the damage site, that caused a decrease in the ground strength parameters as a consequence of watering the ground.
