**THE ASSESSMENT OF HEALTH OF GAS TURBINE
BLADES WITH NON-DESTRUCTIVE METHODS**

**OCENA STANU ŁOPATEK TURBINY GAZOWEJ
METODAMI NIENISZCZĄCYMI**

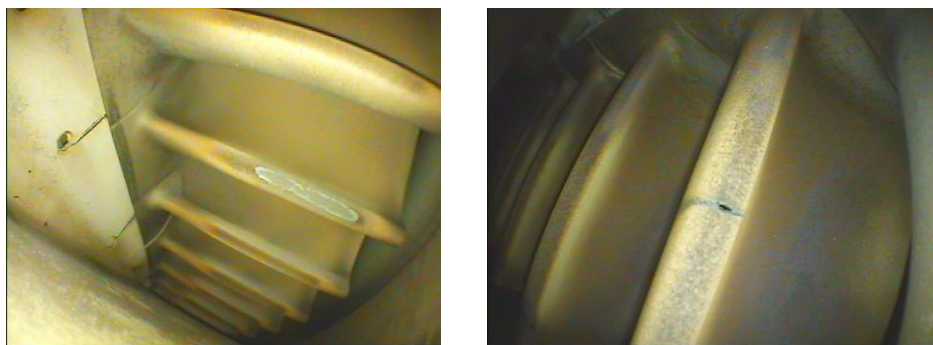
Fig. 1 Temperature-attributable damages to edges of attack of turbine rotor blades, exemplary videoscope records [1]

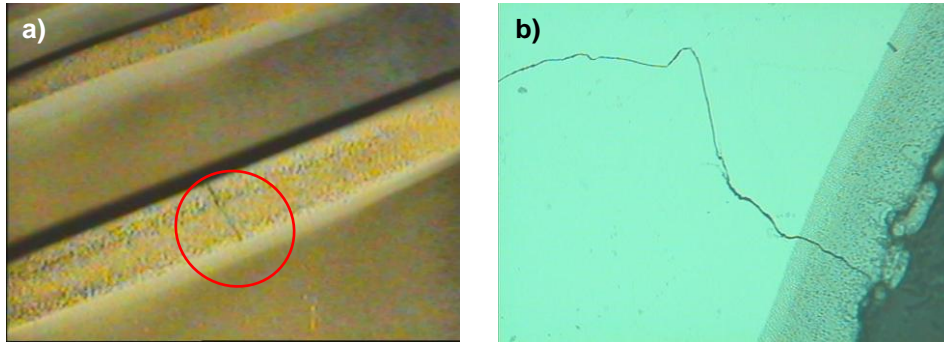
Fig. 2 A protective coating with a crack that propagates into the parent material of the blade [2]. Images from a) a videoscope, and b) a microscope, magn. x 450

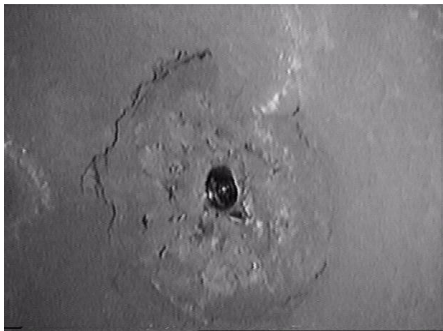
Fig. 3 Carbon deposit on the fuel injector in the gas turbine engine [3]

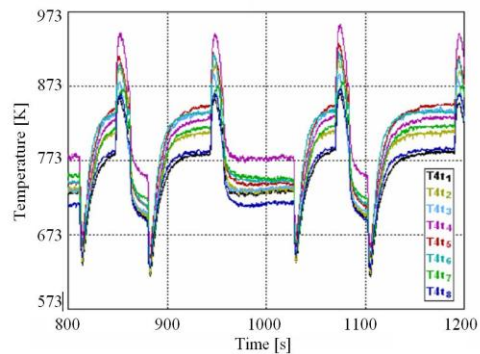
Fig. 4 Exemplary distribution of unevenness of the T4 temperature on the perimeter of the turbine in the function of time and rotation speed of an aircraft aerial engine, measured with help of thermoelements ($T4t_1 - T4t_2$) behind the turbine [4]

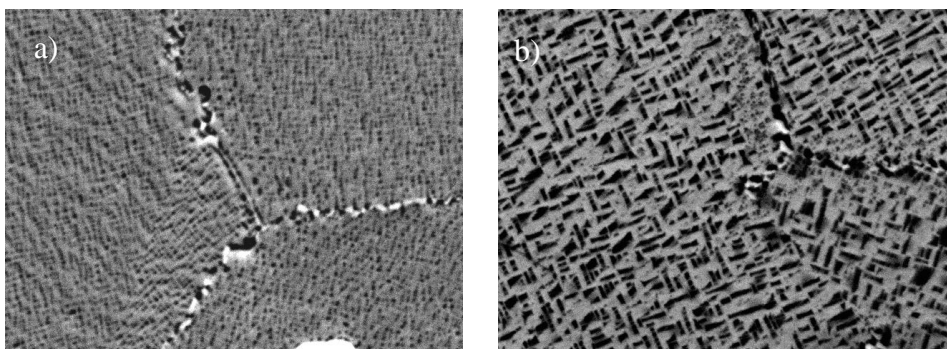
Fig. 5. The EI-867WD alloy microstructure (magn. x 4500)[3]: a) correct, b) overheated

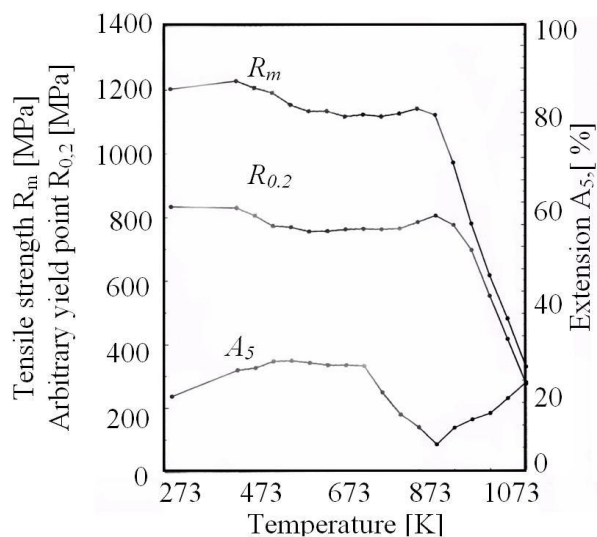
Fig. 6 Mechanical properties of alloy EI-867 versus temperature [5]

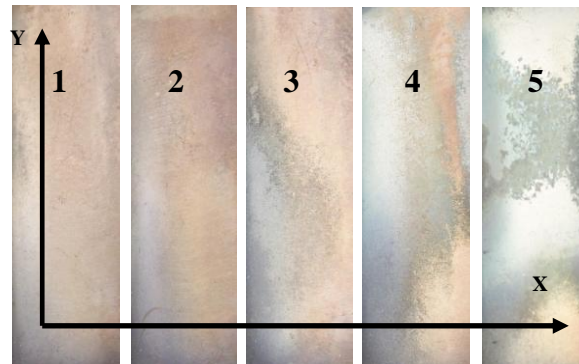
Fig. 7 Images for surfaces of gas turbine blades made of the ŻS-6K alloy, ordered according to the criterion of the increasing degree of the material overheating (1,2,...., particular states of blades) [6]

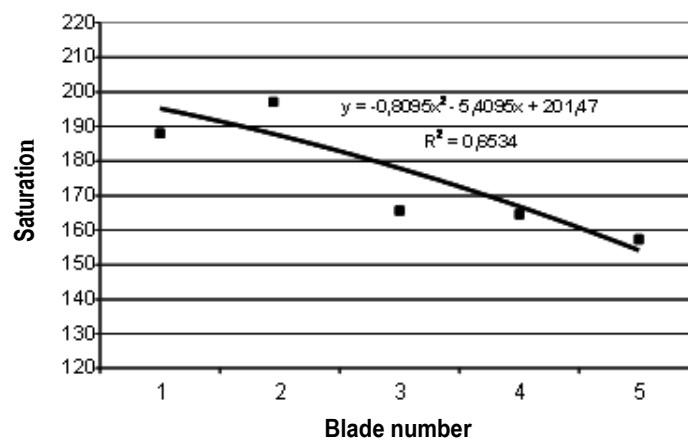
Fig. 8 Variations of the position value for the maximum amplitude of the image intensities for various technical conditions of blades from Fig. 7 (in grey scale) [6]

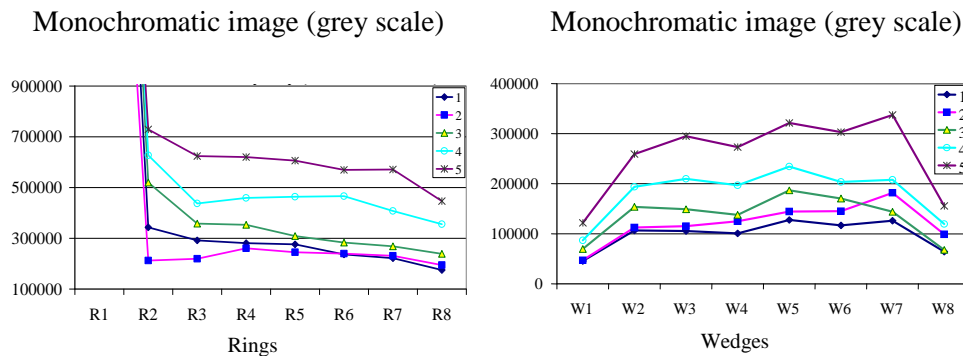
Fig. 9 Values of rings and wedges in the grey scale for individual deterioration degrees of wedges from Fig. 7 [6]

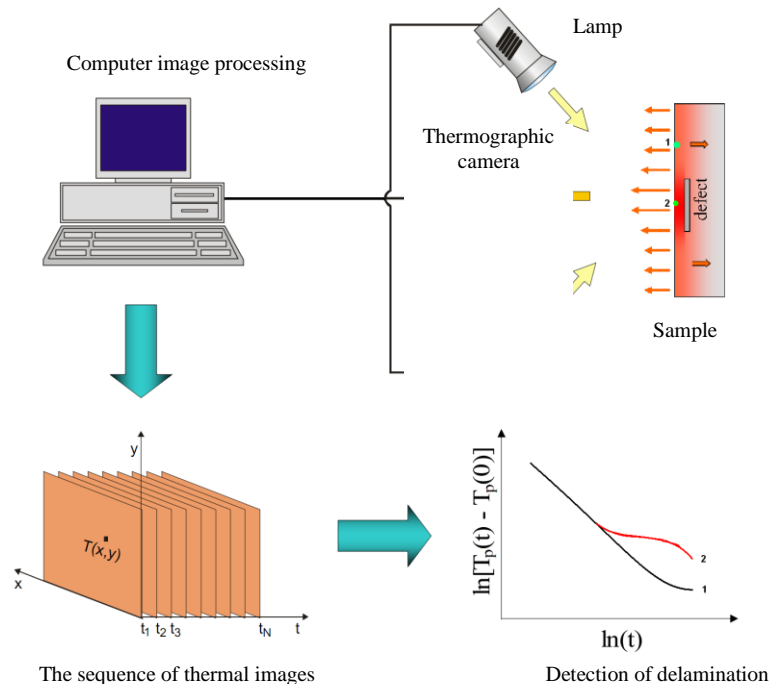
Fig. 10 A diagram of the pulsed thermography measuring system [7]

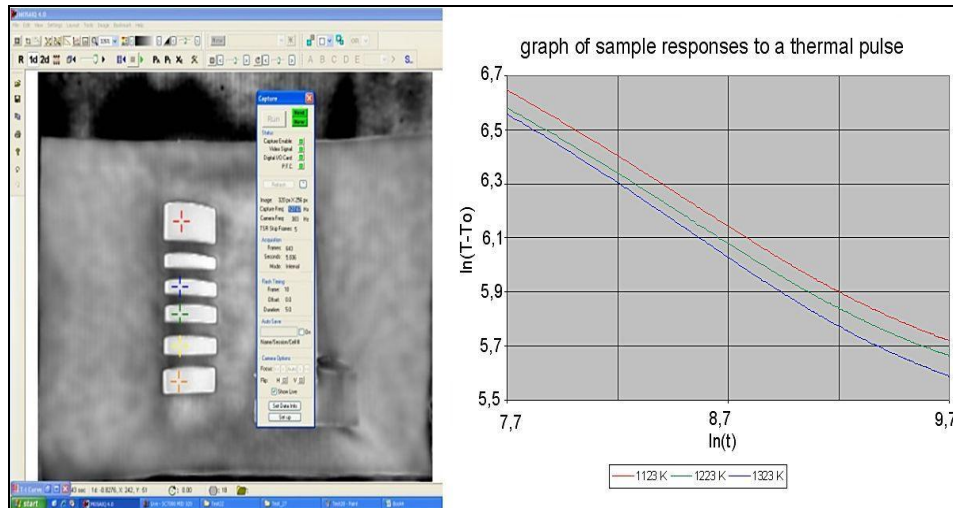
Fig. 11. Thermograms from blades examination, and temperature curves for a selected location upon the blade surface [8]

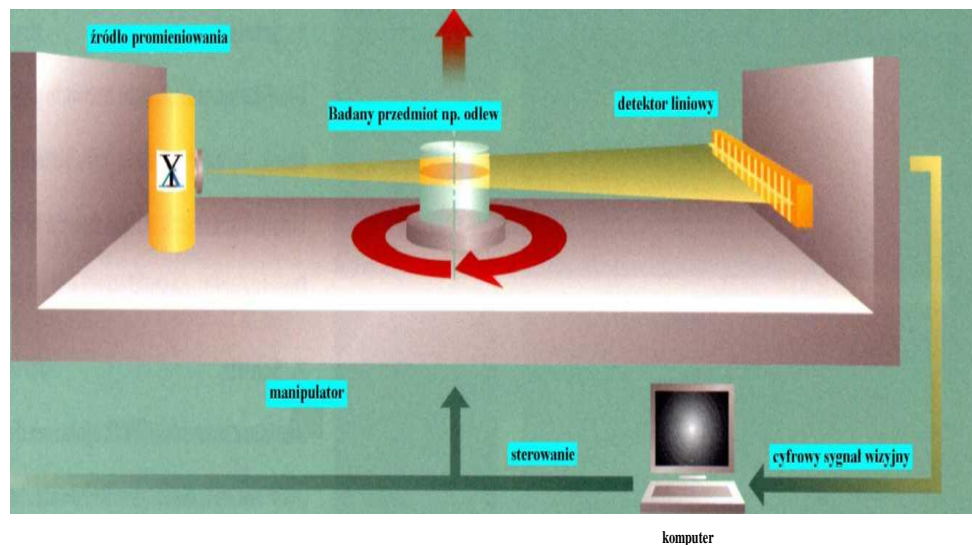
Fig. 13 Example of a tomographic examination with the use of a linear detector [9]

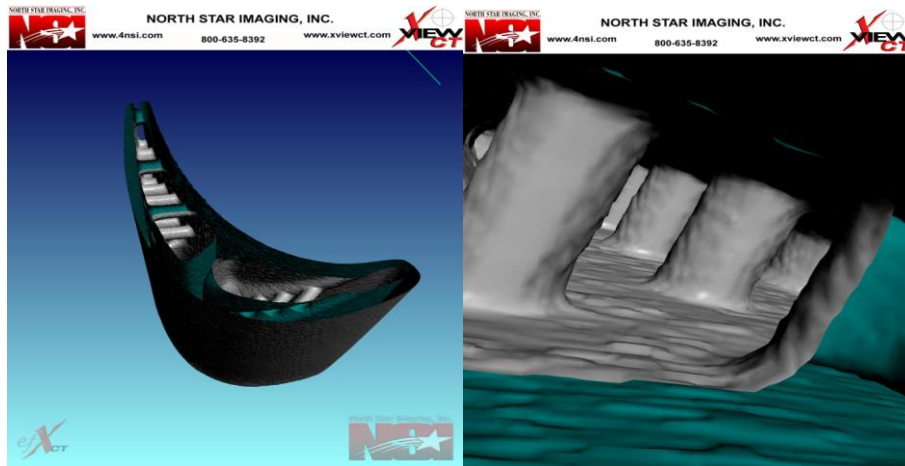
Fig. 14. The image of the gas turbine blade by means of the tomography from North Star Imaging [10]
