THE DEFECTS OF OXIDE LAYERS FORMED ON 10CrMo9-10 STEEL OPERATED FOR 200,000 HOURS AT AN ELEVATED TEMPERATURE

The paper contains results of studies into the formation of oxide layers on 10CrMo9-10 (10H2M) steel long-term operated at an elevated temperature ($T = 545^{\circ}\text{C}$, $t = 200,000\text{h}$). The oxide layer was studied on a surface and a cross-section at the inner and outer surface of the tube wall on the outlet both on the fire and counter-fire side of the tube wall surface.

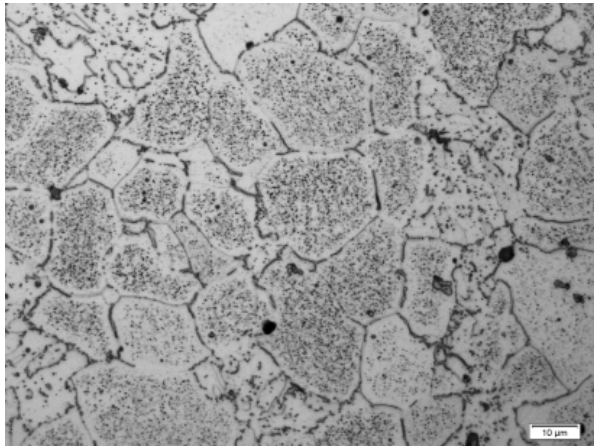
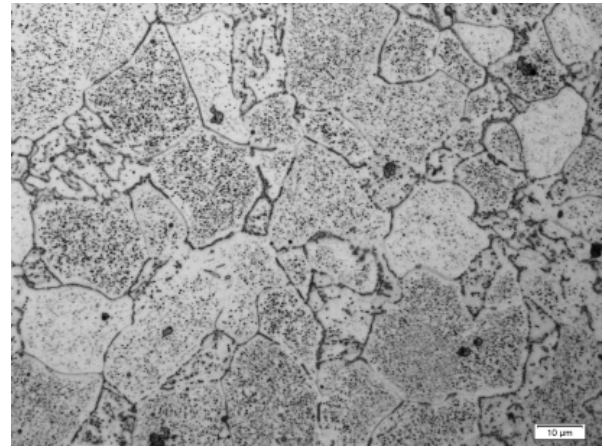
After a long-term operation ($T = 545^{\circ}\text{C}$, $t = 200,000\text{h}$) 10CrMo9-10 steel shows degradation of bainitic-ferritic structure. The extent of degradation on the fire side is much higher than on the counter-fire side, which is presented in Fig. 1. A substantial depletion of boundary areas in carbide precipitates is visible on the fire side. Instead, in both cases carbide precipitates create ‘chains’ along boundaries, in certain places there are also cases of etching around sulphide precipitates and sporadic creep micropores on the

Fig. 1. Microstructure of 10CrMo9-10 steel operated for 200,000 hours at the temperature of 545°C , LM: (a) fire wall, (b) opposite fire wall

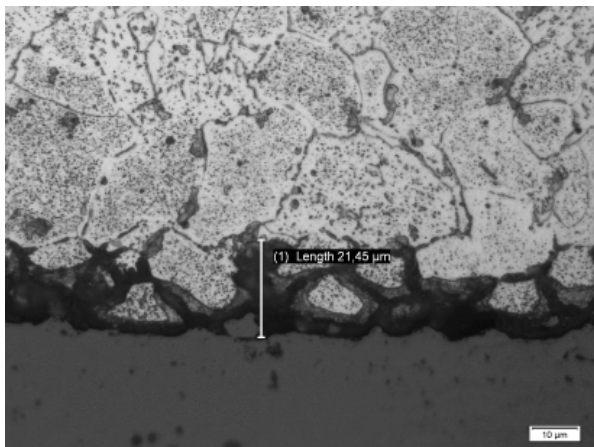
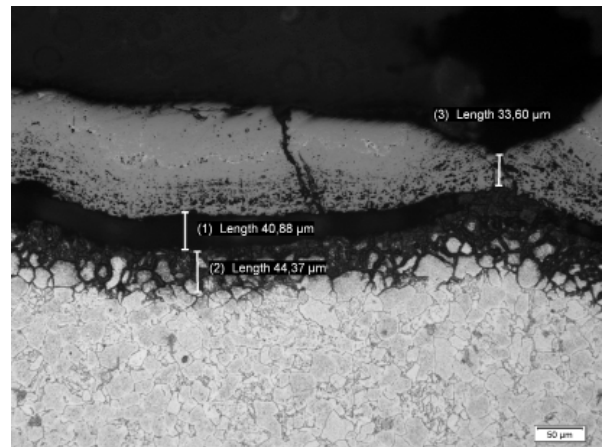
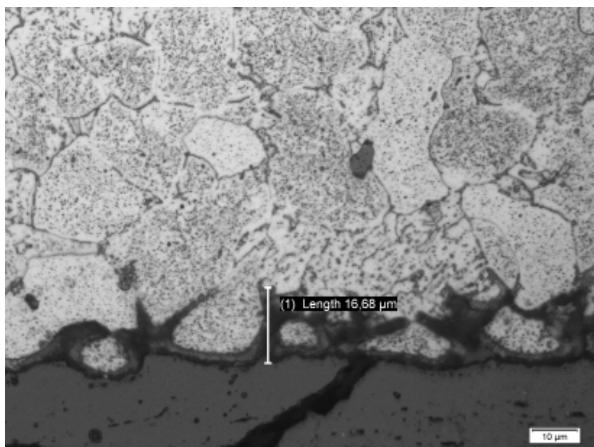
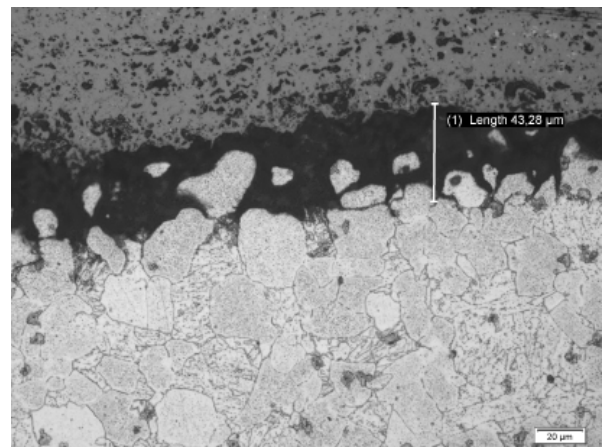
fire side. Corrosion on the grain boundaries also exists, both on the fire and counter-fire side, which is presented in Fig. 2. Such corrosion together with crevice corrosion to the largest extent occurs at the outside wall on the fire side, reaching $84\ \mu\text{m}$ in depth. While on the counter-fire side at the outside wall corrosion exists on the grain boundaries to the depth of $43\ \mu\text{m}$. At the inside wall, on the fire and counter-fire side, corrosion on the grain boundaries exists to the depth of $21\ \mu\text{m}$ and $17\ \mu\text{m}$, respectively.

Fig. 2. Corrosion on the grain boundaries at: (a) inner surface – fire wall, (b) outer surface – fire wall, (c) inner surface – opposite fire wall, (d) outer surface – opposite fire wall

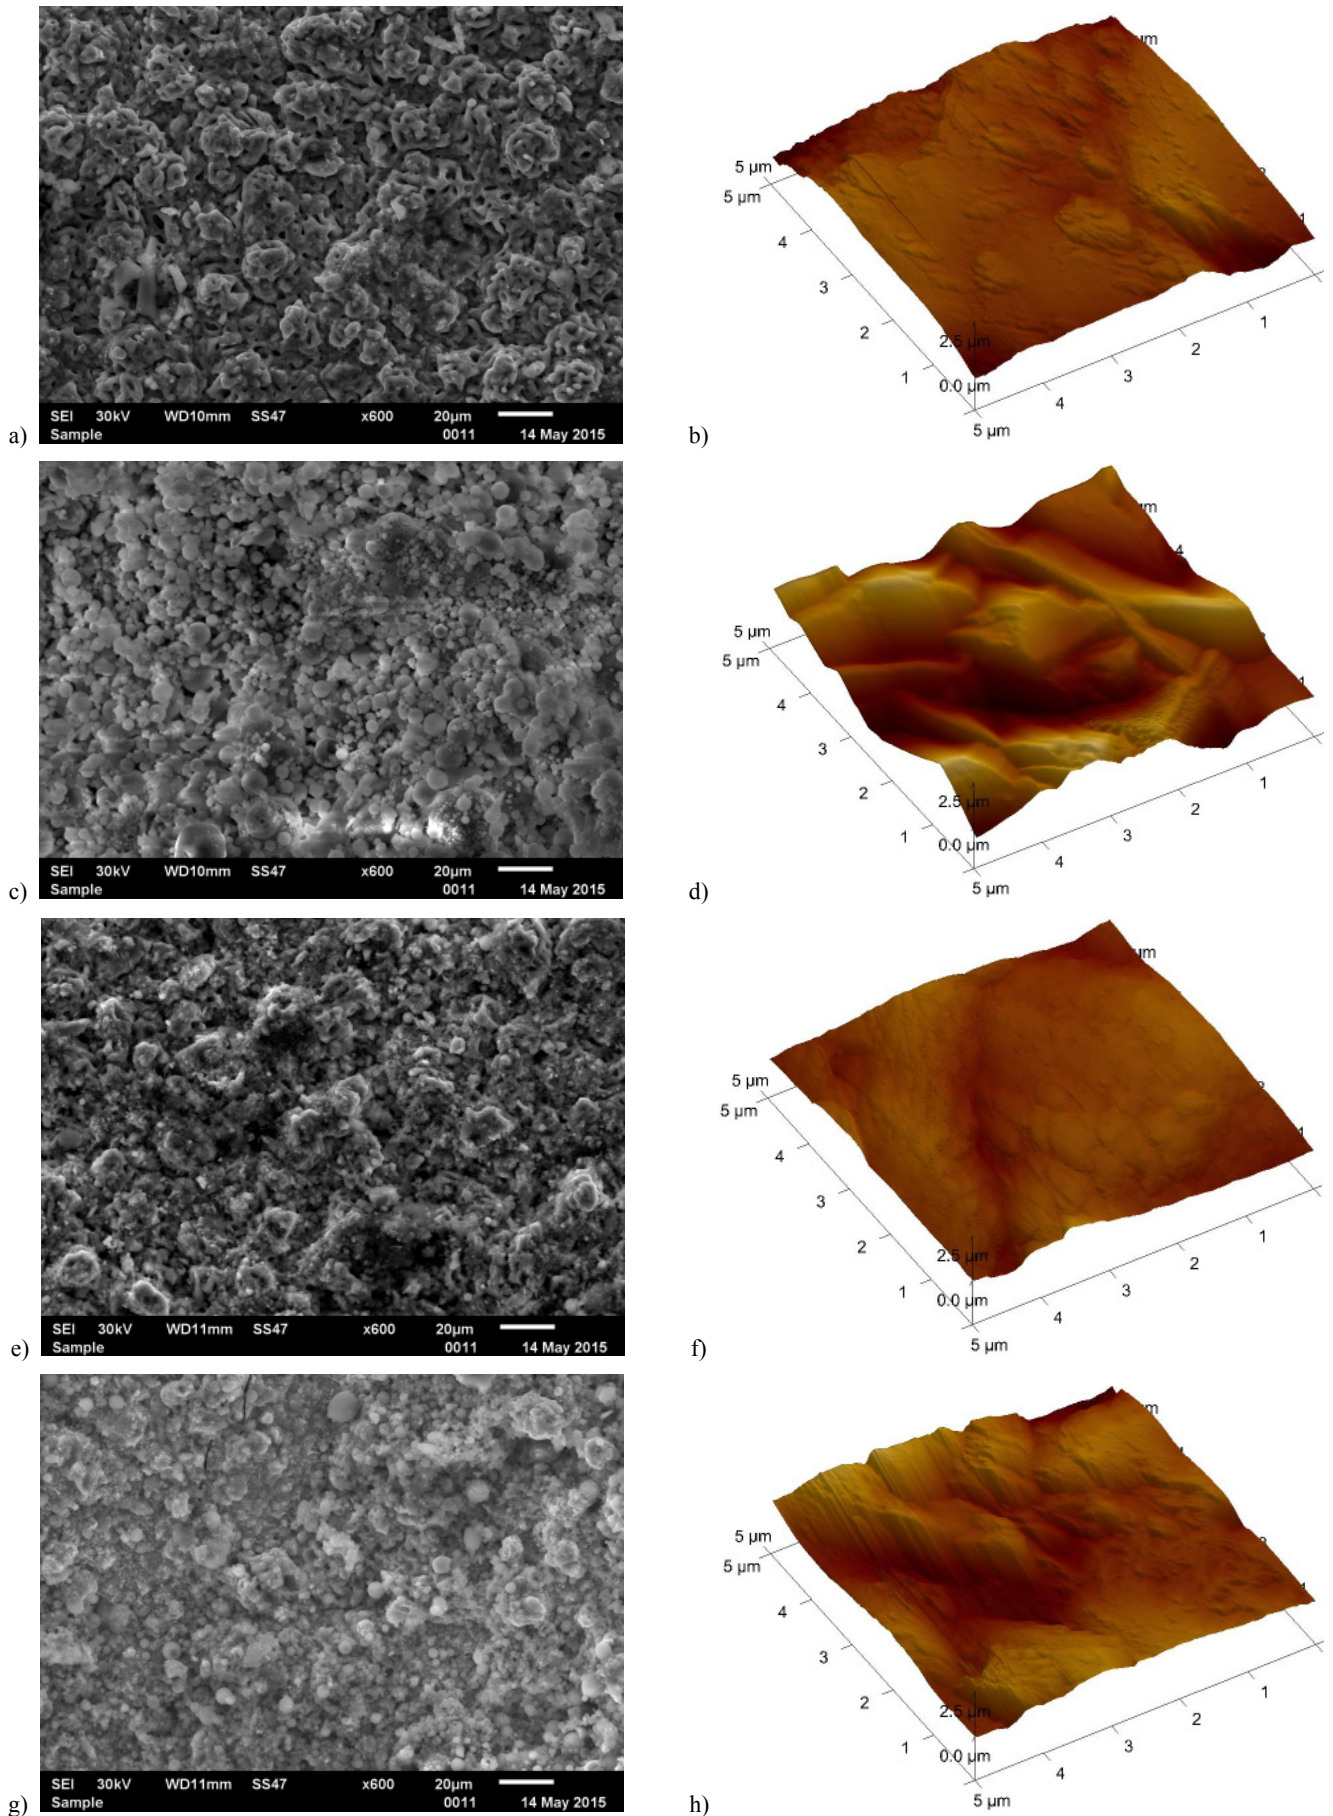
Fig. 3 presents results of surface microscopic studies, where a greater degradation on the outside of tube wall is visible.

Fig. 3. Oxides formed on 10CrMo9-10 steel operated at 545°C during 200,000 hours: (a) inner surface – fire wall, SEM; (b) inner surface – fire wall, AFM; (c) outer surface – fire wall, SEM; (d) outer surface – fire wall, AFM; (e) inner surface – opposite fire wall, SEM; (f) inner surface – opposite fire wall, AFM; (g) outer surface – opposite fire wall, SEM; (h) outer surface – opposite fire wall, AFM

Fig. 3d and h shows spalling of individual deposit/oxide layers on the outside. In the case of fire side, both on the inside and outside, a larger degree of surface development was observed (Fig. 3a and c).

The surface topography studies (Figs. b, d, f, h and Table 1) have shown that the largest degree of surface development occurred on the outside surface on the fire side, where Ra and Rmax were 406 nm and 2790 nm, respectively.

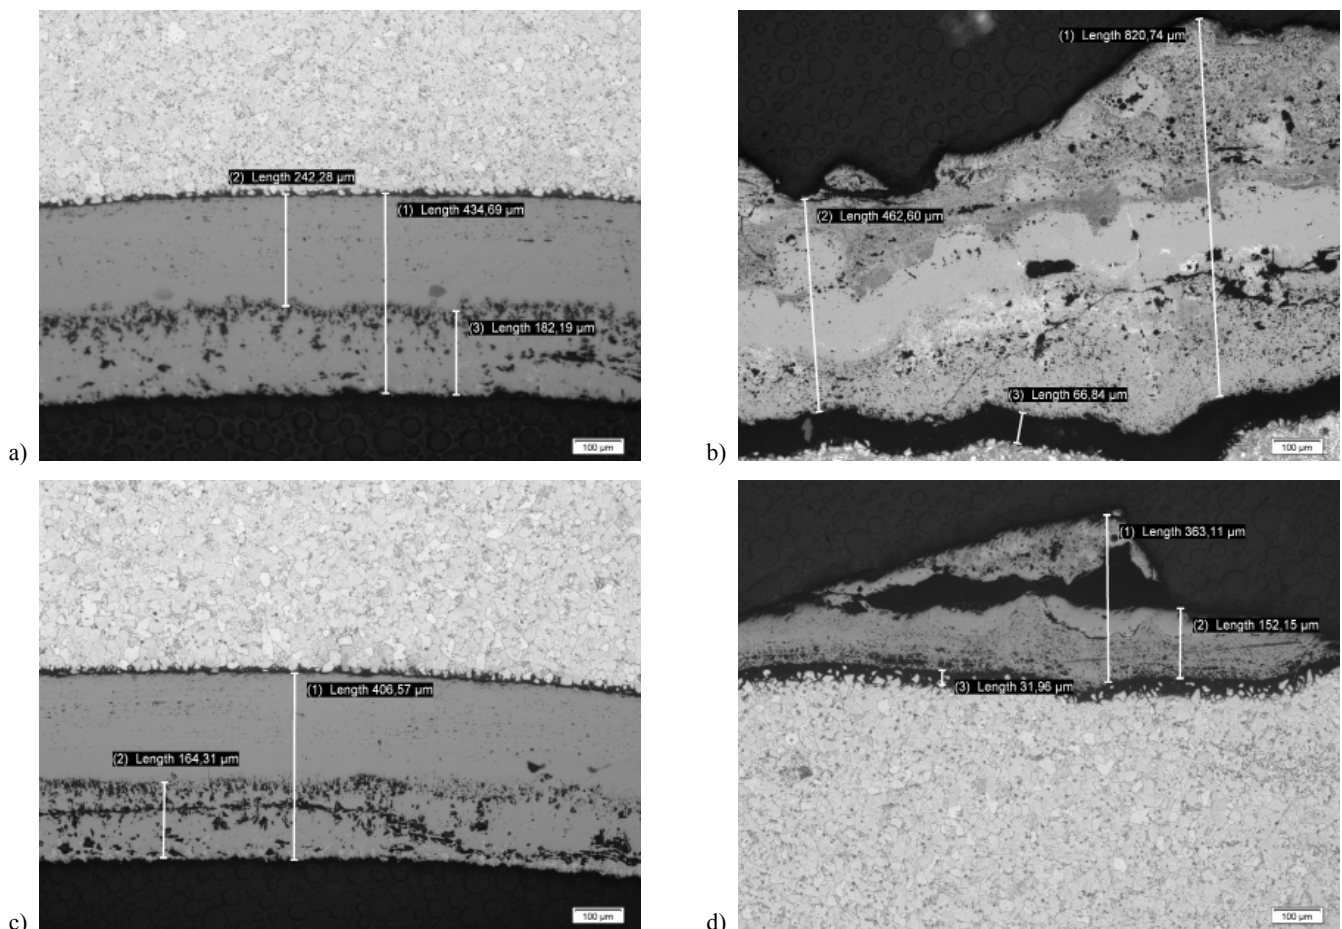
The oxides layer thickness together with deposits on the fire side was 435 μm and 820 μm on the flowing medium and

flue gas side, respectively (Fig. 4a, b). For the counter-fire side on the inside the oxides layer thickness is smaller by 30 μm , while on the outside by as many as 460 μm (Fig. 4c, d). The layer formed on the fire outside shows high degradation, which is presented in Fig. 5b, where a surface after spalling of a thick deposit layer is visible. In addition, a very large fissure reaching the depth of 235 μm may be noticed. Instead, on the inside only local spalling in the oxides layer may be observed directly on the flowing medium side (Fig. 5a).

Fig. 4. The thickness of oxides layer formed on the steel examined, LM: (a) inner surface – fire wall, (b) outer surface – fire wall, (c) inner surface – opposite fire wall, (d) outer surface – opposite fire wall

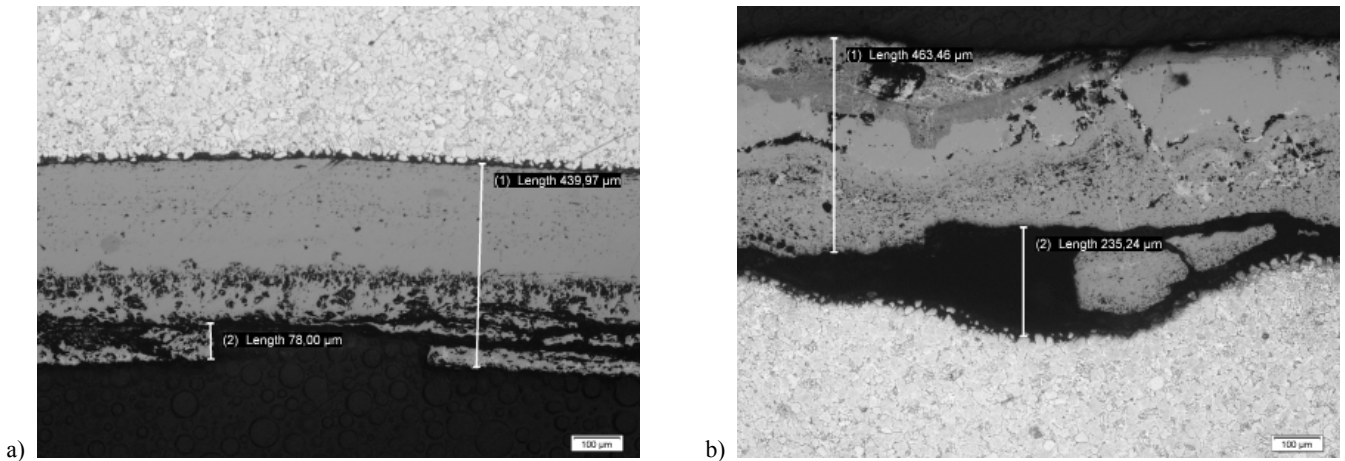
Fig. 5. The damage of oxide layer; cross section: (a) inner surface – fire wall, (b) outer surface – fire wall

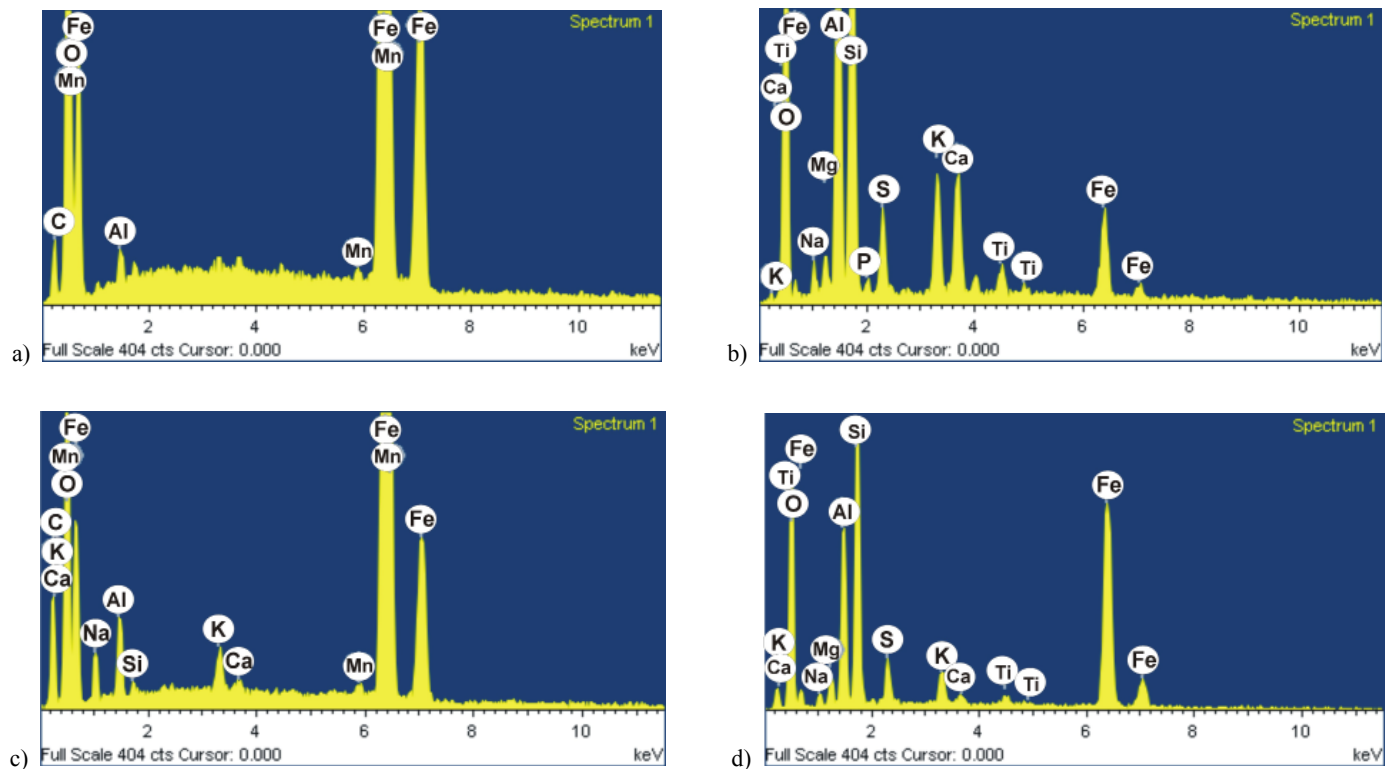
Performed EDS analysis of chemical composition (Fig. 6) combined with X-ray phase analysis (Fig. 7) has shown that oxides occur on the inside surface of tube. Based on DHN PDS and PDF4+2009 crystallographic database it has been found that the forming oxides are: Fe_2O_3 and Fe_3O_4 in accordance with the catalogue card numbers: 01-079-0007, 01-089-0951, respectively. In the case of the outside surface of tube from opposite fire wall apart from the aforementioned compounds also Al, Si, K, Ca, Ti, Mg, Na and S based compounds exist, such as: Al_2SiO_5 . The other elements, such as K, Ca, Ti, Mg, Na, occur in small amounts. Instead, directly on the fire outside only Al_2SiO_5 exists and small amounts of K, P, S, Ca, Ti, Mg and Fe. After removing the external deposit layer on the outside and repeating the XRD analysis it has been shown that the forming oxide layer is built of Fe_2O_3 and Fe_3O_4 (Fig. 8).

Fig. 6. EDS point microanalysis: (a) inner surface – fire wall, (b) outer surface – fire wall, (c) inner surface – opposite fire wall, (d) outer surface – opposite fire wall

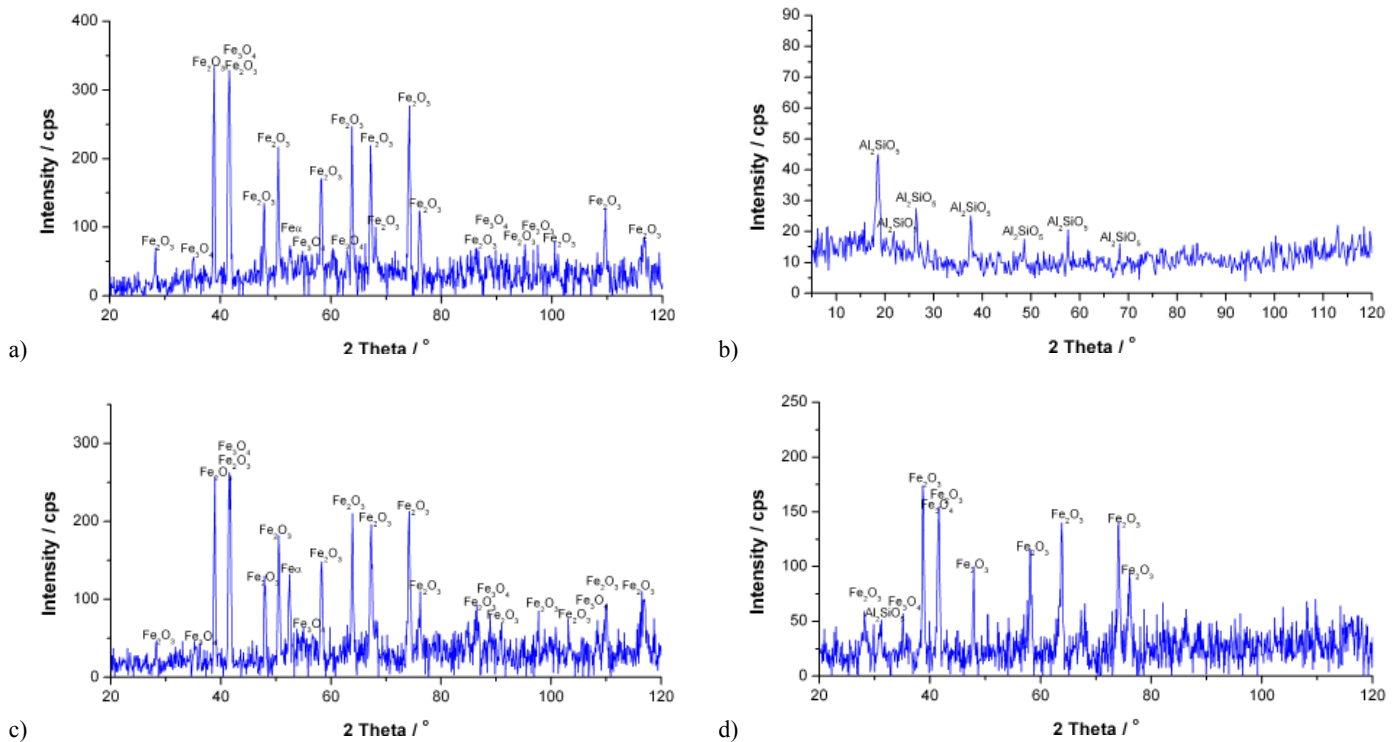
Fig. 7. Diffraction pattern of oxide layers obtained using the XRD technique: (a) inner surface – fire wall, (b) outer surface – fire wall, (c) inner surface – opposite fire wall, (d) outer surface – opposite fire wall

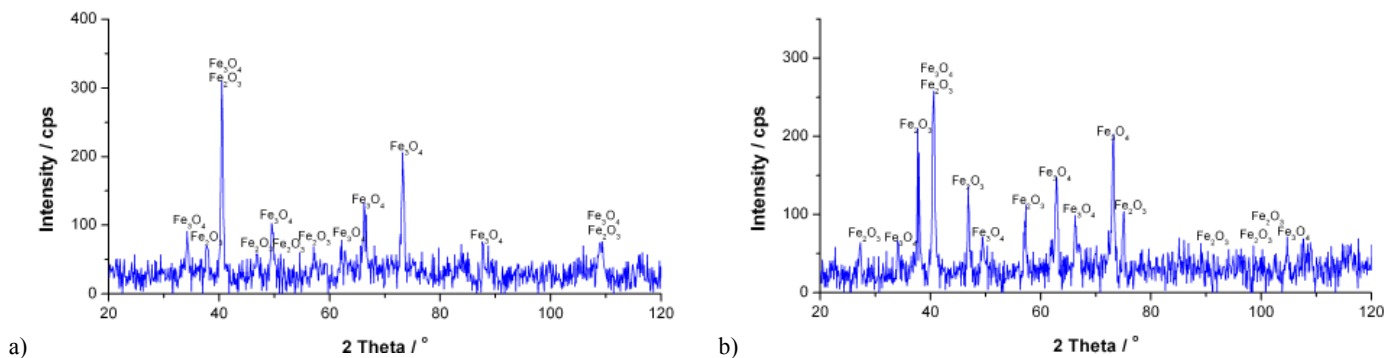
Fig. 8. Diffraction pattern of oxide layers after polishing obtained using the XRD technique: (a) outer surface – fire wall, (b) outer surface – opposite fire wall
