Andrzej Gonet*, Stanisław Stryczek*

**PROTECTING WIELICZKA SALT MINE
AGAINST WATER HAZARD
ON THE EXAMPLE OF THE MINA TRAVERSE****

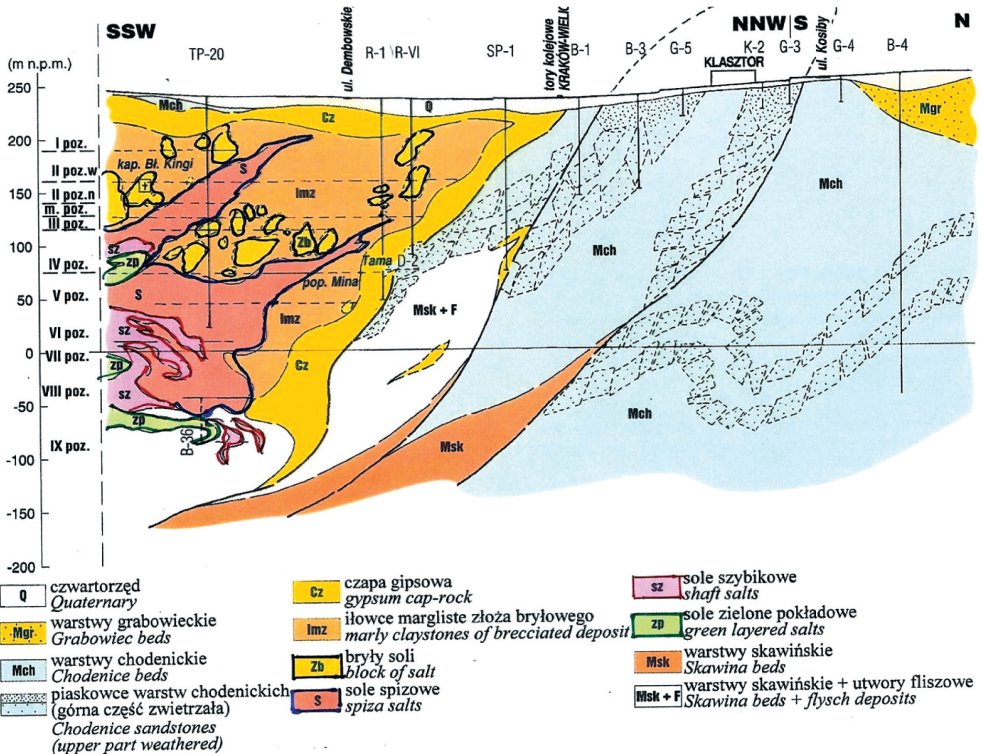
Fig. 1. Cross-section of northern part of the Mina traverse (Szybist)

For the sake of illustrating the geological build and hydrogeological conditions, the most hazarded part of the mine was presented in Figure 1.

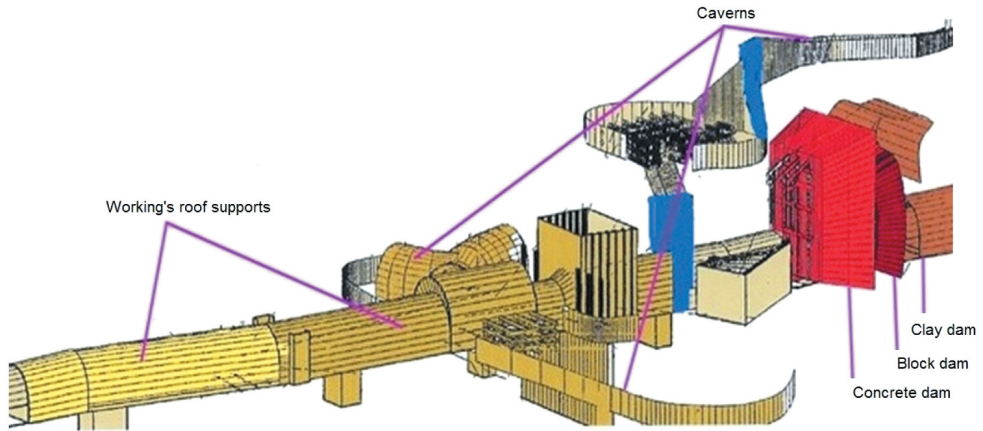
On 7 April 1992, when the face of the working was 3.5 m from the end of the old heading, the water flow from the bottom rapidly increased. On 13 April 1992 between 23:00 and 24:00 hrs a rapid flux of water and solid phase was observed in the Mina traverse (about 20 m³/h). The rescue action was undertaken and timetable of specialist works established. However, on 17 April 1992 another high-rate leak took place, filling the Mina traverse with sediments over a considerable length almost up to its top. In this situation two wells were scheduled to be drilled from the surface to the potential water supply zone responsible for the situation in the Mina traverse. A rescue well R-1 was drilled to 170 m, i.e. to a depth of Mina traverse. It was supposed to play the role of a dewatering well. Pumping water from R-1 did not have any significant influence on the flux in the Mina traverse, where the flow rate still equaled to 500 l/min. On 2 June 1992 the flux to the Mina traverse unexpectedly ceased. On 4 June 1992 it re-appeared at a rate of 200 l/min to completely stop next day at 4:30 hrs. In the period between 5 June and 15 August 1992 the flux stabilized on the level of 0.3 to 1.6 l/min and at a saturation of 50 g/l NaCl. This period was used for elevating a three-segment water dam consisting of a block dam, clay dam and concrete dam in the Mina traverse. A number of injection wells were performed around the concrete segment, then cement slurry was injected to reinforce the rock mass around the dam (Fig. 2). For doing so, a pipeline was installed

Fig. 2. Schematic of protection applied to the end part of the Mina traverse

In view of the safety of miners, the following solution was proposed for the T-4 to T-1 section (Fig. 2):

- first build a steel tunnel,
- fill the space between the rock mass and the steel tunnel with sealing slurry,
- drill directional boreholes and perform zonal injection through them.

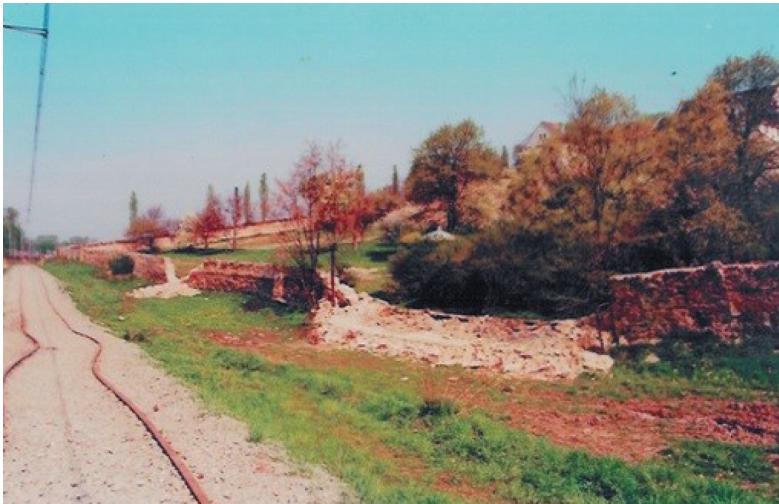
Fig. 3. View on the railway tracks and stone fence around the cloister

On 11 September 1992 a subsidence trough was observed on the surface. First the maximum subsidence equaled to 0.3 m but gradually increased to finally exceed 2 m. Apart from it, under the influence of the underground movement, the railway tracks were distorted on the Wieliczka – Wieliczka Market route, as in (Fig. 3), and part of the stone fence around the Franciscan Cloister got destroyed, too. Dangerous cracks appeared on the walls and the ceilings of the cloister, threatening the stability of the object (Fig. 4).

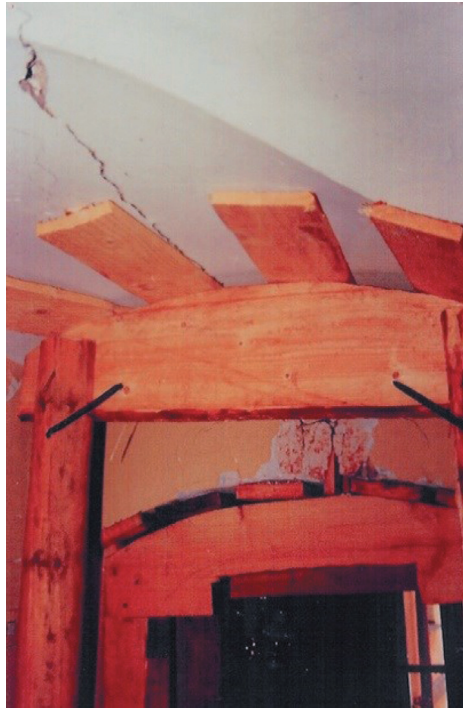
Fig. 4. Fragment of supported roof in the cloister

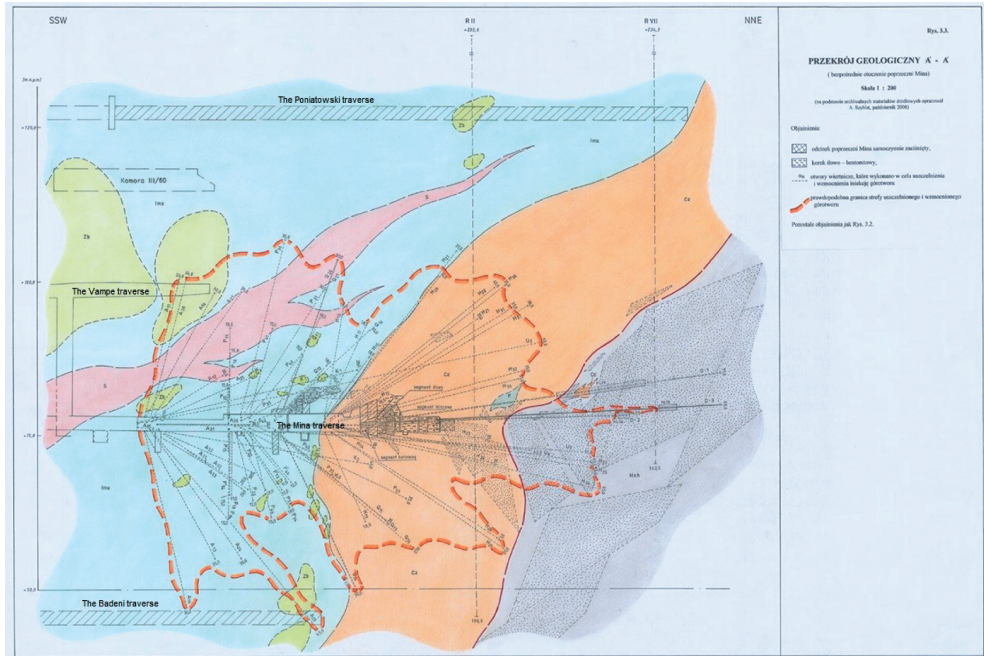
After performing hole injection in the Mina traverse end, the probable range of sealing is as shown in Figure 6.

Fig. 6. Geological cross-section with injection holes and marked zone of potential range of rock mass sealing [8]
