## STRESS ANALYSIS OF THE PZL M28'S AIRFRAME SUBJECTED TO REPAIRS DURING FATIGUE TESTS

*Polskie Zakłady Lotnicze Sp. z o.o., ul. Wojska Polskiego 3, 39-300 Mielec*

## THE CRACK AT THE WING RIB 15

### THE CRACK AT WING RIB 17

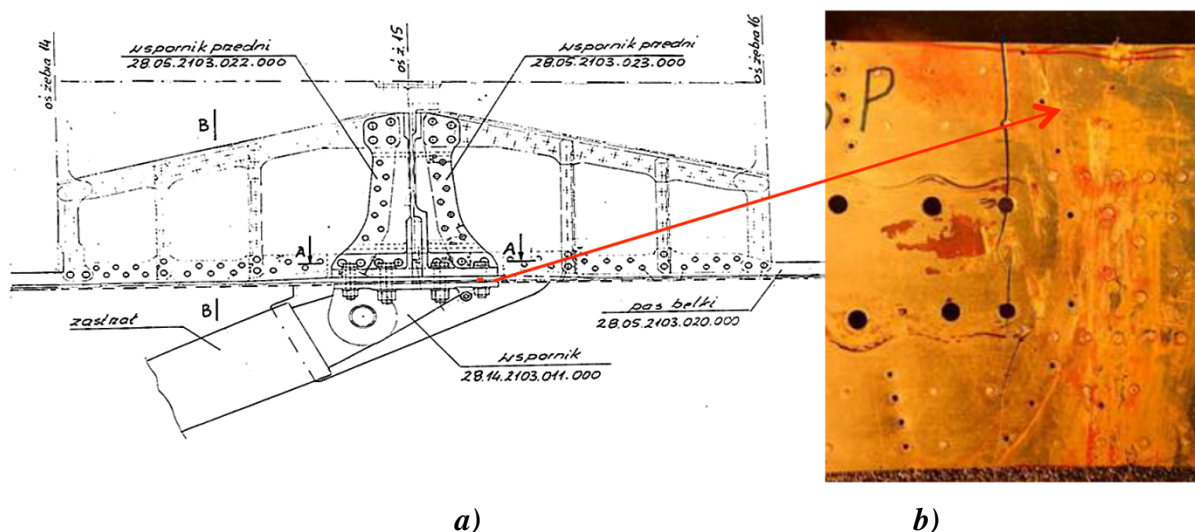
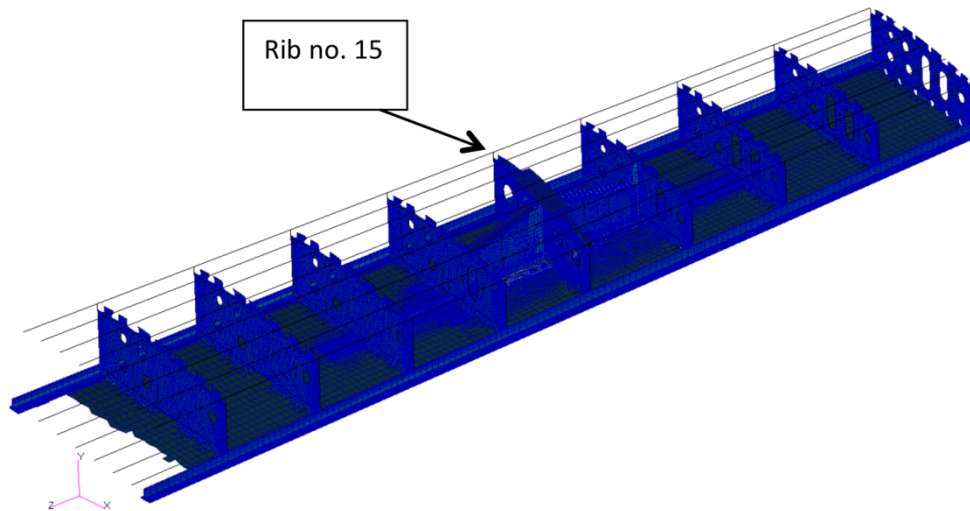
The first significant event in the test was a crack in the wing, in the area where wing strut loads are introduced at the rib 15. The crack was caused by the fatigue damage of the wing in the area of the local stress concentration (holes for bolts in the wing strut fitting mounting). The test was terminated before the damage of the tested wing could spread – see Fig. 1. The subsequent analysis showed that it was possible to repair the critical wing area on the airplane in operation, and in this way significantly extend the airplane's service life. A careful stress analysis was performed for the PZL M28's outer wing, in which the most interesting area was the rib 15, where the wing strut loads were introduced. A detailed FEM model covers the wing area from rib 10 (the root rib of the outer wing, with four fittings of the junction with the centerwing) to the rib 19 – see Fig. 1(c) and Fig. 2.

**Fig. 1. PZL M28 wing area of rib 15:**  
**(a) Sketch of the area of rib 15 with a crack indicated**  
**(b) Cracked wing skin after removal of a wing strut fitting**  
**(c) The FEM model of the wing, general view**

The wing area aft of the rib 19 was modeled as a beam. Design changes implemented in the structural beam lying between the front and rear wingspans considerably increased the service life of the wing. These changes can be introduced to the wing taken from the airplane in operation during the repair process.

The fatigue test was continued after the repair of the wing critical area, with separate design solutions implemented in the LH outer wing and the RH outer wing. This resulted in increasing the test scatter factor for the wing, according to the advisory literature recognized by the Authorities as FAA or EASA [2].

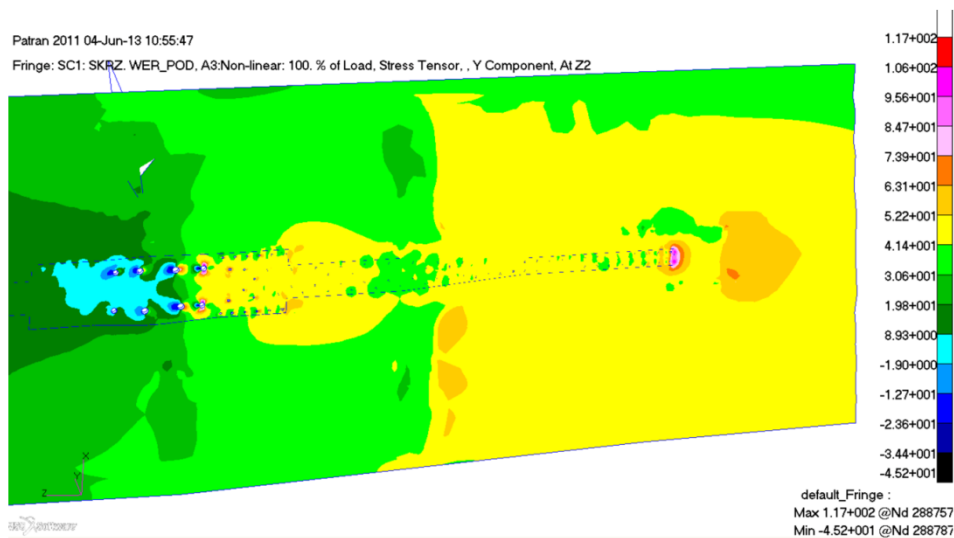
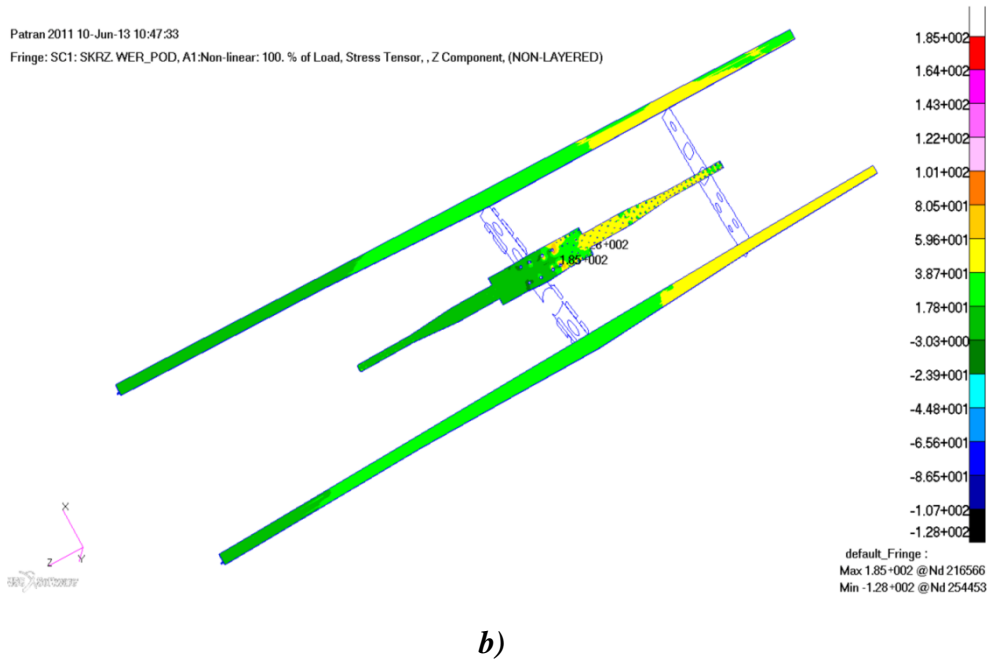
**Fig. 2. Stress distribution in the PZL M28 critical wing area according to the FEM analysis at a maximum load level during the fatigue test:**

- (a) Stress in the lower skin critical area  
 (b) Stress in the wing spars' lower caps and the beam's lower cap

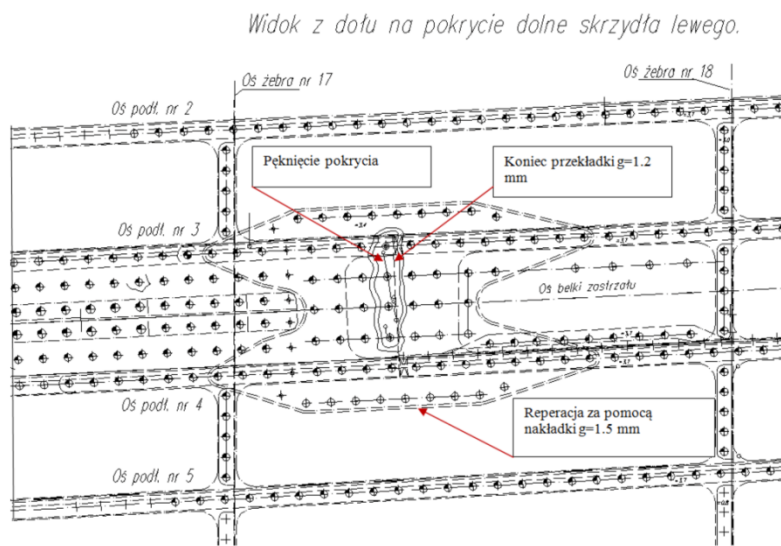
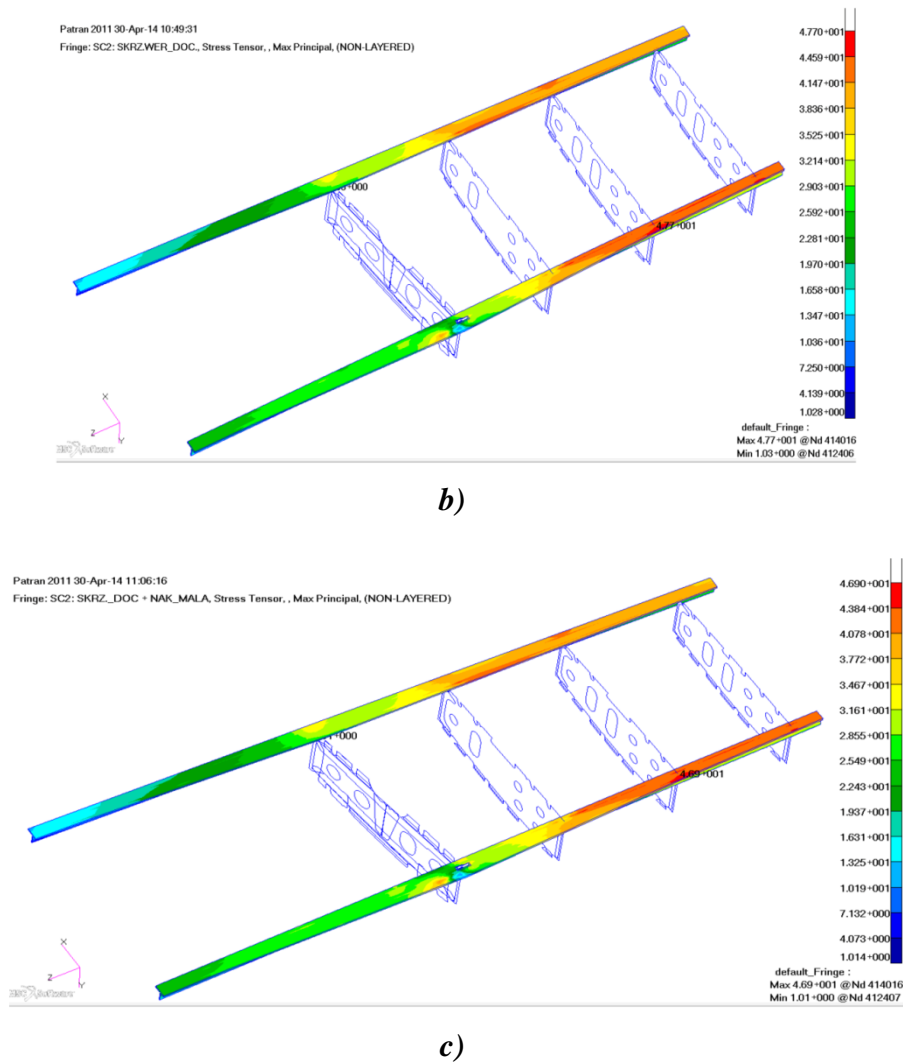
Another crack in the wing was observed at rib 17. The crack was in the wing skin only, so it was assessed as not critical. As it is the area of the integral fuel tank, a crack occurrence is signaled by a fuel leakage. Repair of the airplane in operation is possible, so such repair was made in the tested wing. The FEM stress analysis was performed in order to check the effect of the repair on the stress level in the wing spars – see Fig. 3.

**Fig. 3. The FEM analysis of a crack in the PZL M28 wing area of rib 17 during fatigue testing:**  
 (a) Sketch of the cracked area of the skin between rib 17 and rib 18 with a strap  
 (b) Stress in the wing spars' lower caps for level flight ( $n_z = 1 g$ ) load before the repair  
 (c) Stress in the wing spars' lower caps for level flight ( $n_z = 1 g$ ) load after the repair
