Bogusław ŁADECKI\*, Sławomir BADURA\*, Filip MATACHOWSKI\*

## STRENGTH ANALYSIS OF A GANTRY CRANE OF A COATING STRUCTURE

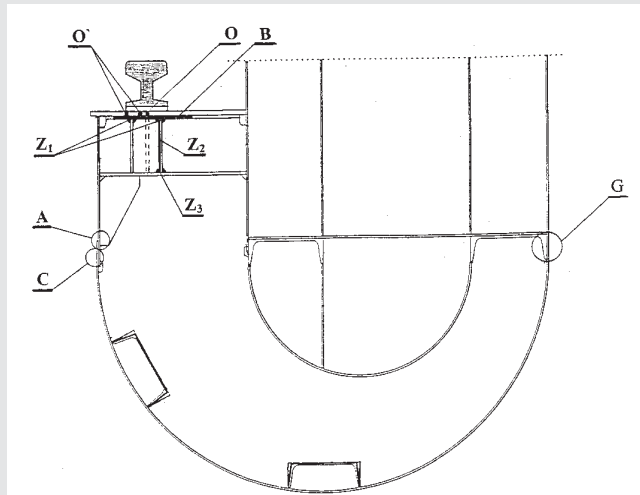
**Fig. 2.** Location of the detected cracks of the crane beam

- Type „A” – welded joint crack, in the lower part of the transverse rib of the crane beam,
- Type „B” – crack of the overhead weld joining the upper double-tee bar with the horizontal crane beam plate,
- Type „C” – vertical crack of the welded joint of a crane beam plate and coating, located in between ribs of the crane beam,
- Type „O” – plate crack under the rail in the direction of the rail axis, close to a rib,
- Type „O” – plate crack under the rail parallel to the rail axis,
- Type „Z<sub>1</sub>” („Z<sub>3</sub>”) – crack of the joint parallel to the rail axis, rib of the transverse frame rib or frame,
- Type „Z<sub>2</sub>” – vertical joint crack, rib of the transverse frame rib or frame,
- Type „G” – welded joint crack.

Apart from sporadically detected cracks of type „A”, „C” and „G”, for various examination series, it was found that there are: 42–47% type „Z” cracks, 13–42% type „O” cracks and 8–25% type „B” cracks, in the total number of detected cracks.

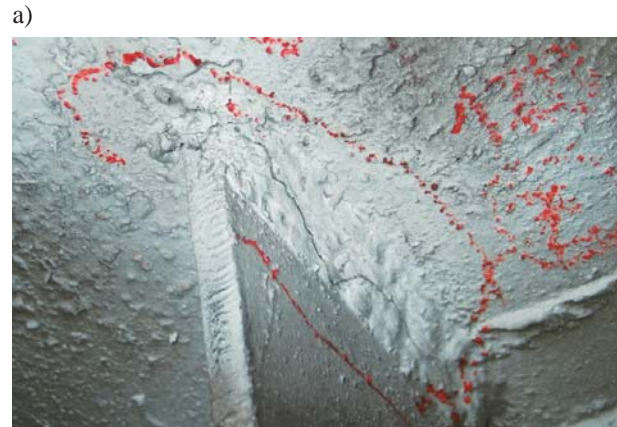
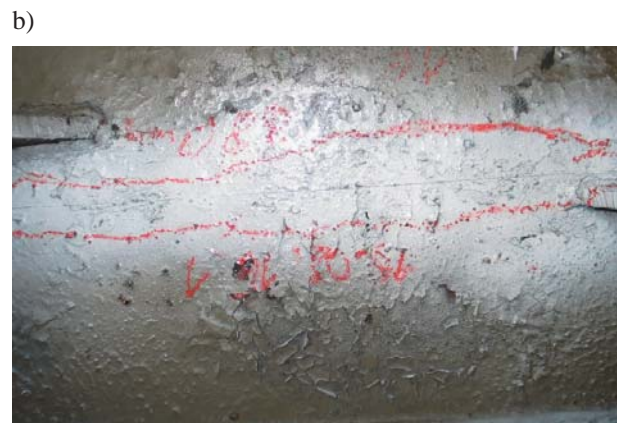
**Fig. 3.** Cracks of the crane beam revealed by means of the magnetic-powder method: a) type „Z<sub>1</sub>” joint 120 mm long; b) type „O” plate under the rail, 380 mm long

ues of the reduced stresses for the crane beams being equal 65 MPa, were obtained for the area of the cracks of the fillet joints of type „B” and „Z”.

cracks type „B” and „Z”, while the source of often detected cracks of type „O” is probably their vicinity to cracks of type „B” and „Z”, from which type „O” cracks the most often were developing.

The exploitation history of the discussed objects is not known, however when taking into consideration the fatigue category, for the crack occurrence area, determined as 57 MPa (PN-90/B-03200), exceeding of the fatigue strength of the welded joints can be indicated as the reason of forming and progressing the fatigue cracks. The presented calculations and measurements can be used for more accurate fatigue strength analysis. They constituted the bases for performing the relevant strengthening of crane structures.

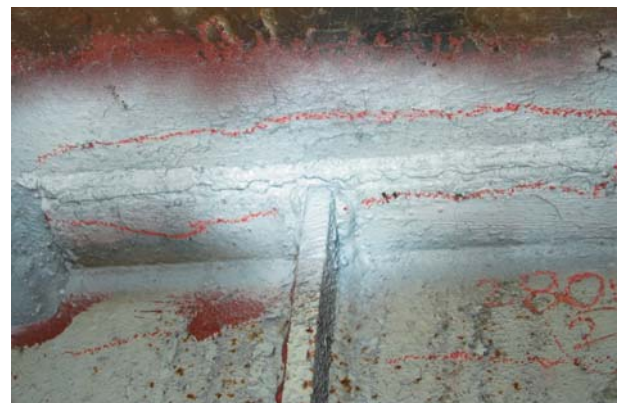
**Fig. 4.** Fillet weld crack of the crane beam type „B” 240 mm long, detected by the magnetic-powder method

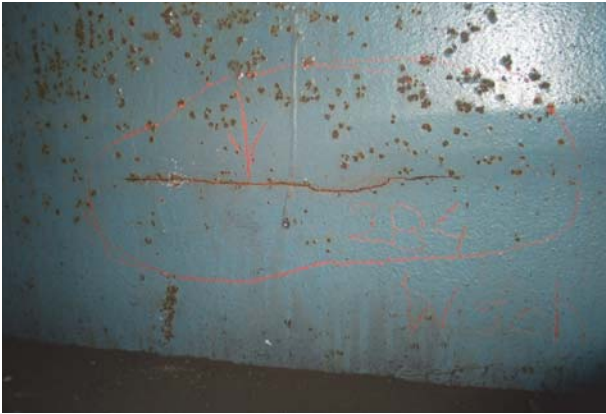
The occurrence of fatigue cracks were also detected in other areas of cranes, out of which the most dangerous were found near the long support (Fig. 5), and in the short support tube buffet (Fig. 6).

Fig. 5. Coating crack – 284 mm long – above the long support

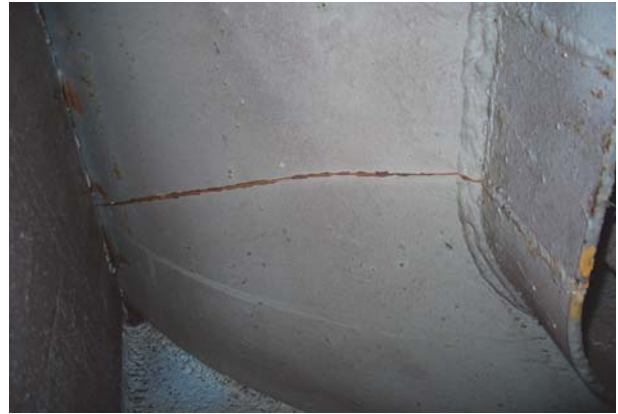
Fig. 6. Crack of the short support tube buffet – at app. 1/3 of a perimeter

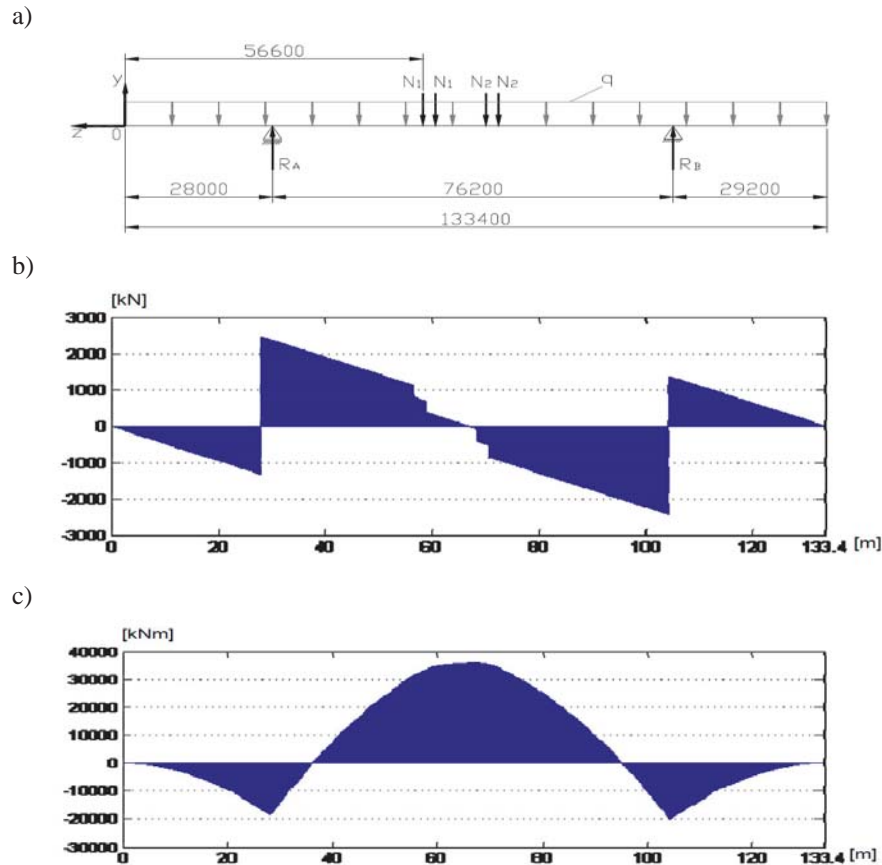
ki 2004). The FEM analyses revealed that for the most disadvantageous conditions of structure loading the extreme shearing forces for the span occur in the support areas, while the extreme bending moment values in the support areas and in the middle of the span length between supports (Fig. 7). These areas are compatible with the areas of the highest intensity of fatigue cracks in crane beams.

Fig. 7. FEM analysis – load variant 2: a) beam model for the truck position 56.6 m; b) diagram of shearing forces; c) diagram of bending moments

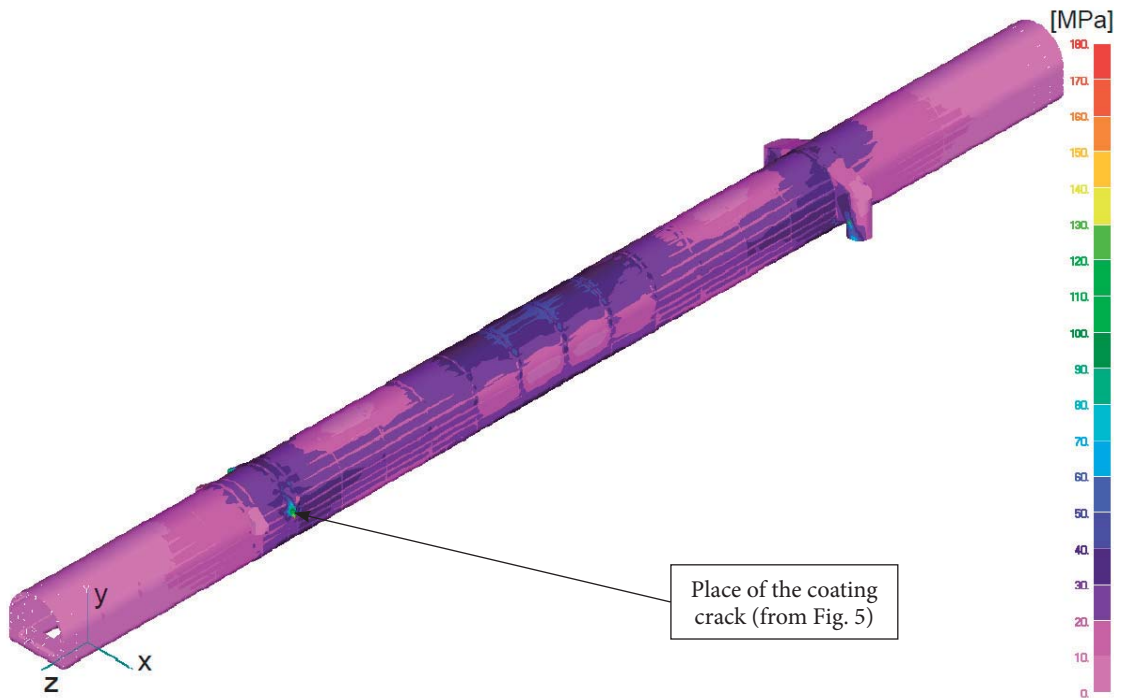
Fig. 8. FEM analysis – distribution of the reduced stresses in the span – load variant 2

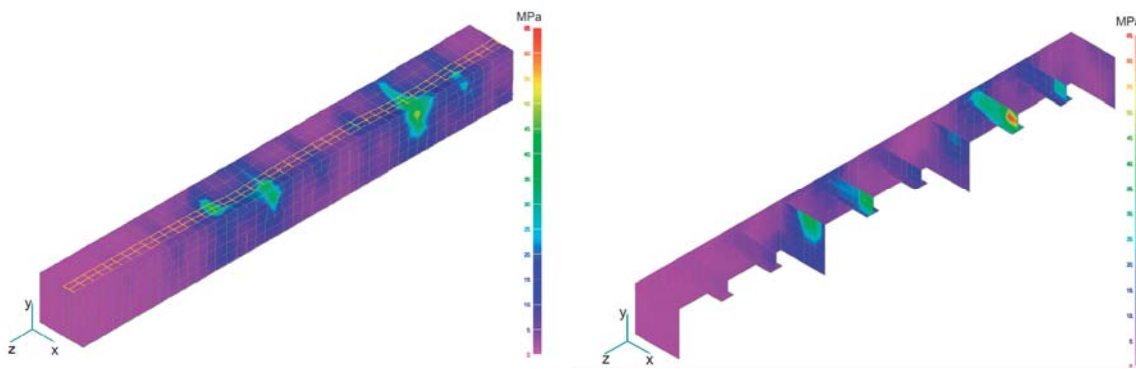
Fig. 9. Distribution of the reduced stresses in the crane beam – load variant 2

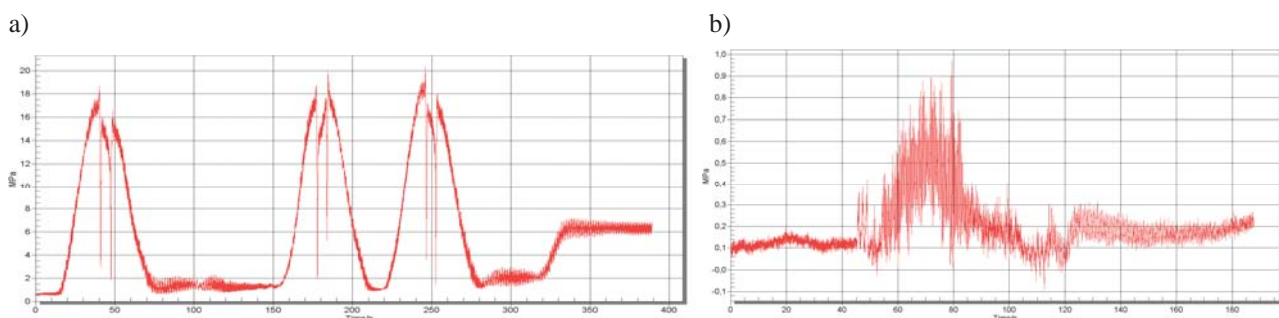
Examples of diagrams of stresses variability recorded by rosette R2: for the work cycle 1 is shown in Figures 11a, while for driving of the whole crane (cycle 2) in Figures 11b. Results shown in Table 2 indicate good compatibility of the calculation results and measurements.

Fig. 11. Diagram of variability of reduced stresses: a) at crane work cycle 1 – rosette R2; b) at cycle 2 of the crane driving – rosette R2
