HISTORY OF THE CHANGES IN THE ROOF STRUCTURE OF A HISTORICAL WOODEN CHURCH

Jacek HULIMKA¹, Magda TUNKEL²

Faculty of Civil Engineering, Silesian University of Technology, Gliwice, Poland

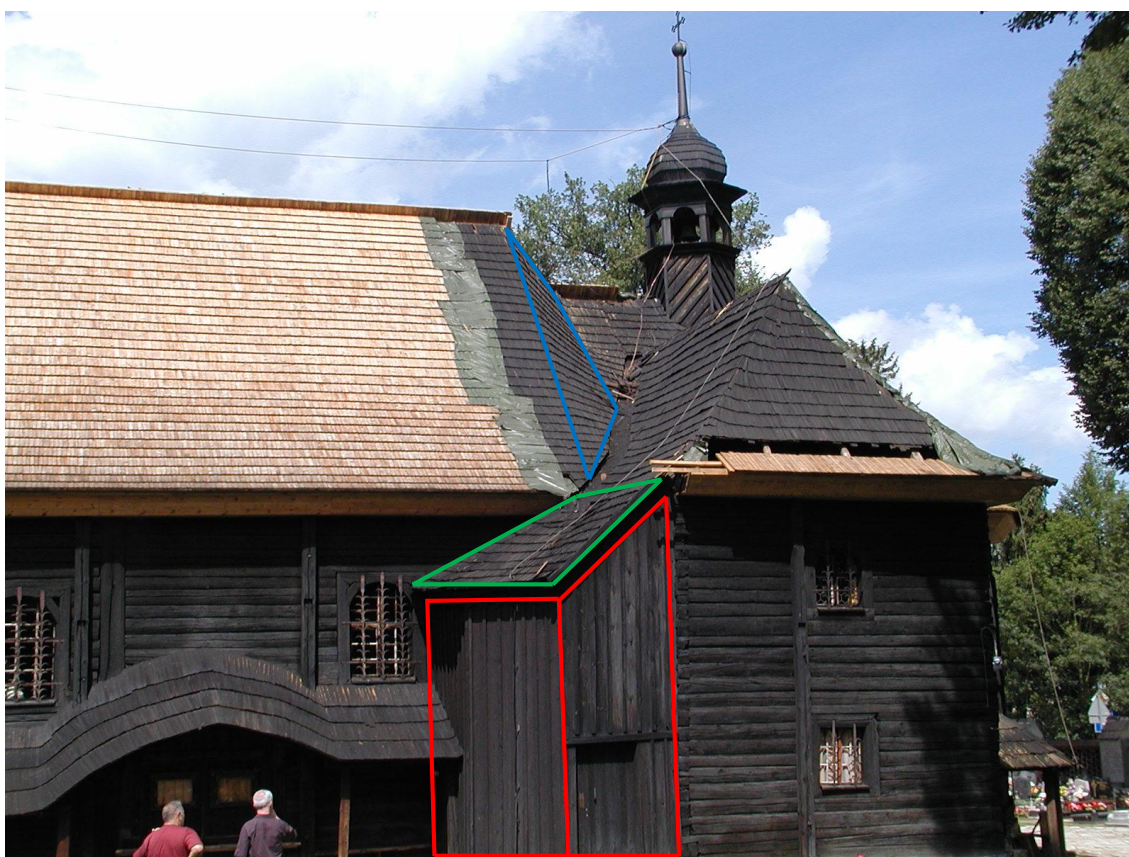
At some point in time, the stairs leading to the collator loge were enclosed with two additional walls, while the western part of the loge roof was stretched out over the new space, slightly changing the roof's slope. The above is clearly visible in Fig. 4, where the additional walls are marked in red, while the new roof is marked in green. As a result of the above, there was a certain interference of the new roof with the original roofs, which led to the creation of a no-drainage zone in the corner of the nave and the loge. In order to avoid this at that time the original joints of the roofs above the nave and the sacristy were reconstructed, changing the stepped roof-to-roof transition to a gentle transition on a curvature (marked in blue in Fig. 4). For symmetry an identical solution was used on the northern side. As was mentioned, the data of this reconstruction remains unknown, however, the roofs were functioning in the described arrangement until 2012.

Fig. 4. View of the church during the renovation of the roof in 2012; walls around the stairs were outlined in red, the roof above the stairway enclosure was outlined in green, and the changed roof joint above the nave and the sacristy in blue

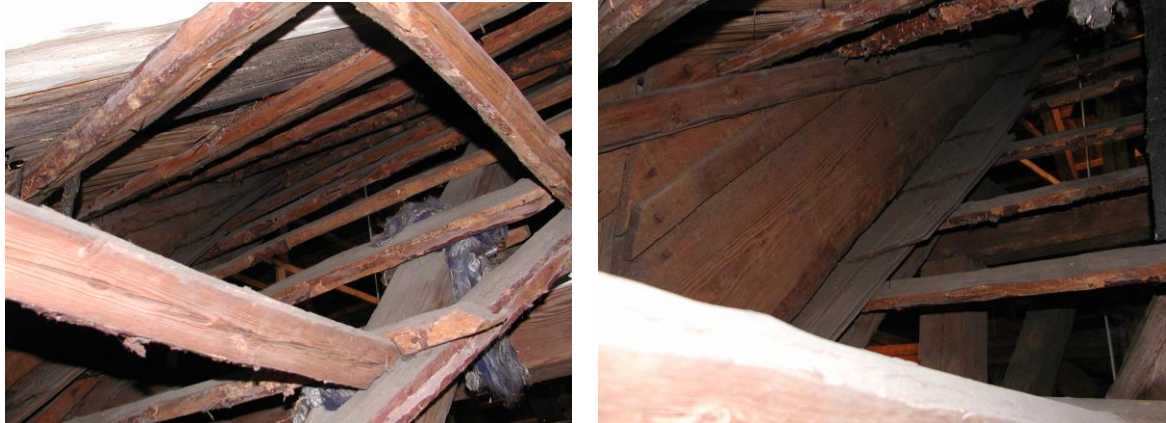
In 2012 works were undertaken to restore the original arrangement of the main roofs: above the nave and the presbytery. The original stepped roof-to-roof transition was very well visible in the attic of the structure where fragments of the endings of the higher roof (above the nave) in its original form were preserved (Fig. 5). Works started on the northern side where they were completed without any problems.

Fig. 5. Fragments of the original roof end above the nave (higher)

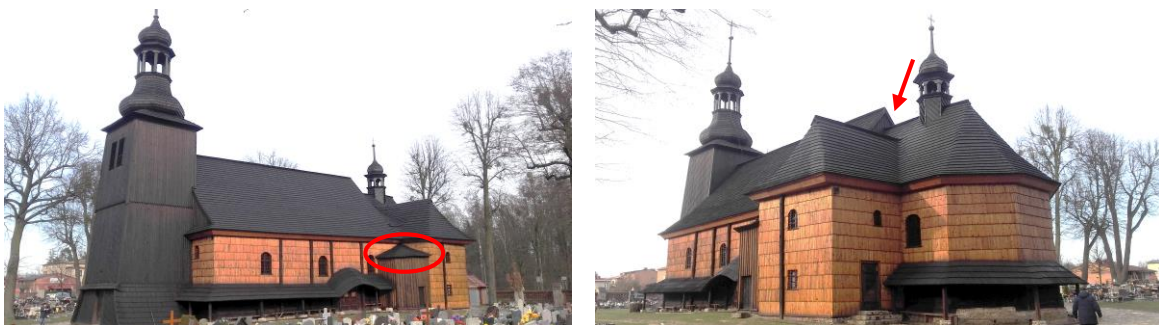
Fig. 6. View of the church after roof renovation: a red oval marks the roof above the lowered stair enclosure, while a red arrow the restored recess of the ridgepole

Due to the historical character of the structure, the final decision was left to the conservator of monuments, who supervised the works. As a result of an analysis of source materials, including archival photographs and drawings a decision was made to lower the original enclosure of the stairs and cover it with a small roof situated below the canopy of the main roofs – which may be seen in Fig. 6. This allowed the renovation of both of the main roofs on the south side to continue as well.
