Radosław PRZYSOWA¹, Marek CHALIMONIUK¹, Danuta GRZELKA-GAJEK¹,
 Ruslan SHAKALO², Artem KARPENKO²

¹ Air Force Institute of Technology (Instytut Techniczny Wojsk Lotniczych)

CT INSPECTION OF COOLED TURBINE BLADES

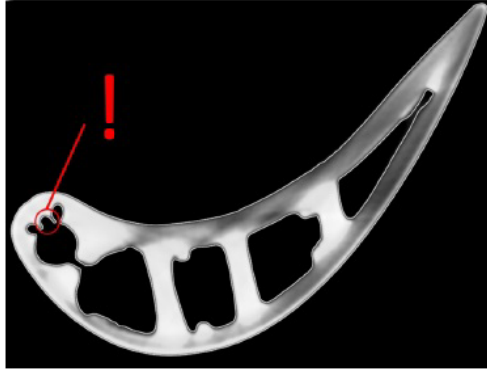
Analyzing the geometry obtained with CT method, internal defects and voids are clearly visible. Fig. 3-5 illustrate the incorrect machining of cooling passages next to the leading edge of blades and in their interior. Such defects are critical for blades and in a very short time, they would result in their overheating and thermal damage. These defects cannot be corrected by machining; thus, the blades were rejected.

Detected manufacturing defects were attributable mainly to the incorrect setting of the tool which drilled cooling holes. As a result, the walls were too thin and sometimes, the adjacent passages were joined.

Fig. 3. Incorrectly manufactured cooling passages in blade 1

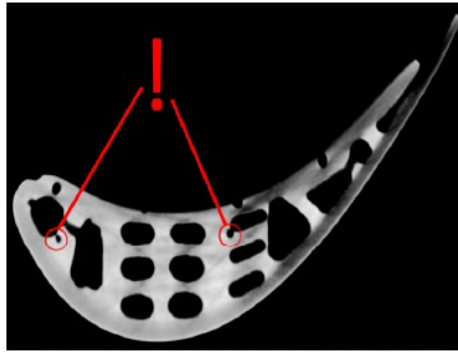
Fig. 4. Perforation errors in the walls in blade 2

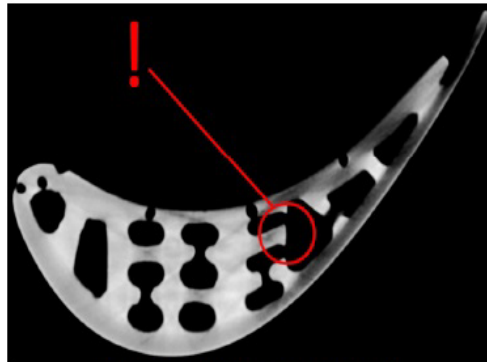
Fig. 5. Manufacturing defect of the cooling passage in blade 2, caused by mispositioning the tool

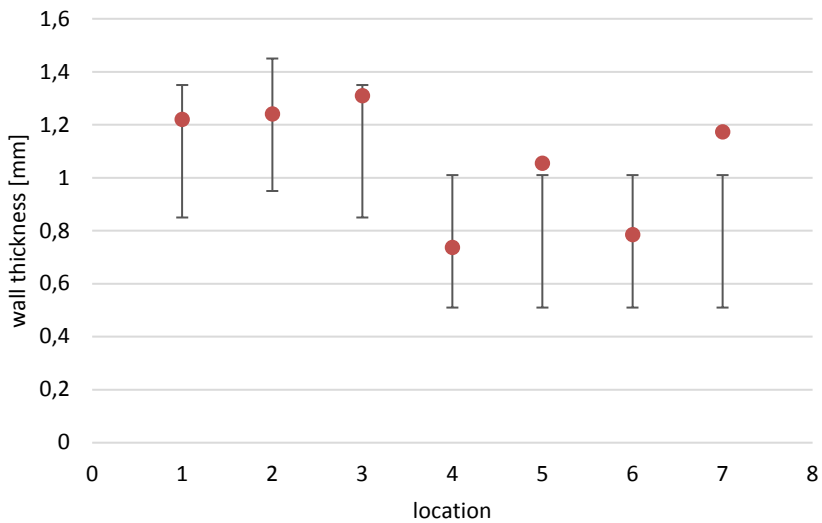
For the selected cross-section A-A of the blade 2 (figs. 7 and 8), measurement results of wall thickness were presented in seven points, and they were referred to the tolerances defined by the manufacturer (fig. 9). Points 1-3 are situated on the leading edge, 4 and 5 on the pressure side, 6 and 7 on the suction side. In five points, the wall is within the tolerance; for point 5, it slightly exceeds it while in point 7, the exceedance is significant (0.2 mm).

Fig. 9. Measurement results of wall thickness. The bars show the tolerance of measurements specified by the manufacturer in the cross-section A-A

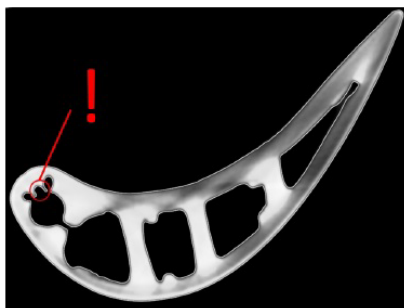
Podczas analizy geometrii uzyskanej metodą CT wewnętrzne wady i nieciągłości materiału są dobrze widoczne. Na rys. 3–5 uwidoczniono błędne wykonanie kanałów chłodzących przy krawędzi natarcia łopatek oraz w ich wnętrzu. Tego typu wady są krytyczne dla działania łopatek i w bardzo krótkim czasie skutkowałyby ich przegrzaniem oraz uszkodzeniem termicznym. Wad tych nie da się skorygować przez obróbkę, więc łopatki zostały wybrakowane.

Wykryte wady produkcyjne wynikały głównie z błędnego ustawienia narzędzia (pręta) wykonującego otwory chłodzące. Efektem tego była zbyt mała grubość ścian, a czasem łączenie sąsiednich kanałów.

Rys. 3. Błędnie wykonane kanały chłodzące łopatki TNC

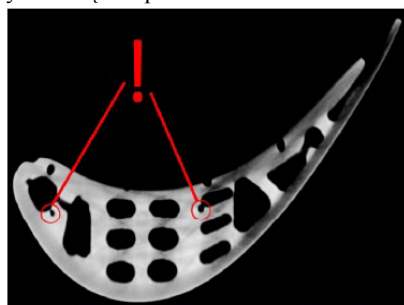
Rys. 4. Błędy perforacji w ścianach łopatki TWC

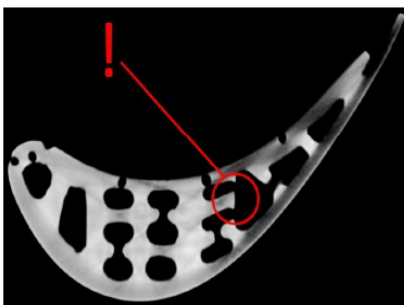
Rys. 5. Błąd wykonania kanału chłodzącego łopatki TWC, spowodowany przesunięciem narzędzia

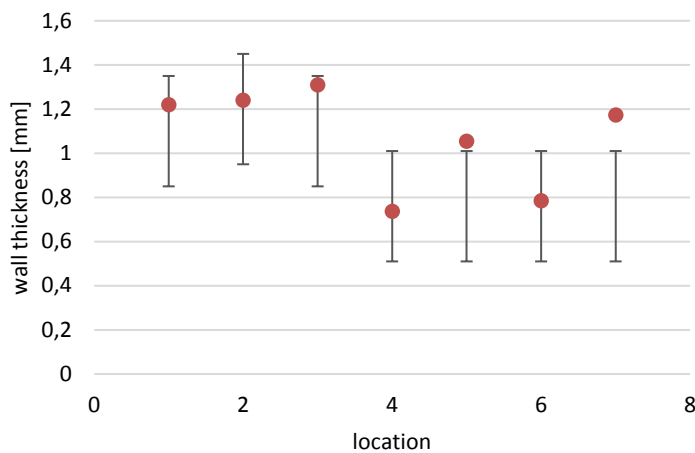
Dla wybranego przekroju A-A łopatk TWC (rys. 7 i 8) przedstawiono wyniki pomiaru grubości ściany w siedmiu punktach i odniesiono je do tolerancji zdefiniowanych przez producenta (rys. 9). Punkty 1-3 położone są na krawędzi natarcia, 4 i 5 w korycie, a 6 i 7 na grzbiecie łopatk. W pięciu punktach ściana mieści się w tolerancji, dla punktu 5 nieznacznie ją przekracza, natomiast w punkcie nr 7 przekroczenie jest znaczne (0,2 mm).

Rys. 9. Wyniki pomiarów grubości ściany. Słupki obrazują tolerancję wymiarów określoną przez producenta w przekroju A-A
