## BUILDING STRUCTURE FAILURES CAUSED BY DEFECTS IN WORKMANSHIP

Sylwester KOBIELAK\*, Edward HUTNIK\*, Zenon ZAMIA\*\*

The article presents the characteristics of collapses of three building structures which occurred as a result of defects in workmanship, including the Hyatt Regency Hotel building in Kansas City, a building in Shanghai and the roof over a part of the grandstand at the stadium of FC Twente in Enschede. These events had a global impact. The paper describes also the construction of and the repair of damage to the elevated reinforced concrete tank for storing liquids.

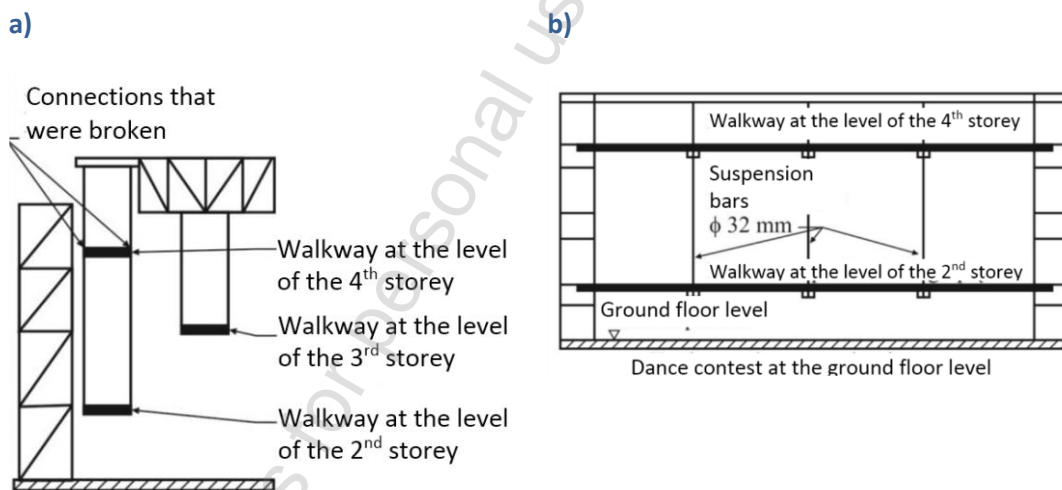
In 1981, in the newly opened Hyatt Regency Hotel in Kansas City two suspended walkways collapsed (Figure 1a) b) c)). The walkways connected the floors on the second and fourth storeys in the hotel atrium and they fell down on the participants of a dance contest organised by a local radio station, killing 114 and wounding 186 people. It was one of the most tragic building disasters (Figure 1d) that occurred in the U.S. The main reason for the collapse of the walkways at the fourth and second storeys was a change in the way of suspending them, introduced by a contractor, replacing the design solution using one bar (Figure 1h) with a two bar system. Thus, in the modified version (Figure 1g), the force applied to the nuts supporting the walkway at the fourth floor was doubled, as a result of which they were subjected to the load  $F$ , instead of  $\frac{1}{2} F$ , specified in the design version (Figure 1h).

**Fig.1.** Collapse of two suspended walkways in the Hyatt Regency Hotel in Kansas City, the U.S., in 1981 [7]: a) short section of the atrium with the truss system to which the bars were attached [6], b) long section of the atrium with the walkways on the fourth and second storeys

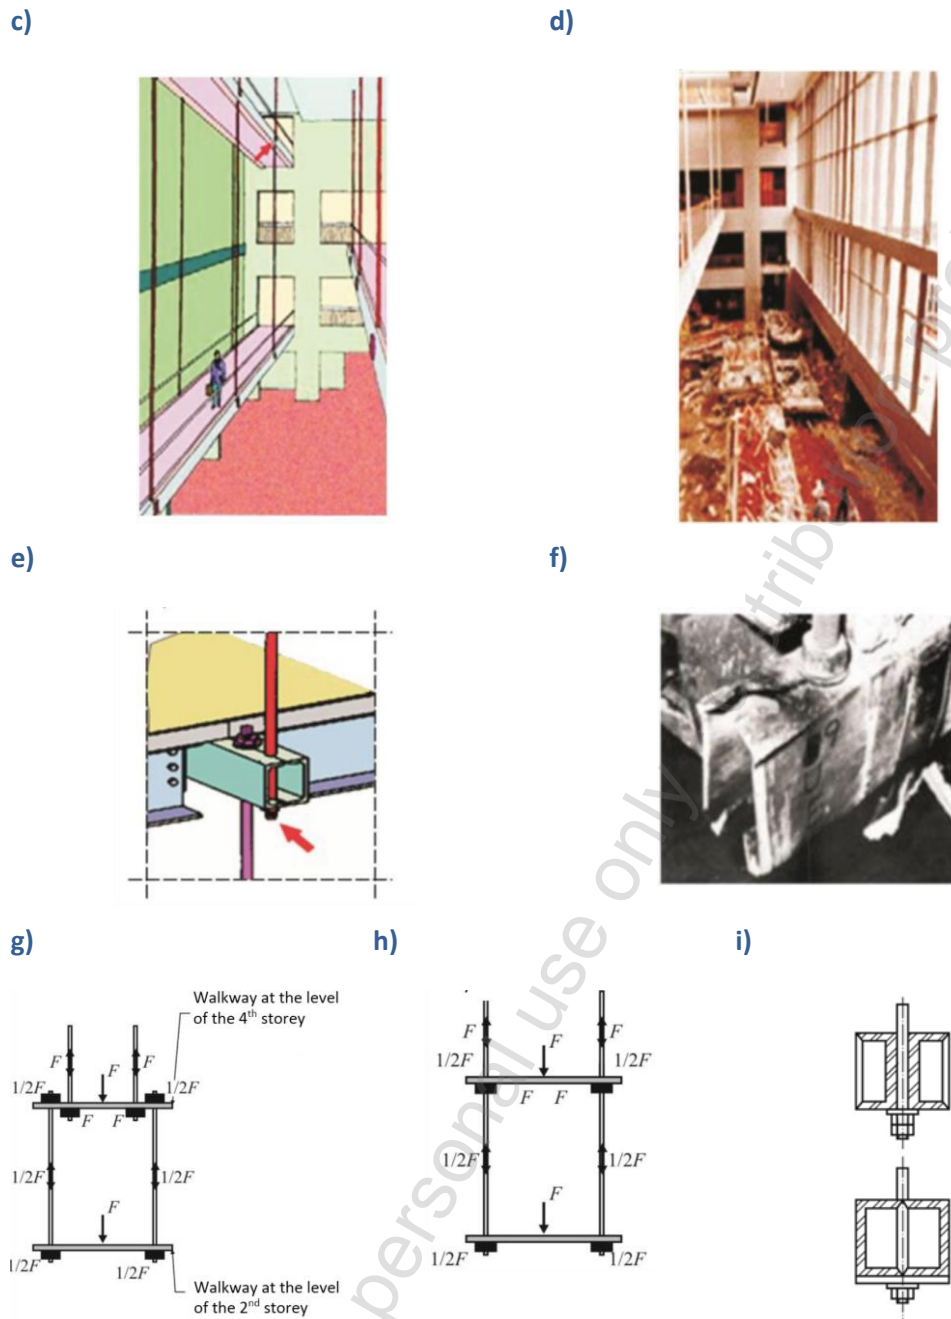
consisted in doubling the load of the steel bar connection, which resulted from an ill-advised change/modification of the suspension of the walkway, i.e. replacing one bar with two, introduced by the contractor in an important design detail without any written approval from the structural designer. The second example also concerns a steel structure, composed of relatively slender elements susceptible to the loss of stability, which actually occurred, because of the lack of bracing elements combined with the simultaneous premature installation of a video camera and the application of other service loads. This mistake resulted from the lack of indispensable coordination and inspection to ensure the safety of the structure [1]. The collapse of the building in Shanghai and the damage to the tank in Głogów also occurred because of simple errors, attributable to contractors' ignorance rather than to design shortcomings [4], [11].

**Fig. 1.** c) view of the atrium before the walkways collapsed, indicating the nut on the upper walkway (the fourth storey), which was broken, d) view of the atrium after the walkways at the second and fourth storeys collapsed, e) view of the attachment of the bars in the box-section rib, consisting of two joined channel bars, in the as-built version, indicating the nut to which the double force was applied, as compared to the value assumed in the design, f) view of the damaged rib after the bar was pulled out, g) suspension detail in the as-built version [13], h) connection detail in the design version [13], i) improvements proposed for the connection of wire ropes and box-sections to increase their load-bearing capacity [3]

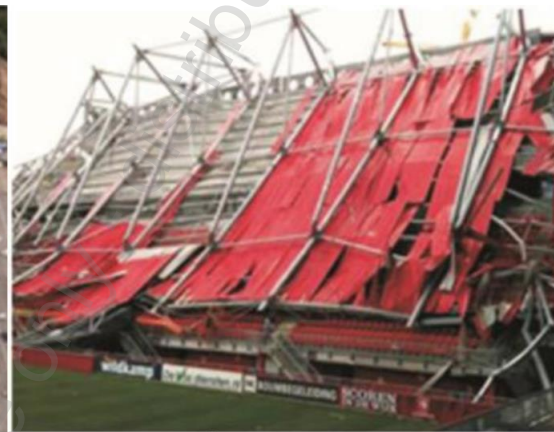
Report [9] (see: [12]) prepared by the Dutch Safety Board concludes that the collapse of the roof occurred as a result of the lack of horizontal bracings at the back of the structure.

The investigation revealed that the main contractor did not check the sequence and method to be followed while carrying out the roof.

**Fig. 2.** Collapse of a part of the roof over the stadium of FC Twente: a) general view of the stadium, b) view of the roof of the stadium of FC Twente after its collapse (photo: AFP), c) short section of the roof with a suspended structure over the grandstand at the stadium.

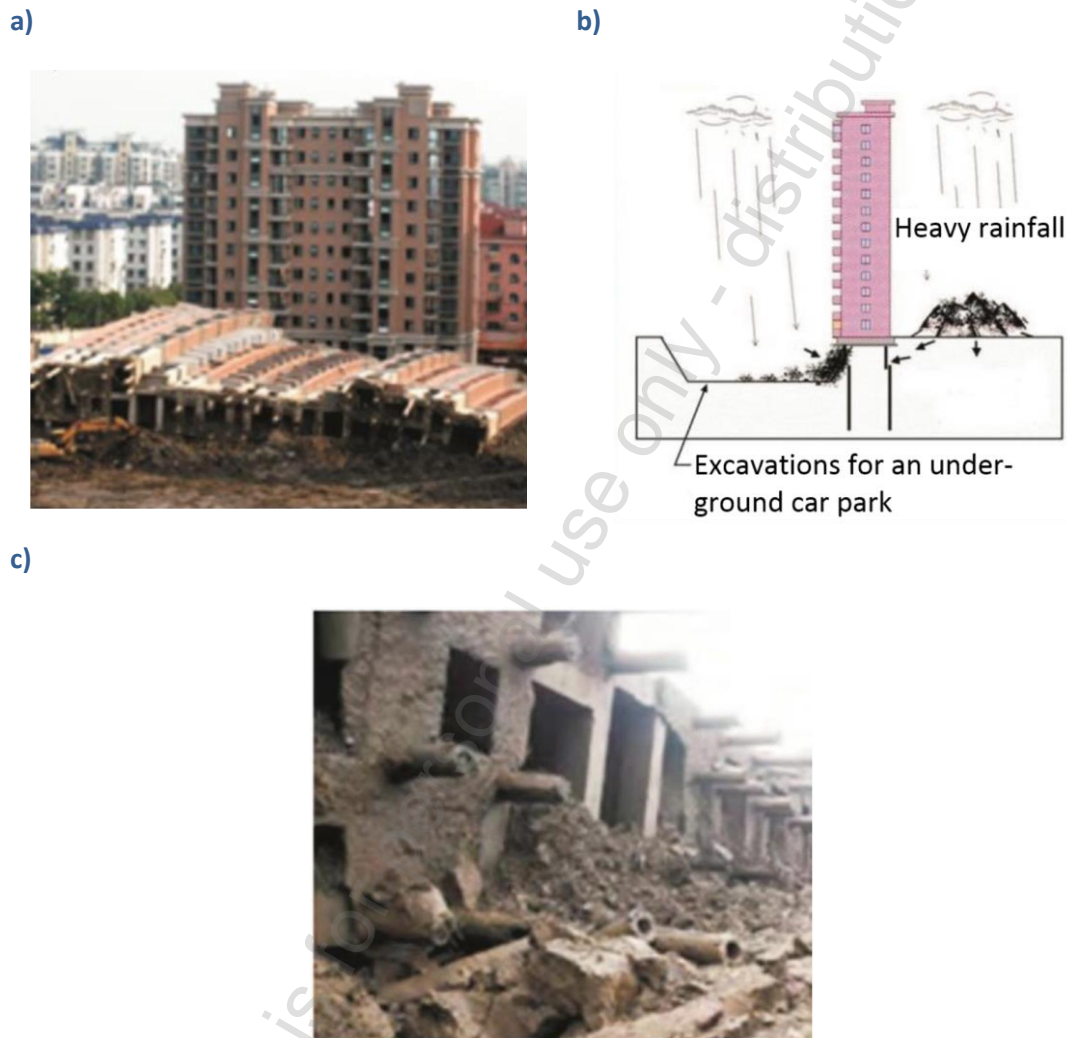
In 2009, a 12-storey building, yet uninhabited, in Shanghai, China (Fig. 3a), collapsed as a result of employing inappropriate workmanship methods. These included: a) carrying out excavations to the depth of 4.6 m on the south side of the building, b) storing the excavated soil on the opposite, north, side of the building, to the height of 10 m. As a result of the above, the building resting on the piled foundation was subjected to unequal pressure coming from the south and from the north. The value of unbalanced horizontal pressure totalled about 3,000 ton. The exerted pressure exceeded the value that could be safely transferred by the piles without breaking them. Thus, the building fell over to the south. It was observed that a heavy rainfall, continuing for several days, contributed negatively to the accident. The described situation is presented in Figure 3b.

**Fig. 3.** Collapse of a 12-storey building in Shanghai, China [11], [14]: a) view after the building collapsed [10], b) probable mechanism responsible for the collapse: 1) heavy rainfall, 2) different values of horizontal pressure exerted by the ground, 3) the building shifted and a shear failure of the reinforced concrete piles occurred, c) view of a section of the piles at the bottom of the building

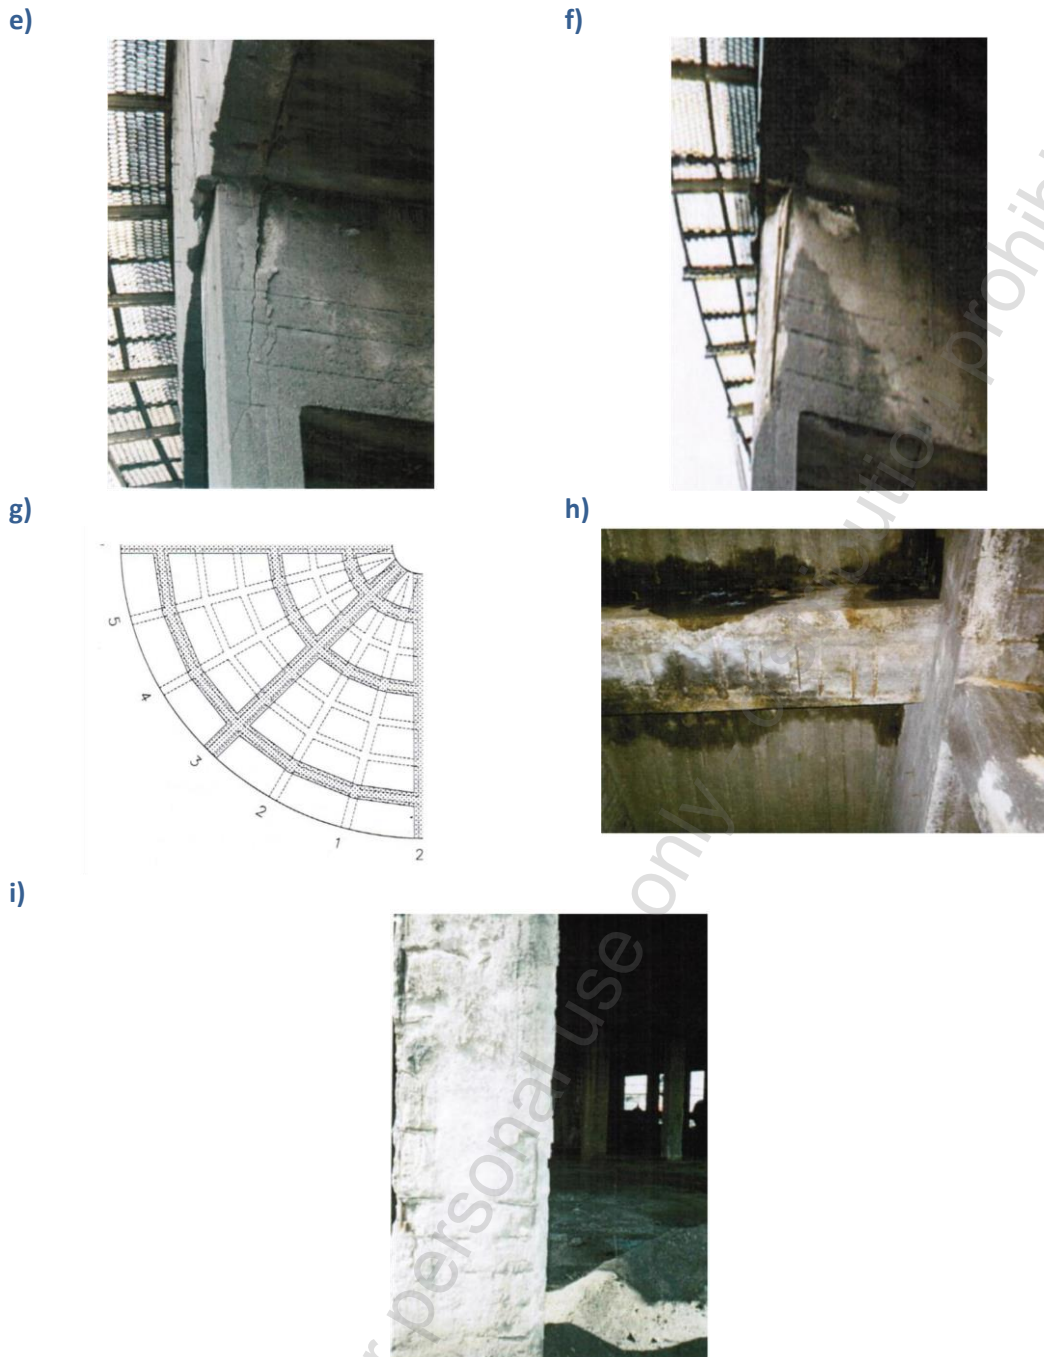
After 23 years of operation in the elevated clarifier made of reinforced concrete (circular plan see: Figure 4a, b, c), intended for process liquids (Figure 4d), cracks were detected in its supporting structure (Figure 4e, f) as well as seepages and damp patches (bloom) visible from outside (Figure h) [4]. The supporting structure of the clarifier is formed by 24 radially arranged frames, composed of four-span horizontal beams, having the dimensions of 600 × 1,000 mm, supported by the central pillar, with a diameter of 2.20 m, and three columns, having the dimensions of 250 × 600 mm. In the direction of the circumference beams are placed, with a cross-section of 500 × 500 mm and spaced every 2.55 m. The arrangement of horizontal beams and beams forms a grate on which the bottom slab of the clarifier, 200 mm thick, rests. In the direction of the circumference, there are three expansion joints in the bottom slab, owing to which its three concentric parts can be distinguished, namely: a) circular central slab, with a diameter of 10.00 m, monolithically connected to the central pillar, limited by the circumferential beam from the outside, b) external ring slab, with the slab strip 2.55 m wide, monolithically connected with the vertical wall of the clarifier, 2.53 m high and 700 mm thick, and c) two strips with the width equal to the spacing of the columns, i.e. 5.10 m, separated with expansion joints. Both these strips are also radially separated by expansion joints in the axis, spaced every third horizontal beam. Expansion joints are filled with a 19 mm thick strip of soft fibreboard. At the top, the pointing of expansion joints was made with monolith. To make it possible for the bottom slab to move (except for the circular central part) in relation to the supporting frame structure, a separator made of building paper was placed between them, but it did not serve its purpose.

The damage presented in the photos was caused by both defects in workmanship (incorrect reinforcement of frame corners) and design errors (insufficient coating of reinforcement bars in the structural members of the clarifier). The first mistake is explained in Figure 4j, presenting the completed reinforcement of the frame corner together with reinforcement bars. The incorrect placement of reinforcement in the column at the height of the horizontal beam (out of plumb instead of being parallel to the outer side of the column) and the lack of reinforcement in the upper fibres of the corner, combined with the simultaneous action of tensile forces transferred through friction caused by the movement of the liquid heated by  $\Delta T$  60°C (temperature of the sludge) along the upper surface of the horizontal beam, with the simultaneous shrinkage occurring in the horizontal beams  $\Delta T = -20^\circ\text{C}$ , caused the cracking of the corners (Figure 4e).

The insufficient coating of reinforcement of the structural members, combined with the concurrent action of aggressive liquids (sulphuric acid with a pH value of 2.0-3.0 and chlorides in the amount of at least 1,000 mg/dm<sup>3</sup>) contributed to the degradation of concrete at the bottom (Figure 4h). Such degradation occurred also on the external surfaces of the columns, due to the presence of harmful gases at the time of precipitation events (Figure 4i).

**Fig. 4.** e) cracked corner of the frame with lumps of concrete falling off, due to thermal deformations of the reinforced concrete structure of the clarifier, f) view of the corner – as in the photo, e) after the removal of lumps of concrete falling off, g) indication of places with seepages and bloom along the leaking expansion joints, h) underside of the bottom slab of the clarifier and the supporting structure with visible seepages and bloom and exposed corroded reinforcement bars, i) photo of the column illustrating its damage, including defects, cracks in the concrete around the bar and corroded reinforcement bars

To ensure the failure-free operation of the Dorr's clarifier it was decided to [4]:

- strengthen the external columns and frame corners by placing reinforced concrete bands (Figure 4j), after preparatory and renovation works have been completed;
- repair the whole outside surface of the clarifier;
- repair the expansion joints and the inside surface of the clarifier, including the application of a chemically-resistant coating.

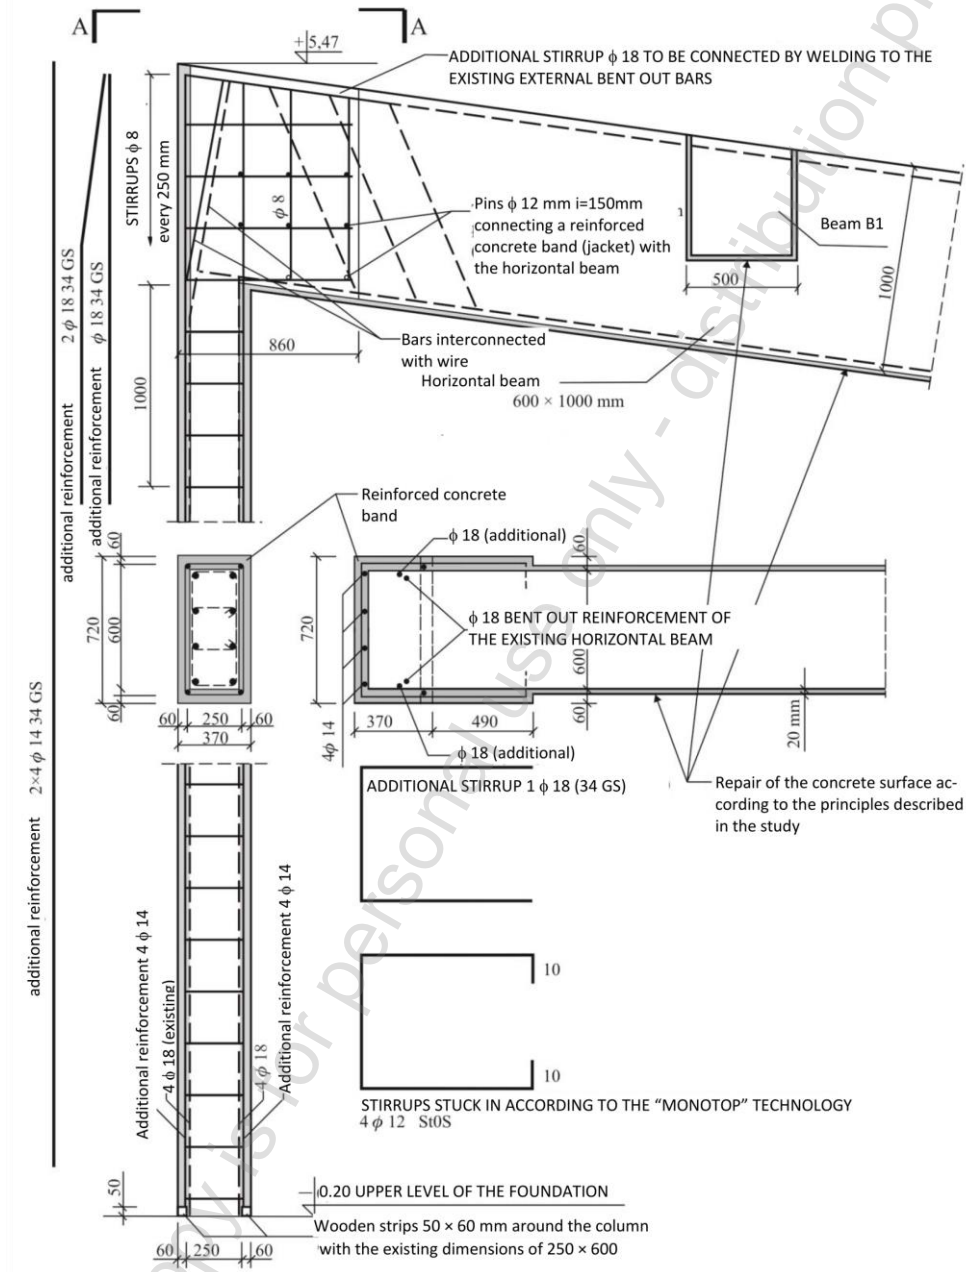
**Fig. 4. j)** strengthening of the frame corner and the column with a reinforced concrete band
