Analysis of design solutions for strengthening the load-bearing structure of a building for further safe use

Purpose: The article presents issues related to strengthening the supporting structure of a swimming pool in a primary school building, paying special attention to the damaged reinforced concrete pillars of supports.

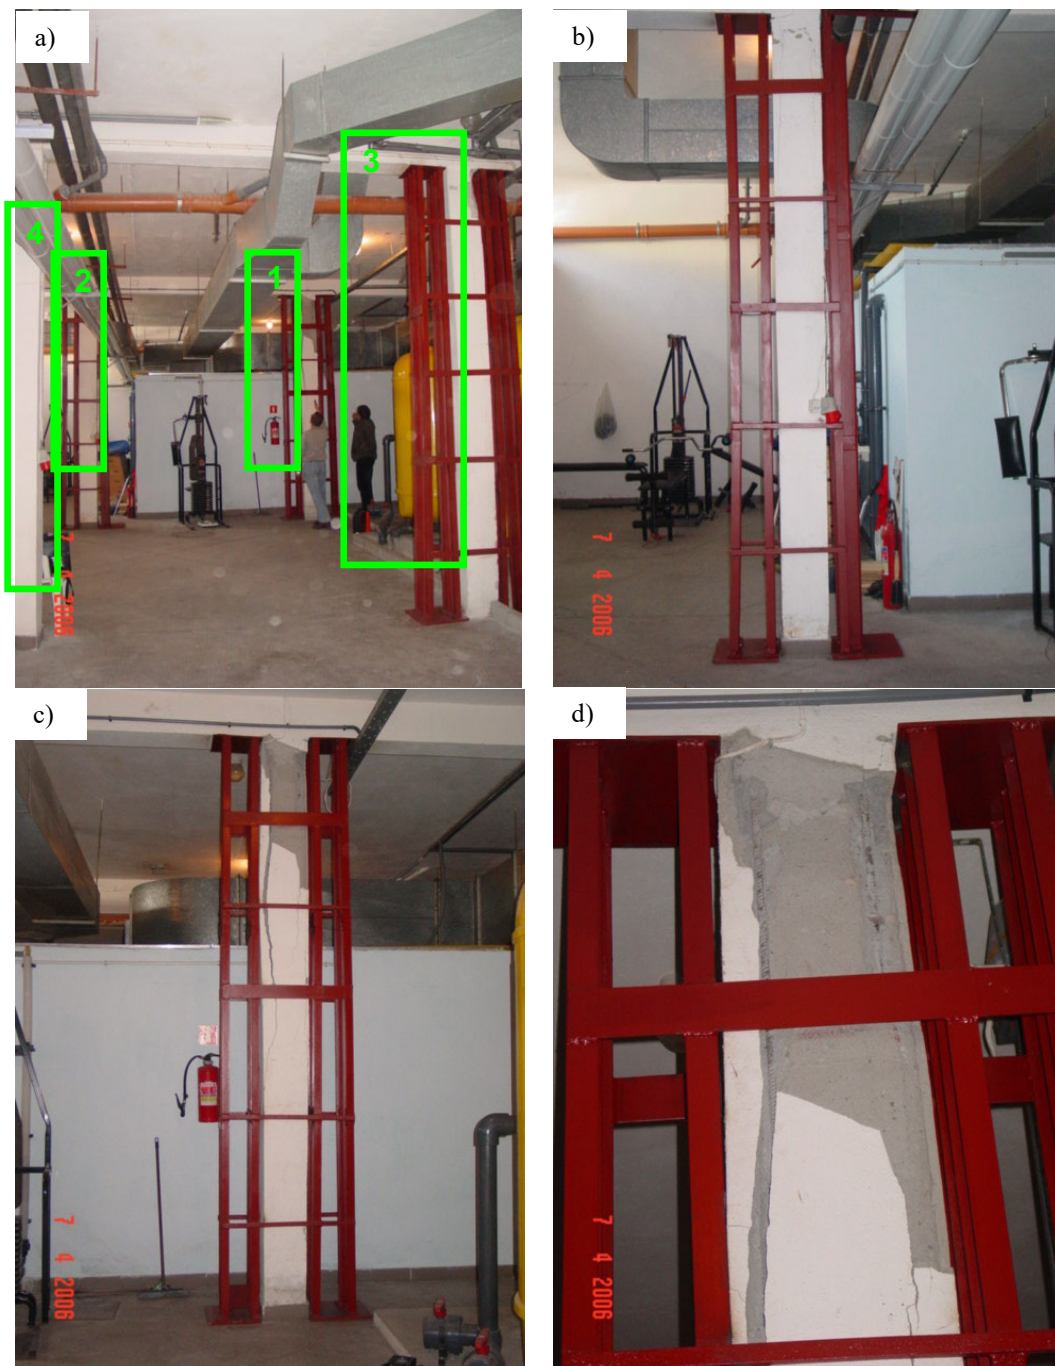
That state of the damaged reinforced supporting beams in the swimming pool basement was described as emergency condition. Engineers carrying an on-site inspection noticed multiple cracks and appearance of bends and notches. There were three pillars that got damaged in the basement rooms – after cracks appeared on the first column (Figure 1a, column no 1) it took a short period of time (about a week) for two more columns to follow (Figure 1a, columns 2 and 3). After the first post lost its load bearing capacity the weight transferred onto two neighbouring pillars that got overloaded as a result. The project contractor immediately undertook construction work that involved assembling a temporary steel supporting structure that prevented construction disaster.

Fig. 1. Overall view of the damaged reinforced concrete pillars in the basement rooms, damaged pillars are marked with 1, 2, 3 numbers

The concrete in the damaged pillars was 10 years old. Reinforcement concrete pillars were operated in dry conditions. Concrete in the pillars was made of gravel of up to 4 mm grain size. Assessment of concrete grade in the

The average concrete strength in the damaged pillars was concluded as corresponding with class B10 (C8/10 according to PN-EN 206-1:2002). This concrete did not meet standard requirements of construction material for use in reinforced concrete constructions.

The new construction of the reinforced concrete pillars was designed as a four-arm equal-angled cross-sections of L 80 x 80 x 10 made of 18G2A steel where $f_{yd} = 295 \text{ MPa}$. The load per pillar is equal to $Q = 450.86 \text{ kN}$, additional safety factor (adopted do to the damage) is equal to $\gamma_{dod} = 1.5$, therefore total calculated load imposed per pillar is $Q(r) = 676.29 \text{ kN}$.

Engineers first checked the resistance of the steel rods and established that the damaged reinforced concrete pillars do not transmit the load imposed on them. The total load will be taken on by the new supporting steel construction and the reinforced concrete elements will remain as non-structural components.

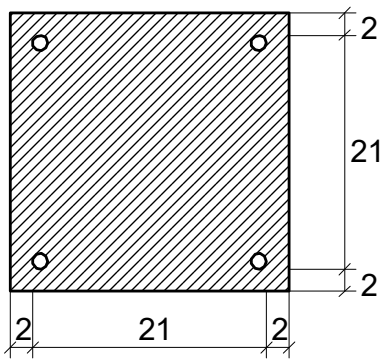
According to Figure 2 the following geometrical data for damaged reinforced concrete pillar were accepted:

Fig. 2. Pillar cross-section

If we take into account the actual design resistance for class C8/10 concrete that was found in the damaged pillars as $f_{cd} = 5.2 \text{ MPa}$, then beam resistance is:

$N_{Rd} = 404.33 \text{ kN}$ – ultimate limit state (ULS) condition is not met.
