# Industrial floor faults caused by volume changes in concrete and subsoil: case study

## Radim Cajka<sup>1</sup>, Jana Vaskova<sup>2</sup>, Martina Smirakova<sup>3</sup>, Kamil Burkovic<sup>4</sup>, Zdenka Neuwirthova<sup>5</sup>

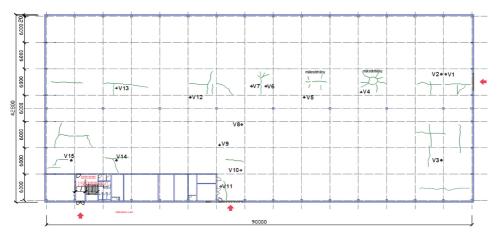
Fig. 1. Scheme of cracks and sampling points of the industrial floor of the production hall in Ostrava-Vítkovice

With regard to the operating conditions (operation in the hall with machine tools could not be interrupted), the actual area was divided into the reference section with the highest incidence of faults (Fig. 2). 15 samples were taken in this reference section. In Fig. 1, the locations of the samples taken (V1 to V15) are marked and numbered.

The results of diagnostics and laboratory analyzes show that failures of both industrial floors were caused by an insufficient amount of reinforcement – DRAMIX fibers. The

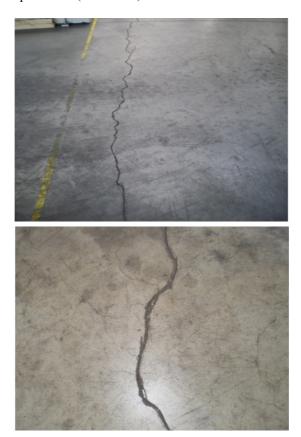
Fig. 2. Cracks of the industrial floor near the entrance to the production hall

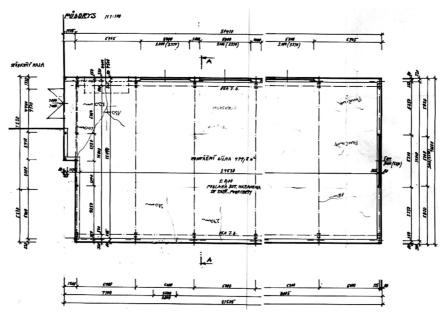
Fig. 3. Scheme of cracks in the floor of the storage hall in Frýdek-Místek

approximately one year, faults in the floorboard were found, consisting of microcracks (cobwebs) and visible cracks, the positions and lengths of which were recorded in the diagram below in the Fig. 3.

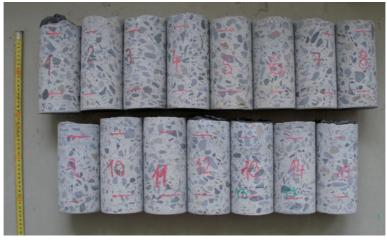
Fig. 5. Laboratory samples from the industrial floor of the production hall in Ostrava-Vítkovice

Drilling of laboratory samples was performed based on the selection of accessible places with the largest number of failures (marked in Fig. 1). A total of 15 drill holes were removed (Fig. 5). Statistical evaluation of the set of results of fiber concrete compressive strength was performed according to the conformity criteria ČSN EN 13 822 (Principles of structural design – Evaluation of existing structures). The average compressive strength

of concrete is 37.15 MPa. The resulting characteristic (cubic) compressive strength of concrete is 30.23 MPa, the concrete corresponds to strength class C 25/30.

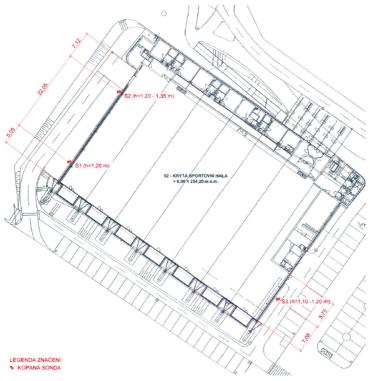
Fig. 9. Scheme and location of test sites

The third case is a production hall in Ostrava–Vítkovice (Fig. 9). In this case the floor is not reinforced by fibres at all. The floor is reinforced by a net. This case is included for diversity why each crack may occur. The construction diaries show problems during the

implementation of slag embankments – interruption of work due to frozen layers of water between the plain and slag, removal of slag and re-filling with slag. There is also a mention of wetting the subsoil from an undrawn pipeline. The subject of this analysis was the determination of the material composition of three samples of backfill material and a prognostic assessment of the susceptibility of samples of backfill material to volume changes based on the mineralogical and petrographic analysis of the delivered samples. Excavated probes that were carried out in the vicinity of the assessed object were marked with the description S1 to S3 (Fig. 10). Examination shows that in three supplied samples, therefore, stable pieces of mass of various origins and potentially unstable grains of slag from various metallurgical technologies are dominantly present. Coarse grains are cemented with a sandy-dusty mass of grains of steel slag, grains of sand from rocks and quartz, grains of tailings and ceramics incl. smelter of ceramics and bricks. Individual samples differ primarily in the relative representation of individual components. This is waste that is extremely unsorted, polycomponent and materially heterogeneous – an extreme case of materials from the so-called "cold roll". Further examination also shows that hydration and carbonation reactions and the volume changes of reactive components caused by them have not yet been completed.

In the third case industrial floor reinforced by net was inspected. From the results of the performed diagnostics and laboratory analyses, it follows that the cause of the malfunctions are not the volume changes in the concrete mixture itself as in the two previous cases. Cracks were caused by volume changes of the subsoil formed for the most part from the so-called "cold dump". As a result of these changes in volume, tensile stresses in the concrete floor exceed the tensile strength of the concrete, causing cracks and weaving of the floor. This problem needs to be approached at a design phase as a suitable backfill material for the subsoil needs to be used, more proper use for a subsoil fill would be a blast furnace slag instead of a steel slag. These are two most common slags used in a civil engineering. Blast furnace slag, which is produced during the production of pig iron in blast furnaces, is mainly used in the construction industry today. Steel slag, which is produced during the production of steel, can also sometimes be used in the construction industry, however, this slag often exhibits undesirable volume changes.
