**Agnieszka LISOWSKA-LIS**

STATE HIGHER VOCATIONAL SCHOOL IN TARNOW  
8 Mickiewicza St., 33-100 Tarnow, Poland

# Thermographic monitoring of the power transformers

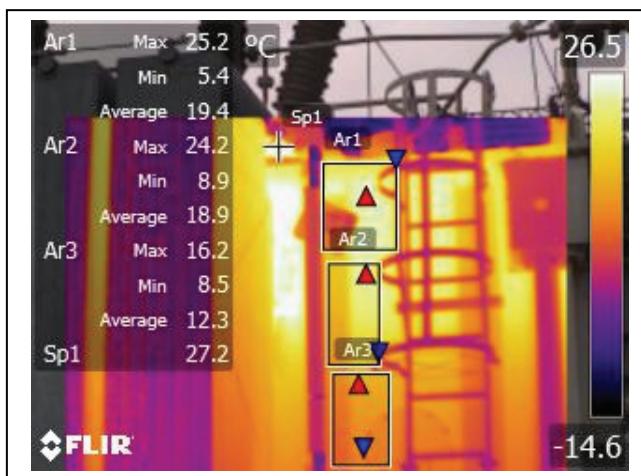
For a well-insulated transformer, the lower areas on the surface of the device were cooler. In Table 3 three groups are indicated with different letters ("transformer with good electrical insulation" – "upper", "middle" "lower" part of the tank surface). The coolest areas (also regarding the hot spots) were recorded on the bottom of the tank. In the case of a transformer with good insulation, the biggest differences in temperature were recorded between the upper and lower tank areas (regarding hot spots), which was not affected by season of year and which renders the cooling very efficient.

Fig. 1. Thermogram of a power transformer with good electrical insulation (about 10 years of exploitation). The lower parts are usually cooler than the upper parts of the machinery

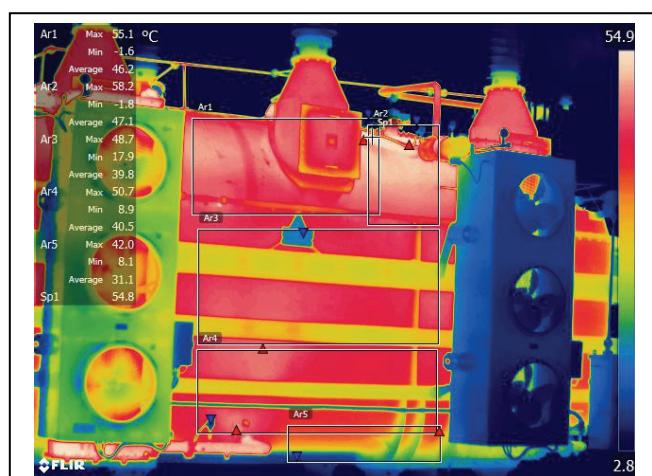
In many thermograms, hot spots of higher temperatures were detected in the lower tank areas rather than in the middle parts. These cases pertained to the thermograms made on summer evenings, which could be due to the fact that for many hours during the day the air temperature and humidity were high, which made it much more difficult to cool down. The cooling efficiency of the device was therefore far from satisfactory.

Fig. 2. Thermogram of the power transformer with deteriorated electrical insulation (about 50 years of exploitation). High temperature areas can be seen in the upper, middle and lower parts of the machinery surface

Cooling with the use of a forced oil circuit in combination with a forced air circulation system, with high air temperatures (heatwaves) and high humidity may prove ineffective and cause overheating of a transformer. As a consequence, the insulation conditions deteriorate even further (oil and paper aging occurs) [10], [16]. Also, in the course of analysis of the thermograms for the poorly insulated transformers, the biggest differences were detected between the hot spots at the middle surface and at the bottom of the enclosure during the summer. Depending on external conditions, the transformer surface was subjected to cooling, with cooler parts of the oil flowing down to the bottom of the device. In the case of bad weather conditions (high temperatures during the day, intensive sunshine on the surface, high humidity, no wind), the oil, despite the forced circuit and airflow to the tank, would almost completely not cool down, and, as a result, overheated areas were detected both in the upper, middle and lower parts of the tank.
