MICROSTRUCTURE AND MECHANICAL PROPERTIES OF CRMOV STEEL AFTER LONG-TERM SERVICE

The paper presents the results of research on the microstructure and mechanical properties of 12HMF steel after long-term service. The investigated material was taken from a pipeline with circumferential welded joint after 419 988 hours of service at the temperature of 490°C, steam pressure 8 MPa. Performed research has shown that the 12HMF steel after service was characterized by a typical microstructure for this grade of steel, that is a ferritic-bainitic microstructure without any visible advanced processes of its degradation. The investigation of mechanical properties has shown that the examined steel after service was characterized by a very low impact energy KV, and yield strength lower than the required minimum. Whilst tensile strength and yield strength determined at elevated temperature was higher and similar to the standard requirements, respectively. It has been proved that the main cause of an increase in brittleness and a decrease in yield strength of the examined steel should be seen in the segregation of phosphorus to grain boundaries and the formation of precipitate free zones near the

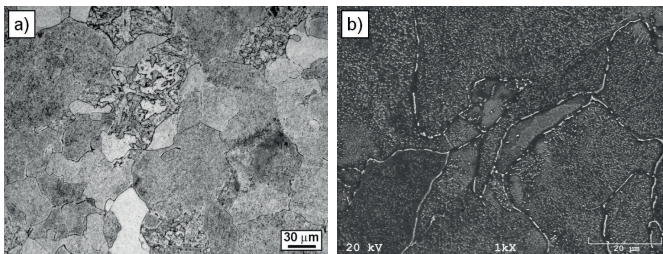
The microstructure of the investigated steel was ferritic–bainitic with the dominant quasipolygonal ferrite amount (Fig. 1). The estimated volume fraction of particular microstructure components was the following: quasipolygonal ferrite – ca. 60%, polygonal ferrite – ca. 30%, bainite – ca. 10%. Quasipolygonal ferrite is ferrite with a large amount of fine dispersive carbides precipitated inside the grains. In the microstructure image with the optical microscopy zoom, this type of ferrite can be seen as grains of grey colour. Quasipolygonal ferrite, at the moment of being formed, has the chemical composition similar to the chemical composition of austenite, out of which it is formed. As a result of carbon supersaturation, during cooling after the austenitization process, and mostly after the following tempering, numerous fine dispersive carbides are precipitated. The colour of polygonal ferrite in the image obtained with optical microscopy is bright. At the forming stage, the chemical composition of ferrite is similar to the equilibrium one, therefore, it does not contain carbides, or it contains some single precipitations [2]. The size of ferrite grain, determined using illustrated models [6], amounted to 5, which corresponds to the mean diameter of grain: 62.5 μm .

Fig. 1. Microstructure of 12HMF steel after long-term service: a) OM; b) SEM

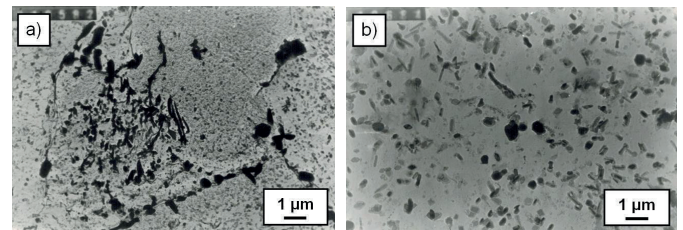
impedes grain gliding against each other, and at the same time contributes to an increase in the microstructure strength, however, at the expense of lowering its ductility. In CrMoV steels in the as-received condition (after the heat treatment), a number of carbides of different thermodynamic stability can be observed (M_3C , M_2C , M_7C_3 , $M_{23}C_6$, MC). Their type and amount depends on the chemical composition (amount of carbon and carbide-forming elements) and the heat treatment parameters [7-10]. Stability of carbides in the serviced low-alloy CrMoV steels is very high. Researchers have noticed the occurrence of all types of carbides in the serviced steels, even after more than 150 000 hours of work at elevated temperature above 500°C [11-13]. Nevertheless, during the service, not only the enrichment of precipitated carbides with chromium and molybdenum, but also the changes in the morphology and quantitative fraction could be observed. Moreover, during the service of CrMoV steel, precipitation of M_6C carbides and compound complexes of precipitates, referred to as „H – carbides”, were seen [12, 13]. Performed identifications have shown the occurrence of the following precipitates in the examined steel after service: M_3C , M_2C , M_7C_3 and MC. Precipitates of M_2C and MC type were revealed inside quasipolygonal ferrite grains, whilst the M_7C_3 carbides were observed mostly on the boundaries of grains and in bainite. In bainite, also the M_3C carbides were noticed. Example of the morphology of carbides in the investigated steel is shown in Fig. 2.

Fig. 2. Morphology of carbides in the examined steel: a) in the bainite area and on the grain boundaries, b) inside ferrite grains, carbon extraction replica, TEM

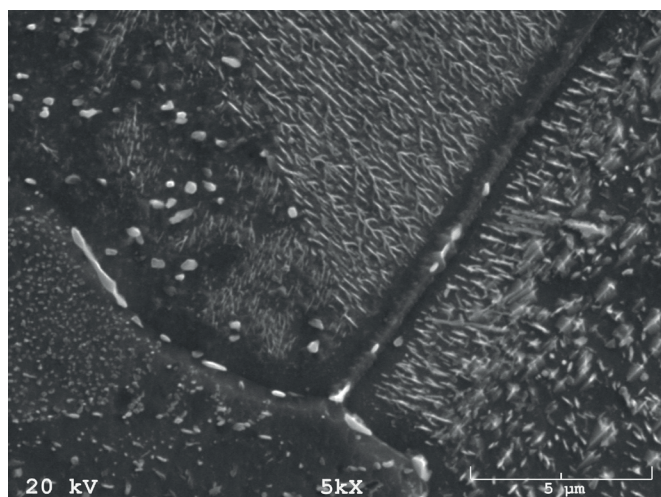
Fig. 3. Precipitate free zone near the boundaries of ferrite grains

According to researchers [2, 15, 16], the formation of these zones is connected with the processes of precipitation and growth of carbides on the boundaries of grains, and the width of this zone is dependent on both: the service parameters and chemical composition of the steel [2, 16]. The depletion of precipitates in these areas near the grain boundaries decreases the strength of these areas and constitutes a deciding factor responsible for the slowly progressing decline of strength properties throughout the service time.

The strength properties determined at room temperature were similar to the minimum required ones (Table III). The observed decrease in the value of yield strength in the examined steel should be associated with the presence of carbide free zones in the microstructure.

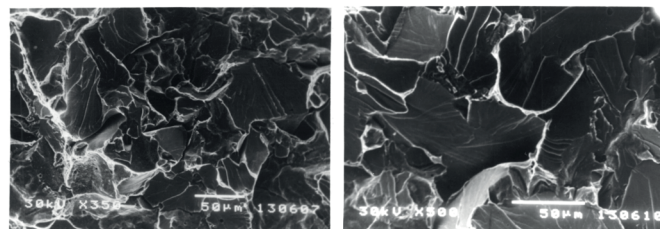
The studies of mechanical properties have shown that the CrMoV steel after service was characterized by very low impact energy KV, which was over five times as low, compared to the required minimum of 27 J (Table II). Performed fractographic tests have proved that the examined steel was cracking with the brittle transcrystalline cleavable mechanism (Fig. 4). Moreover, on the fracture, numerous secondary cracks were observed. They ran on the boundaries of grains. The presence of intergranular secondary cracks proves the brittleness and softening of the boundaries.

Low impact energy is connected with the brittle fracture transition temperature, shifted to positive temperatures, which amounted to + 65°C for the criterion of 27 J. Shifting the temperature of brittleness threshold for the examined steel to positive temperatures indicates the deformation ability of

the steel at room temperature. The decrease in the impact energy and growth of the brittle fracture transition temperature in long-term serviced low-alloy CrMoV steels should be associated with an increase in the number and size of the carbides precipitated on the boundaries of ferrite grains.

Fig. 4. Fractography of the fracture in the examined steel
