DAMAGE ANALYSIS OF THE BLADE TO THE ROTOR HUB CONNECTION IN THE WIND TURBINE

The paper analyzes possible causes of bolts fracture in the connection of the blade to the hub of the wind turbine rotor. This failure has been growth shortly after the wind turbine was started, a few days after the storm. During the storm, electric power was turned off in the whole surrounding area for many hours, therefore it was impossible to control the device. After an initial analysis of failure modes in other wind turbines, it was found, that the bolts failure in the analysed case may be regarded as quite rare. Due to the fact that a significant part of bolts was broken brittle (flat fracture surfaces and lack of permanent elongation), it was decided to analyse the structure of the material in the direction of stress corrosion and hydrogen embrittlement. Among others, microscope analysis of fracture surfaces after their proper cleaning from corrosion products was carried out. The broken bolts were made as undersized, what is mainly used in fasteners intended for hot-dip galvanizing. On the basis of the purchase documentation analysis, it was presumed that the bolts were not galvanized by their manu

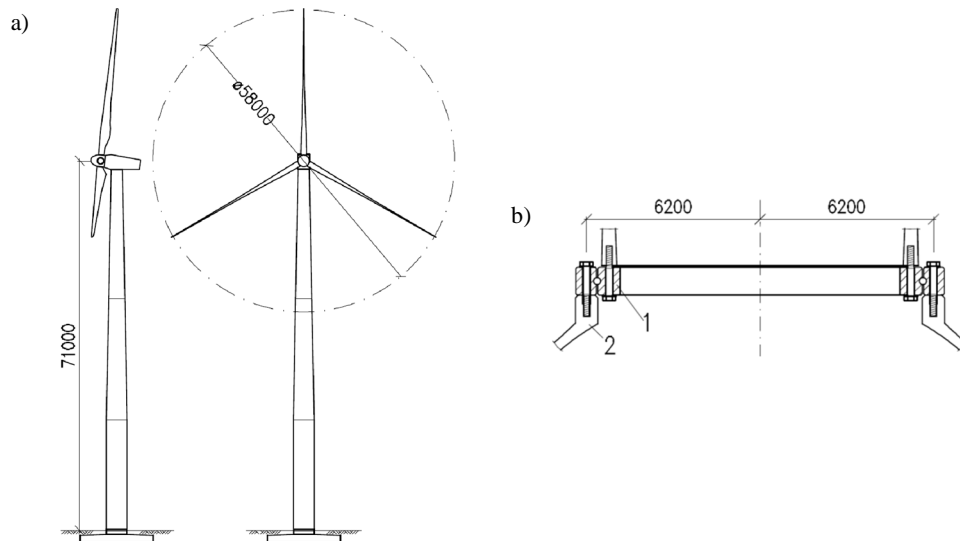
Fig. 1. Wind turbine: a) general view, b) joint between blade and hub, 1–bearing, 2–hub

In the connection of the blade to the hub four-point contact bearings, bolted on one side to the hub and on the other side of the blade, were used (Fig. 1b). The hub was made of nodular cast iron in a spherical form and fixed to the main shaft bearing. In the hub, threaded holes were made and in the blade, threading inserts were placed. To connect the bearing to the hub, 52 bolts M24 class 10.9 with the mark W of the manufacturer and with the additional marking U (10.9U) i.e. with undersized thread were used (Fig. 2). Such a thread is sometimes executed to maintain the required minimum clearance for the threaded connection after applying a thick layer of zinc coating in the hot dip galvanizing process.

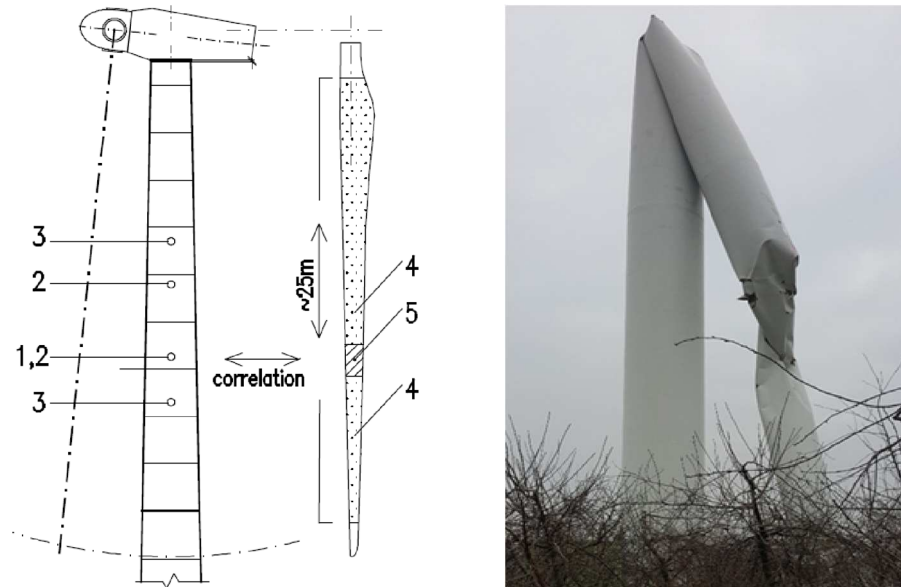
The disaster was preceded by a period of a few days strong winds, during which the wind turbine was at least twice immobilized: for the first time automatically due to exceeding the permissible wind speed and for the second time due to lack of power supply. A few minutes after it was restarted, disaster has occurred. One of the blades crashed into the tower causing its brake-down (Fig. 3), what was observed by the windmill owner. This blade was detached from the rotor and discarded (thrown) far away from the windmill. During the in-situ inspection, it was found, that this blade's shells have been stripped off (Fig. 4a) and its supporting beam (spar) has been partly broken at the point of impact on the tower. A view on a bearing devoid of broken bolts has been shown in Fig 4b.

Fig. 3. Wind turbine damage: 1–point of the blade impact, 2–ends of twisted section, 3–ends of braking, 4–area of a blade without shells, 5–broken section of a blade

The shaft of the tower in the level of the blade's impact has been twisted, which may indicate a hit as a factor initiating its collapse. On the basis of calculations, the tower collapse due to its insufficient load capacity was excluded. The tower was calculated assuming that the level of its quality declared in the documentation was preserved. It was decided to carry out a wide-spread analysis of the whole structure as well as possible problems in the connection.

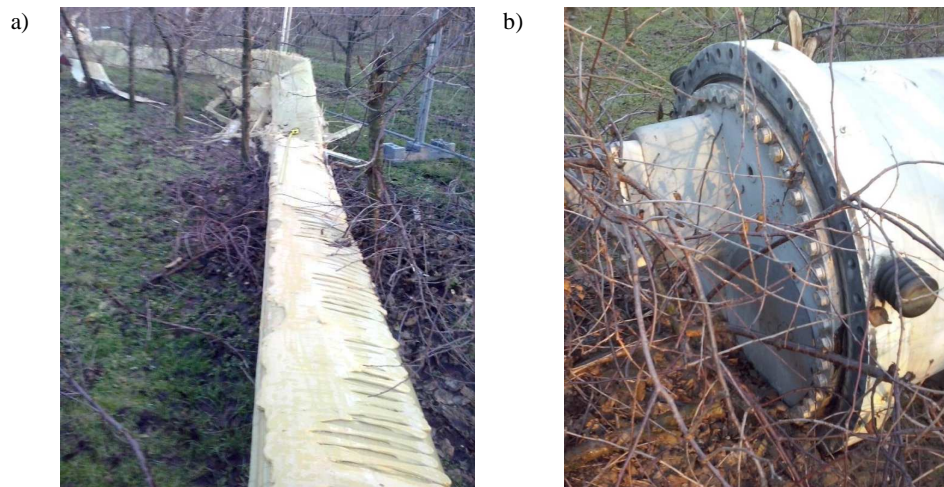
Fig. 4. Detached blade: a) supporting beam without shells, b) bearing without bolts

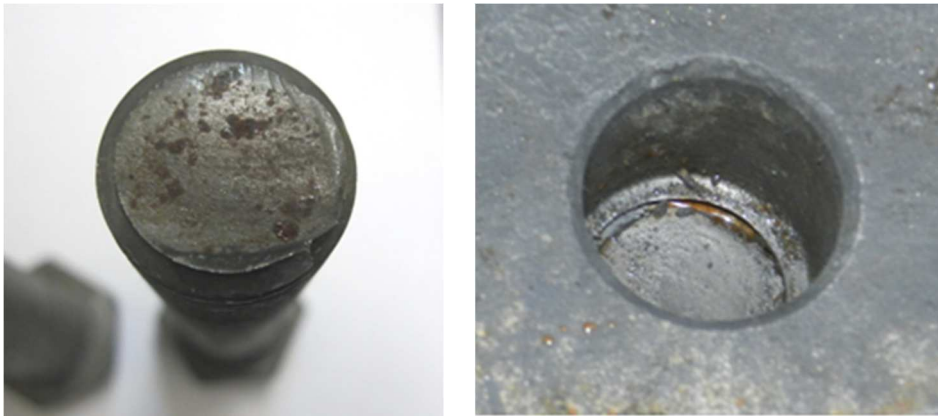
The immediate cause of the failure of the blade-to-rotor connection was a fracture of bolts, what is rare in wind turbine failures. During the inspection it was found, that some of the bolts at about 1/3 of the circumference of the joint were destroyed with very small elongation or brittle (Fig. 5).

Fig. 5. The brittle fracture surface of bolt and a hole with end of bolt

The remaining bolts on about 2/3 of the circumference of the joint were destroyed plastically, some of them with very visible elongation and necking, which were estimated at up to 20%. The fracture surfaces of a part of bolts indicated a brittle fracture.

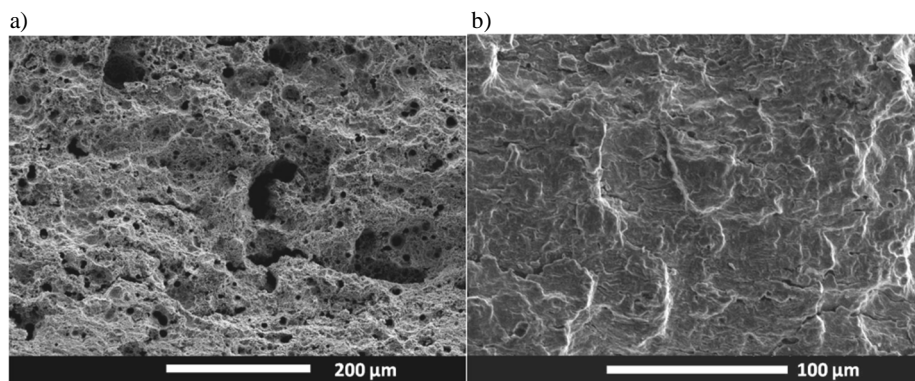
The fracture surfaces of three selected bolts were examined. Tests confirmed macroscopic observations regarding the manner of their destruction. The fracture in bolt '1' was characterized with a ductile morphology with characteristic cavities (dimples) typical of this type of fracture (Fig 6a).

Fig. 6. Fracture surfaces of bolts: a) ductile of bolt 1, b) brittle of bolt 3

Such a fracture testifies destruction of the material after exceeding the yield point. The fracture of bolt 3 was mainly brittle (Fig. 6b) and the fracture of bolt 2 was mixed (both brittle and ductile).

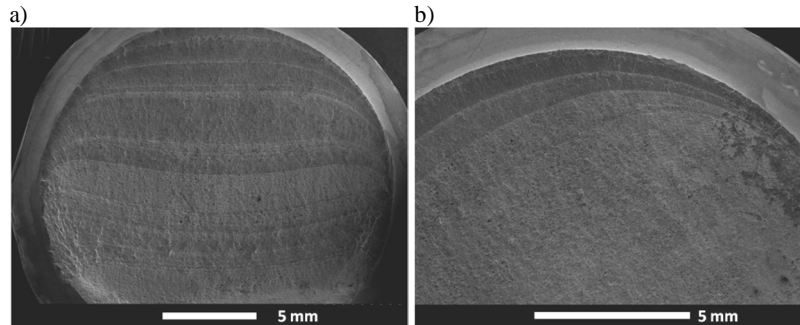
Almost over the whole surface of the fracture of bolt 3, characteristic lines resembling fatigue beach marks are visible (Fig 7a). The areas between these lines are brittle. The appearance of the fracture suggests that the material was destroyed gradually, e.g. during alternating bending of the bolt. On the fragment of the fracture of the bolt 2, near its surface, characteristic lines indicating the fatigue cracking are also visible (Fig. 7b). Such a character of the fracture, at the surface, can occur not only as a result of alternating bending of the bolt but also in the case of hydrogen-induced cracking.

Fig. 7. Fracture surfaces of bolts: a) bolt 3, b) bolt 2

Theoretically, there should be no significant stress amplitudes in a preloaded bolt, what is reflected in the recommendation given in standard [2] allowing to adopt a reduced range of stress fluctuating for such a bolt. The brittle fracture of the bolt material characterized with symmetrical fatigue beach marks (beach lines) relative to the axis passing through the centre of the cross-section (see Fig. 7a) may indicate an alternate bending of the bolt after a separation was created in the connection of the blade with the rotor. Therefore, the hypothesis may be put forward, that the bolts in the tensioned zone had broken up first. Then, in partly damaged joint an alternate bending of bolts in compression zone and as a result their fatigue failure occurred.
