Historical wooden-pillared Kenan Dede Yanık Mosque – restoration proposal

Historical wooden-pillared Kenan Dede Yanık mosque – restoration proposal

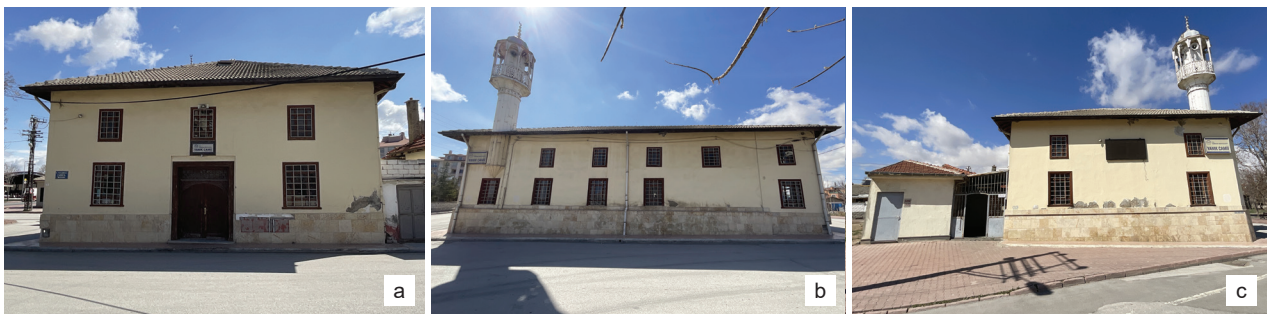
Fig. 3. The views of the outer walls of the Kenan Dede Yanik Mosque: a) northern, b) eastern, c) southern (photo by F. Bademci)

The rain pipes and gutter system on the façade of the building, which were added later, are damaged by rup-

ture, cracking, breaking, bending, etc. The contact of the water flowing from here with the structure damages the building. At the same time, damages in the rain pipes and gutter system cause visual pollution on the façade. For this reason, the rain pipes and gutter system on the façade of the building should be replaced. The nameplates and signboards on the façades of the building cause visual offensive on the façade. Signboards made of different materials on different parts of the façades should be removed. Wooden signs should be used instead of these signs. Moreover, pipes and air conditioning systems used for different purposes are seen on the façades of the building. It would be appropriate to remove these elements in order to prevent visual pollution on the façade. The removal of the loudspeakers on the façades of the building will also contribute to the prevention of visual ugliness.

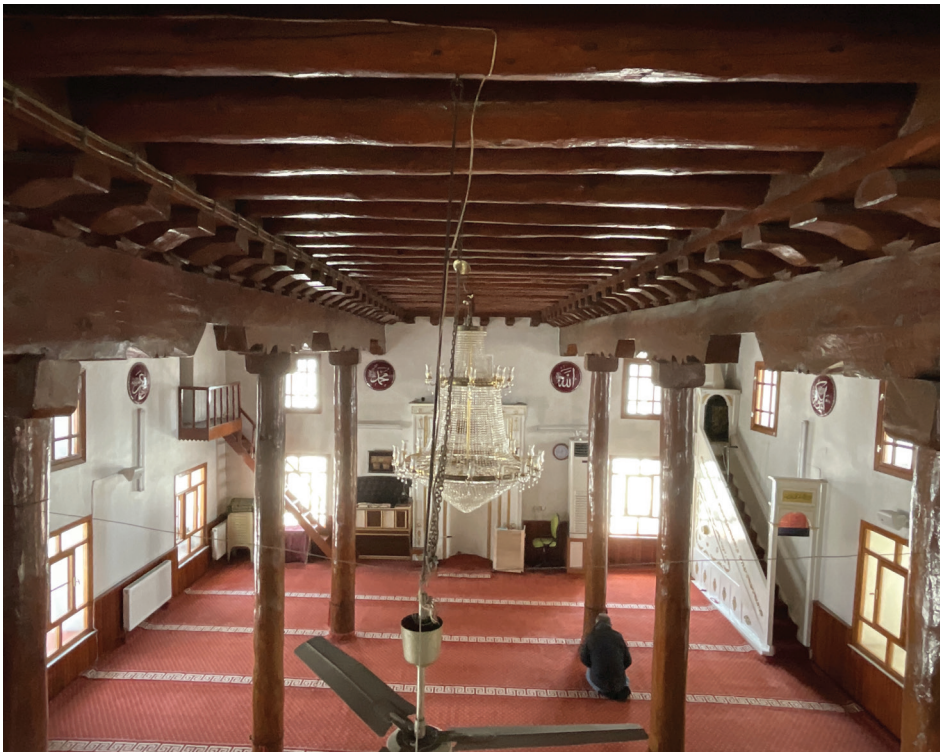
In addition to the load-bearing wall, there are load-bearing wooden pillars in the haram section of the building. There are profiled wooden pillows perpendicular to the mihrab on wooden pillars, wooden bondbeams perpendicular to the mihrab on the pillows, circular wooden beams parallel to the mihrab on the bondbeams, and wooden covering boards perpendicular to the mihrab on the beams (Fig. 4).

Fig. 4. The ceiling and column details of the wooden pillars of the Kenan Dede Yanık Mosque (photo by F. Bademci)

The first thing that should be protected in a structure built with wooden pillars is the load-bearing system. Any deterioration in the structural system of the building may cause irreversible damage. For this reason, wooden pillars, bondbeams, pillows, and beams in the load-bearing system of the building should be checked. Deterioration should be detected. If the load-bearing properties of the deteriorated parts have weakened and disappeared, these parts should be replaced by reproducing them from the same wood material.

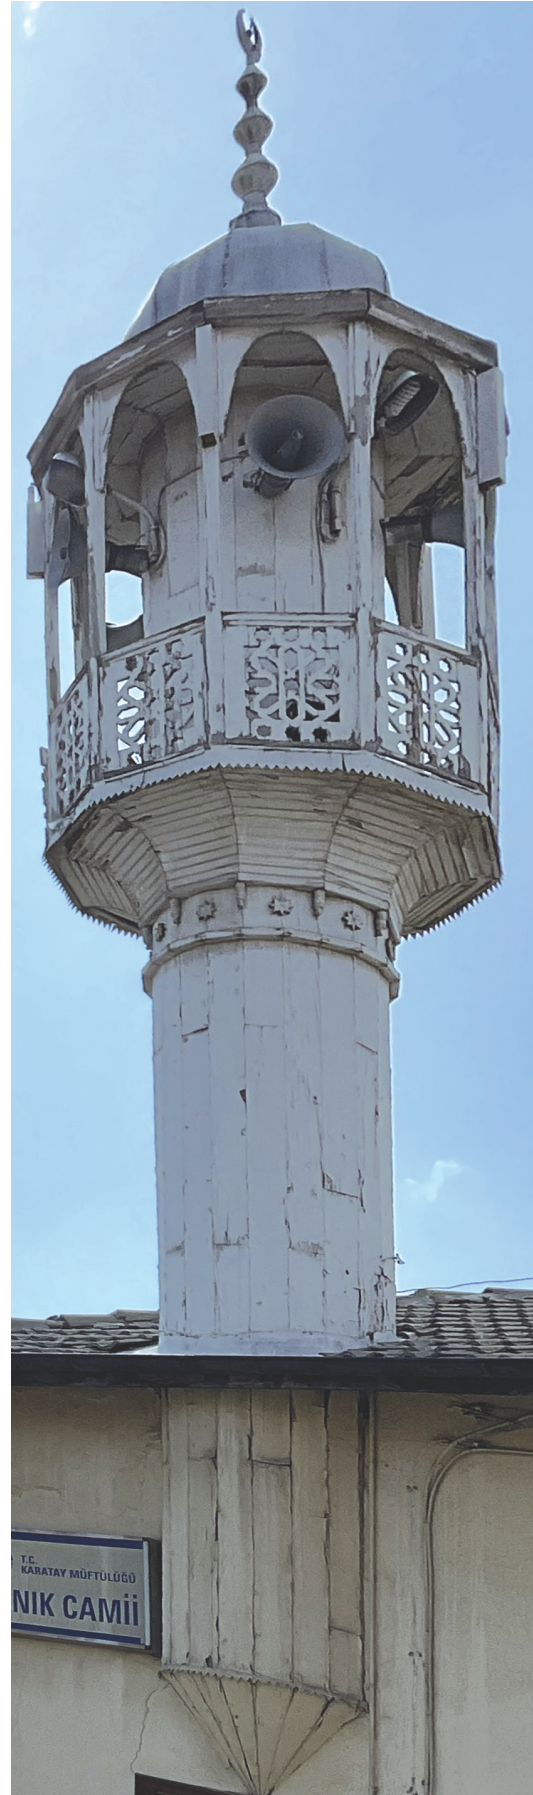
Fig. 5. The view of the minaret of the Kenan Dede Yanik Mosque (photo by F. Bademci)
 Il. 5. Minaret meczetu Kenan Dede Yanik (fot. F. Bademci)

The wooden minaret of the mosque has historical importance. It is seen that the paint on the minaret has fallen off in some places. The paint on the minaret should be scraped, and the wood should be checked for deterioration. If the worsening of the corrupted timbers can be stopped, a decision should be made in this direction, and the impairment should be stopped and the wood should continue to be protected in place. The timbers may need to be replaced according to the degree of deterioration. In the minaret, especially in the railing sections of the bal-

cony, the ornaments show partial breaks. These broken parts should be identified, and the missing parts should be produced from the same wood material to ensure integrity. There are sound and lighting systems that cause visual disturbance in the balcony section of the minaret. These sound and lighting systems should be redesigned and replaced to eliminate visual pollution. There are rust fragments on the cone and the crescent of the minaret. These rusty parts should be eliminated.

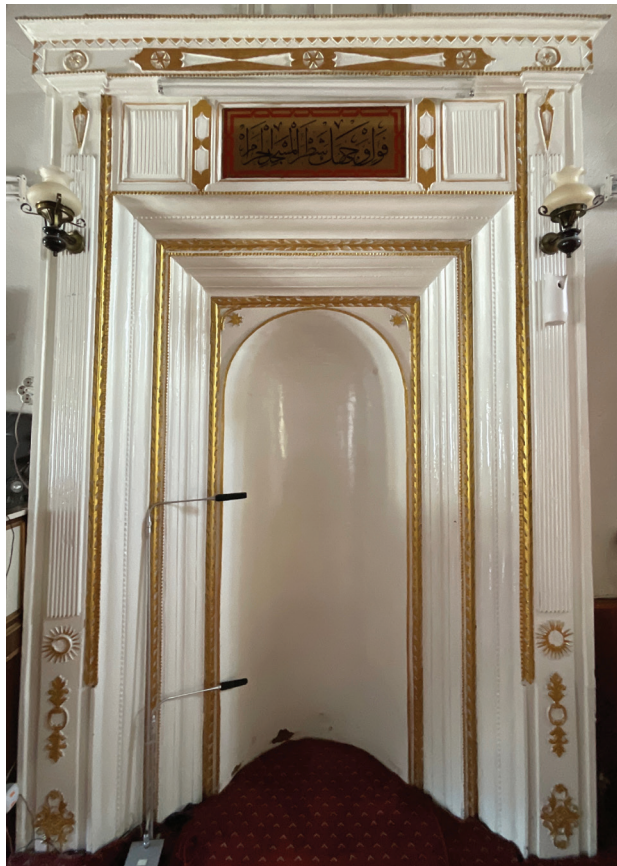
Fig. 7. The view of the mihrab of the Kenan Dede Yanık Mosque
(photo by F. Bademci)

The paint on the mihrab in the building should be scraped, and deterioration should be detected and repaired. Afterwards, the mihrab should continue to be protected by varnishing. However, the missing parts on the mihrab should be identified, and the parts should be produced from the same wood material and inserted in their places. At the same time, the lighting elements on the mihrab should be removed. On the other hand, there is a window on the mihrab that is estimated to have been closed later. This window should be opened. The paint on the pulpit should be scraped, and deterioration should be detected and repaired. Afterwards, the pulpit should continue to be protected by varnishing. At the same time, the timbers thought to be made later in the pavilion and passage sections of the pulpit and the curtain made for the entrance section should be removed. However, the lighting element in the pavilion section should be removed. It is seen that the paints, which are thought to have been applied later, on the doors opening to the last congregation place and the haram, have fallen off. This paint layer should be completely scraped, and the door should continue to be protected by varnishing.

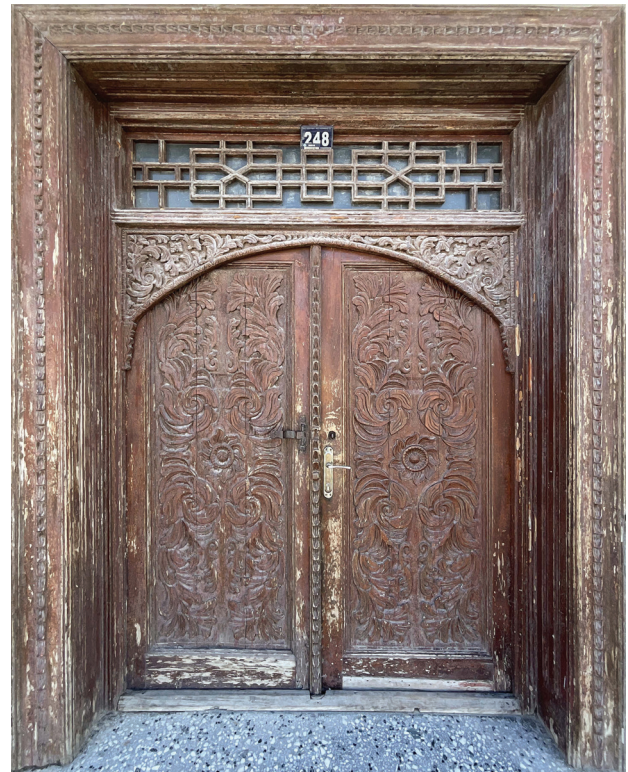
Fig. 8. The view of the door of the Kenan Dede Yanik Mosque (photo by F. Bademci)
