The Impact of Material Selection on Durability of Exhaust Valve Faces of a Ship Engine – A Case Study

Hanna Smoleńska¹, Włodzimierz Kończewicz², Sylwia Bazychowska^{2*}

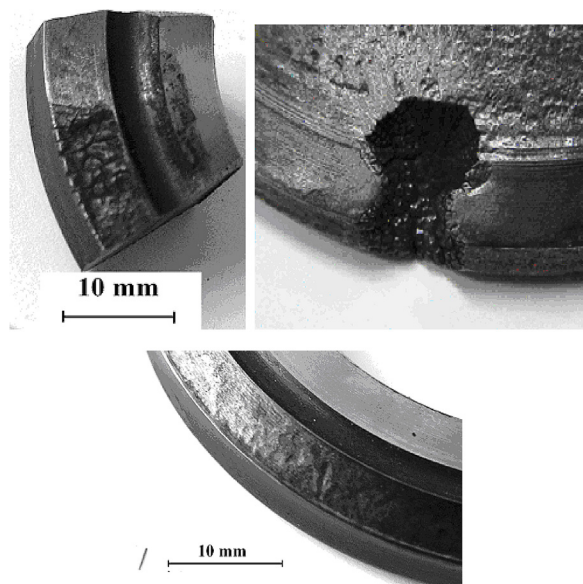
- loss of tightness caused by corrosion pits resulting from erosive exhaust fumes (Fig. 1b),
- over burning of the valve head edges caused by the flow of extremely hot gases through the leaks (Fig. 1a),
- cracks, scratches and splinters caused by fatigue of the face layer (Fig. 1c).

Fig. 1. Examples of damaged exhaust valve of the marine engine: (a) corrosion of the face – “pavement”; (b) destruction of the face and substrate due to valve leaks – irreparable; (c) face wear – repairable

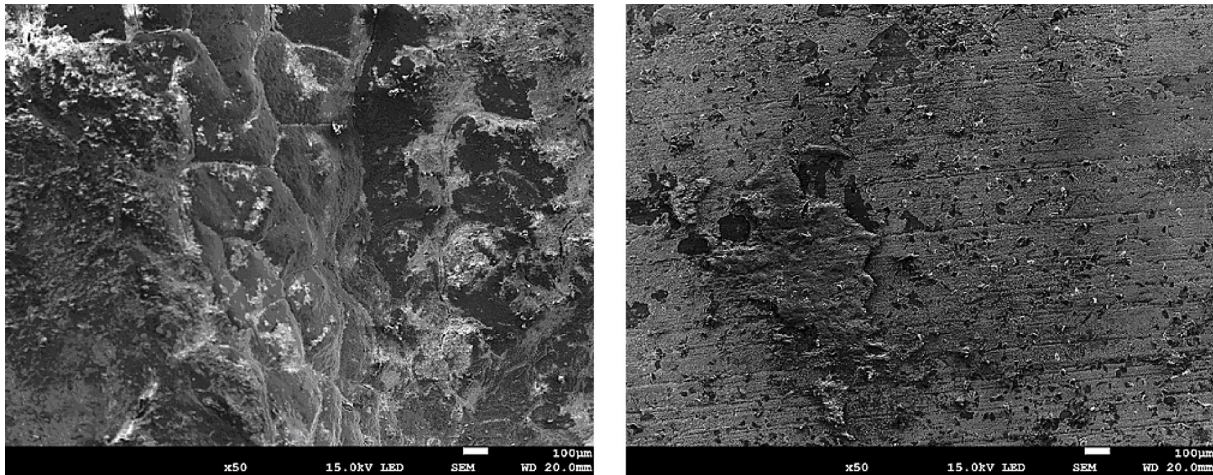
Fig. 4. N valve destroyed during operation – face surface (a), face surface in a different area (b)

condition of the N valve after service. Significant differences of the appearance of the valve face surface were observed. It also indicates different properties of the material in different area of the face which is not acceptable.

Observed destruction of the face can be caused by various factors. It may be the result of incorrect selection of padding materials, improper parameters of the padding process, but also mechanical causes of damage, i.e. overloading or improper valve grinding should be taken into account. In this work only chemical composition of the clad and changes in mikrostrusture were analyzed.

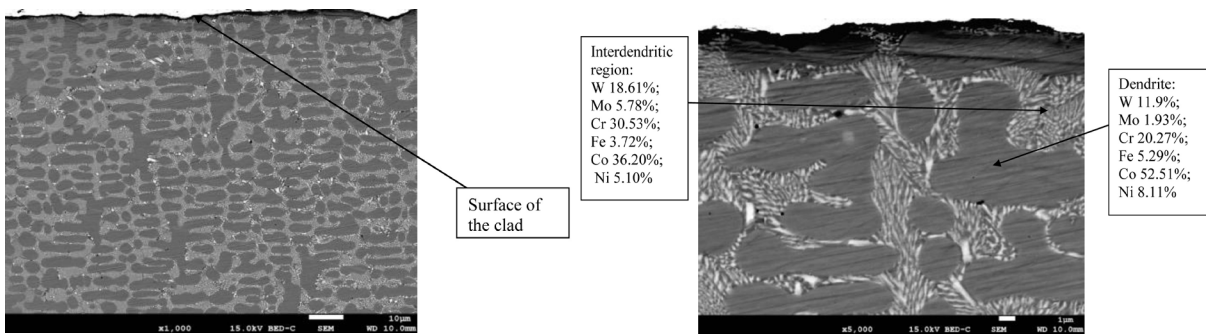
Fig. 5. N valve destroyed during operation – microstructure on the cross-section, close to the face surface; it is visible dendritic structure characteristic for free solidification of melted metal during surfacing (a); microstructure on the cross-section, near the top surface; EDS results for dendritic and interdendritic region (point analysis) (b)

The valve was cut into samples, included and a specimen prepared, which was observed on a scanning electron microscope (SEM). On Figure 5 is presented mikrostruktue of destroyed valve N. Mikrostruktue is typical for cladding

technology [3, 4, 10, 26]; visible dendritic structure (dark) and interdendritic regions (light under low magnification). Dendritic region are a solution of alloying additives in cobalt, mainly nickel, iron, chromium, tungsten and molybdenum. The interdendritic region consist of mixture of carbides end eutectics (Fig. 5a). During previous tests of welds made of the same powder as designated L12, occurrence was found was found by XRD analysis presence of carbides were identified as mainly $M_{12}C$ (Co_6W_6C), M_7C_3 and $M_{23}C_6$ ($Cr_{23}C_6$). EDS analysis shows a significant presence of tungsten, chromium and molybdenum

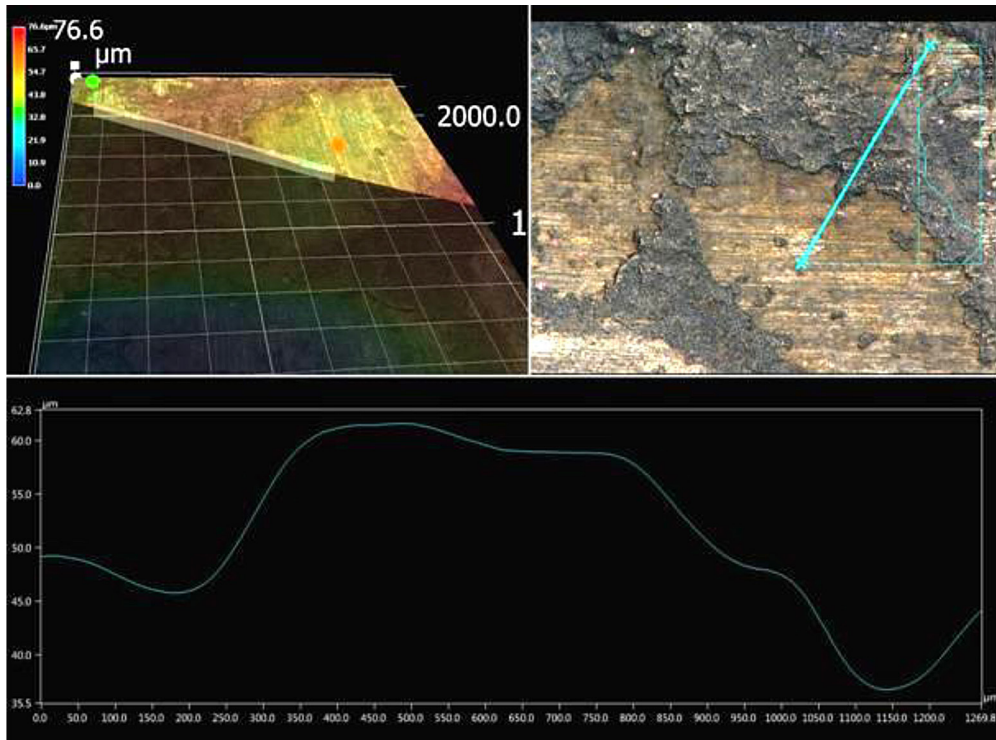
Fig. 6. Surface profile of L12 valve face after operation –visible regions of existing scale. Analyse made by laser profiler KEYENCE

surface of the outlet valve face has been slightly degraded. Keyence equipment was used for surface analysis. This equipment is a microscope coupled with a profilograph and allows measure the surface profile of targets in X and Z directions. The height, width or gap on a surface profile can be measured. Observation of the face surface showed the presence of crumbling scale and areas of the exposed metal surface. In

Figure 6 a multilayer scale with a tendency to crack and delaminate is visible. However, the largest layer thickness did not exceed 60 μm. SEM analysis of the valve face marked L12 showed the slight plastic deformation of the surface was observed, which can be interpreted as the effects of plastic deformation during work, this is illustrated in Figure 7.

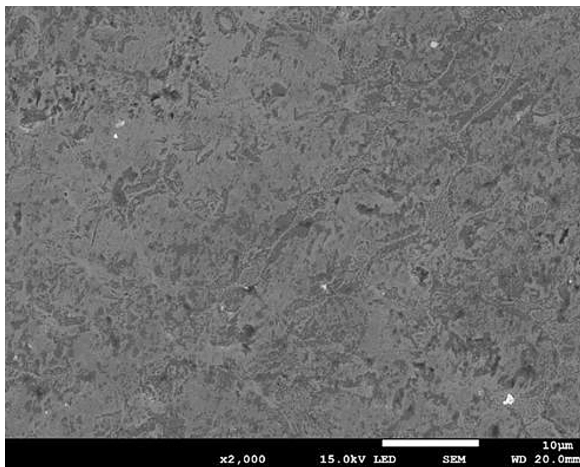
Fig. 7. L12 valve face after operation – plastic deformation

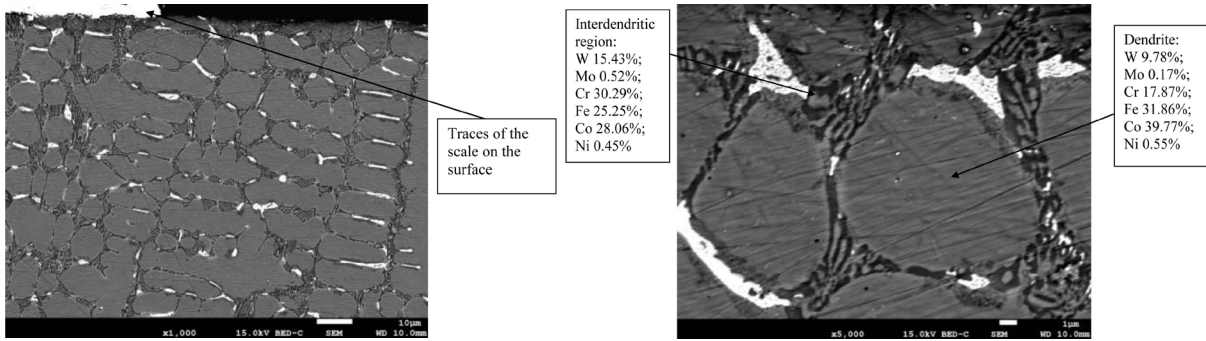
SEM observation of the cladding layer cross-section does not show any significant changes in relation to the typical microstructure of the clad layer. However, the presence of the scale on the face surface indicates changes in chemical composition resulting from diffusion processes. The EDS analysis results for the padding area just below the scale was as follows: Si-2.49%; Cr-23.12%; Fe-31.83%; Co-35.30%; Ni-0.60%; W-5.79%; Mo-0.86%. It may cause changes in material hardness because the scale is mainly composed of chromium oxide, which has protective properties. This is also the reason for using alloys with such high chromium content. Chromium is mainly contained in carbide secretions and they are also the main source of diffusion to the surface. Degradation of carbides decreases the hardness of the material [10, 24, 25].

Fig. 8. (a) L12 after operation - microstructure on the cross-section, near the top surface. No visible changes in dendritic microstructure under the scale (b) L12 after operation - microstructure on the cross-section, near the top surface. EDS results for dendritic and interdendritic region (point analysis)

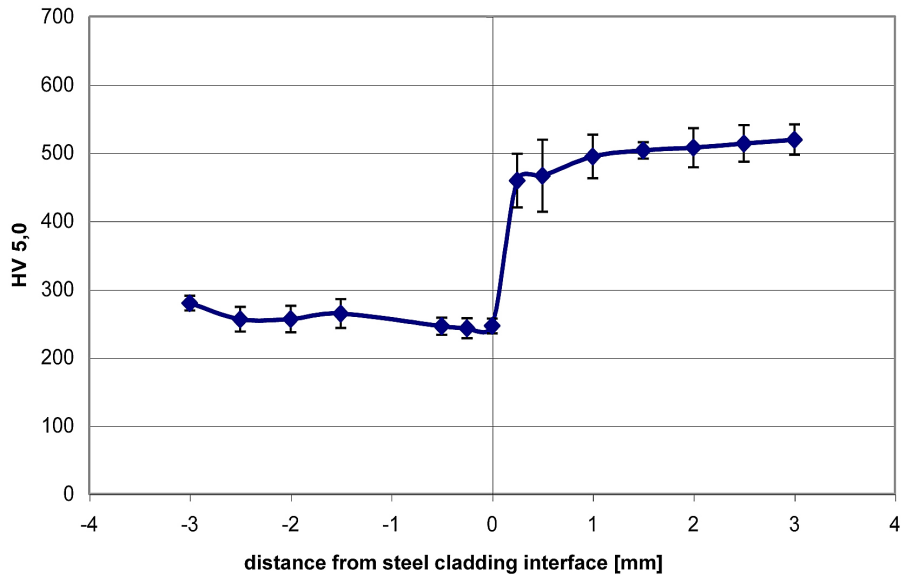
Fig. 10. Statistical analysis of the hardness measurements for the L12 valve after 3000 hours of operation

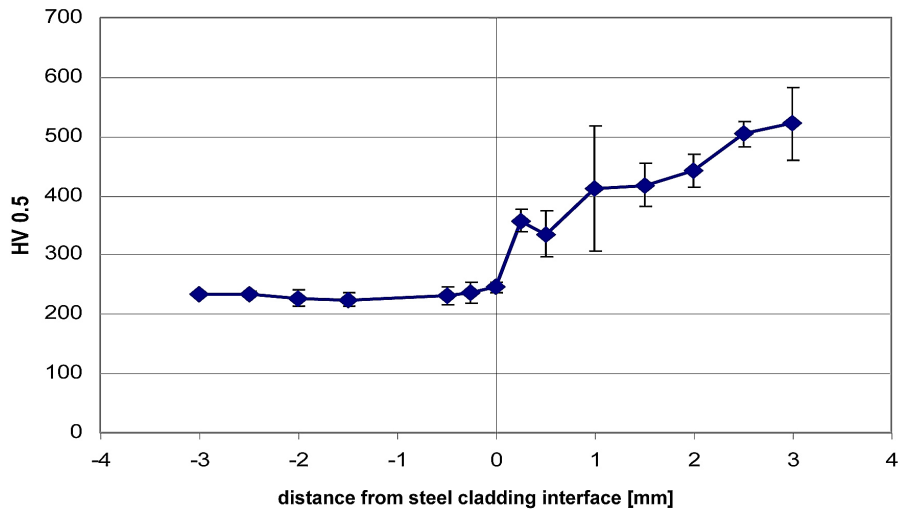
Fig. 11. Statistical analysis of the hardness measurements for N valve after 2000 hours of operation

found in the range 480 to 581 HV5.0 at distance 3mm from the steel-clad interface (close to clad top surface) – similar to L12, but in the deep of the clad hardness decreases up to 195-447 HV5.0. In means large changes in hardness on the cross-section. In both cases no significant decrease in hardness was observed close to the top surface, which indicates that despite the formation of the oxide layer, no degradation of the material will occur.

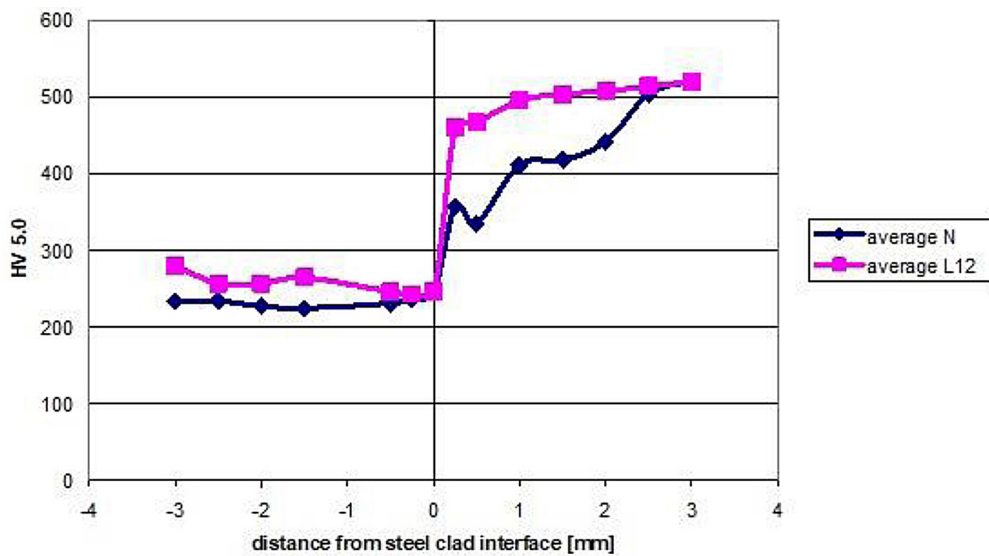
Fig. 12. Comparison of average values of hardness of the N and L12 faces claddings

3. Hardness measurements showed stable hardness of the L12 surfacing weld, higher than the hardness of the substrate. While a constant decrease in the hardness of the N-weld surfacing across the thickness is observed which could affect its durability.
