Building modernization located in the conservation protection zone in the aspect of technical conditions

Abstract

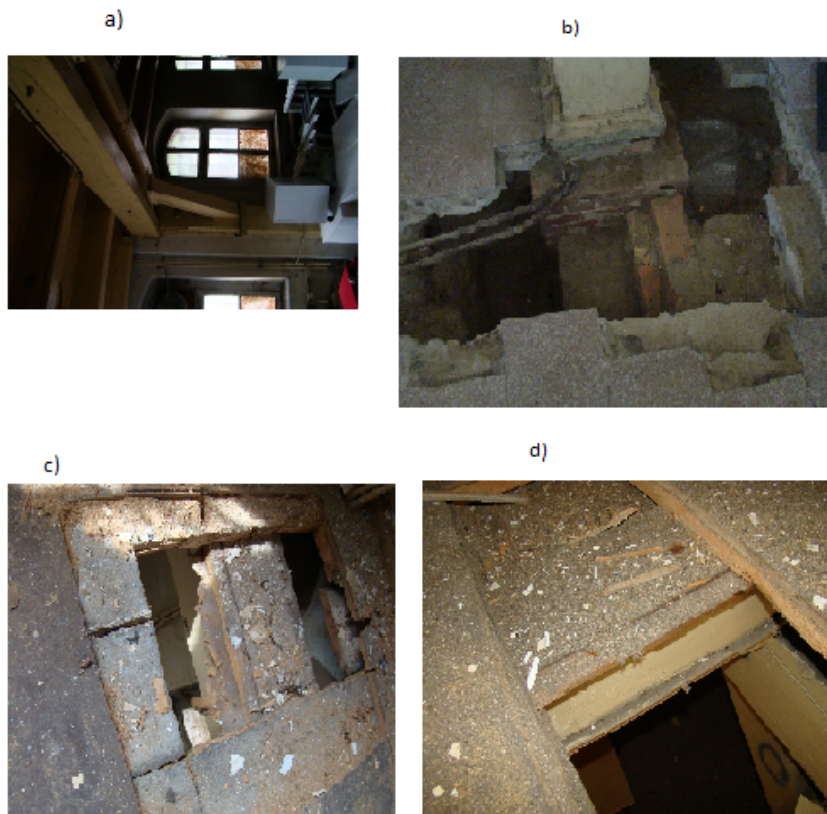
Figure 7. Building planned for modernization ceiling above the ground floor: a) fragment of the wooden frame, b) foundation of the column, c), d) structure of the stop

Wooden posts and wooden bolts on the ground floor level showed numerous scratches, delamination and cracks (Fig. 7a). The dimensions of the wooden poles in the cross-section were 32x32 cm, the transoms were made as two-branch transoms from beams 2x15x31 cm. The foundation of the columns on a brick foundation (Figure 7b) was to ensure the vertical non-deformability of the wooden structure. Stiffening of the structure of wooden frames was provided by swords measuring 15x35 cm. Wooden ceiling beams with dimensions of 15.5x28 cm were spaced from 65 to 80 cm. The ceiling above the ground floor was made of wooden naked. In the outcrops, it was found that the floor beams were made of 3.8 cm thick boards (Fig. 7c and Fig. 7d). On a part of the ceiling, additionally, during the period of operation, a hard-type fibreboard with a thickness of 0.5 cm was impaled on the boards.

The wooden beams of the ceilings above the ground floor, first and second floors had locally visible traces of larvae and insect feeding. Damage of this type occurred in the level of all inter-story ceilings and was caused by the lack of protection of wooden elements during the building's operation period against the action of technical wood pests.

- wooden load-bearing structure (mullions and transoms) - local reinforcement and replacement of mechanically damaged wooden elements, affected by biological corrosion and damaged as a result of feeding larvae and insects,

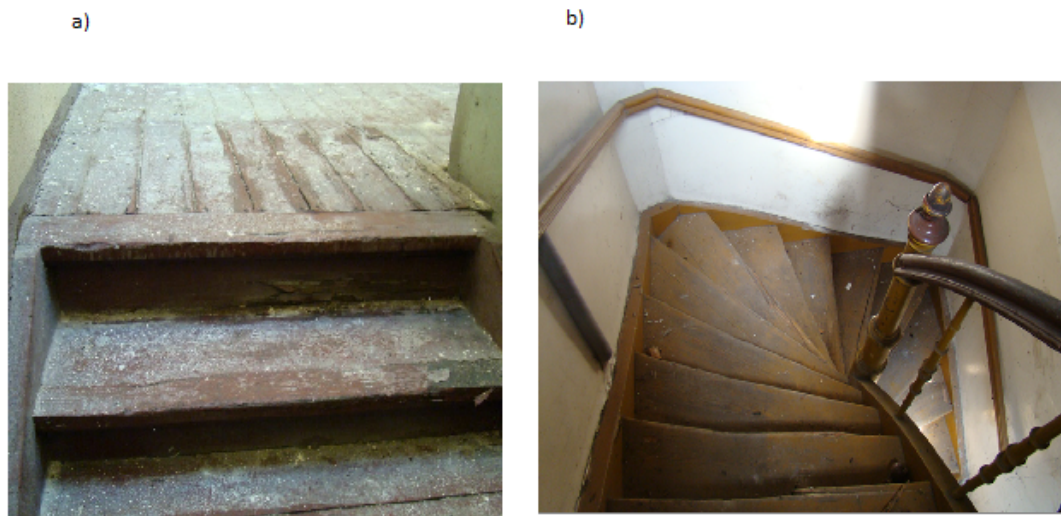
Figure 11. Building planned for modernization - damage to the runs of staircases: a) main and b) side

The main staircase had landings and running boards made of wooden elements. The steps were worn, the footrests and legrests were mechanically damaged (Fig. 11a), with extensive traces of larvae and insect feeding. The side

staircase was in a very similar technical condition, the communication of which was provided by the return operation stairs (Fig. 11b).

- staircases - reconstruction of staircases with particular emphasis on the need to adjust the width of escape routes and fire protection of structural elements.

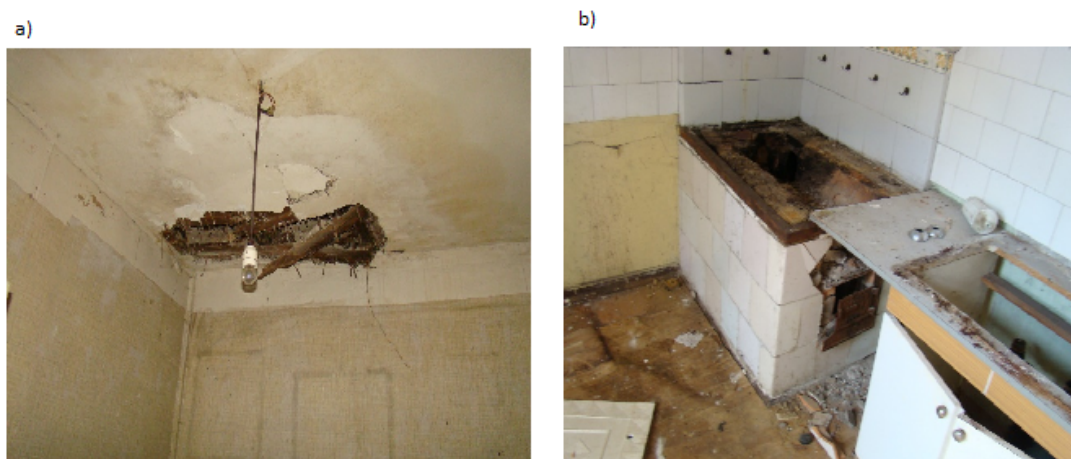
Figure 12. Building planned for modernization – lokale mieszkalne: a) broken ceiling above the ground floor, b) depreciation of equipment

The residential premises in the area of the building were out of service, there were visible traces of extensive water stains and mechanical damage to the finishing layers (Fig. 12). The walls and ceilings of the plastering were chafed and locally damp. There were pipe installations in the rooms, and the cable systems in most of the rooms of the residential premises were also dismantled.
