Thermography of the Extensive Green Roof of the Brno-Komín Kindergarten

The article deals with the behavior of an extensive green roof in winter. The behavior of the green roof of the Kindergarten Brno – Komín is described in the case study. The condition of the roof was determined using thermovisual technology. An extensive green roof shows significant temperature differences in winter compared to roofs without vegetation. The vegetation layer on roofs partially acts as an insulating layer. From this structure, the ventilation shafts and sanitary equipment emerge thermally. As part of thermography, the influence of the revision segment on heat conduction was determined. The overall thermal technical condition was evaluated using a thermal camera.

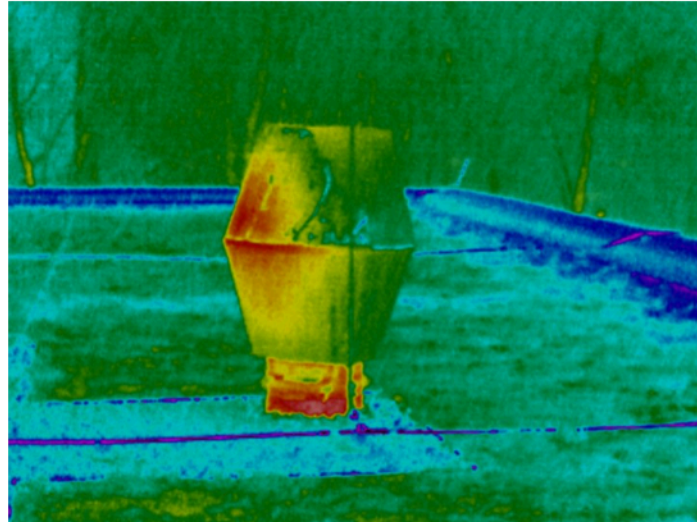
A large difference between the temperature of the air handling unit body and the surrounding material was captured in dark vision images of shaft penetrations. [Figure 1] The lowest temperatures were shown by the construction of the attic sheeting and aluminum profiles around the perimeter of the roof, where the aggregate was poured. Likewise, very low temperatures were experienced by the lightning conductor, which is routed along the entire roof in the shape of a square net. The ventilation shaft was divided into two parts and according to the picture it was clear that only one part of the vent was in use, therefore the body shows a temperature difference on both sides.

Fig. 1. Thermalvision image of the ventilation system

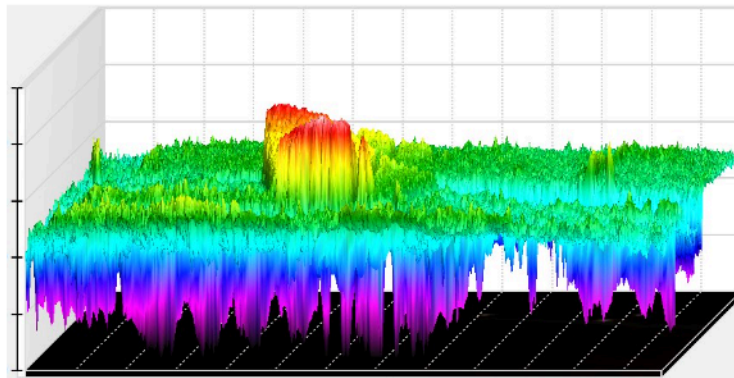
On the contrary, we can see minimal temperature fluctuations in the surface of the substrate and vegetation. The only minor change is in the area where the aggregate is poured. [Figure 2]

Fig. 2. 3D-IR image of the ventilation system

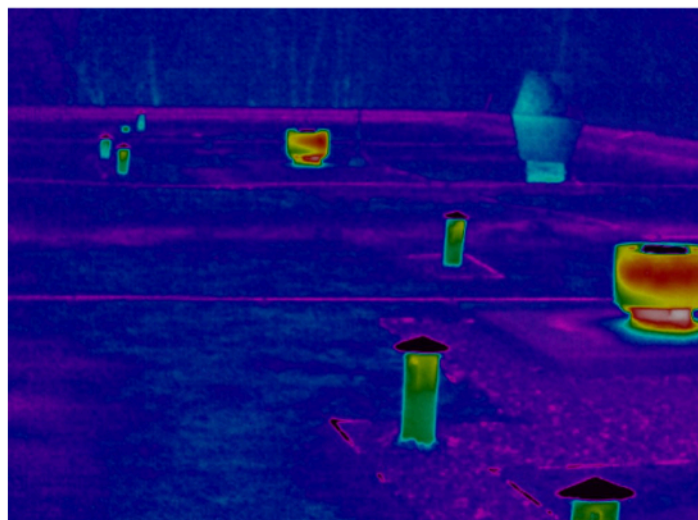
Fig. 3. Thermalvision image of shaft 3D-IR image of the ventilation system

On Figure 3, we can see the temperature differences of the vents of the installations and the surface of the roof. On Figure 4, we can again see the 3D-IR graph of temperatures in the area.

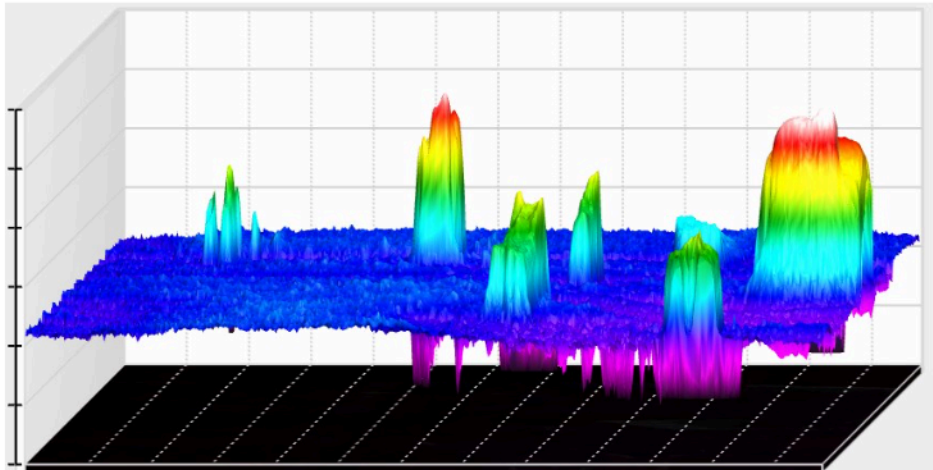
Fig. 4. 3D-IR image of the ventilation chimneys

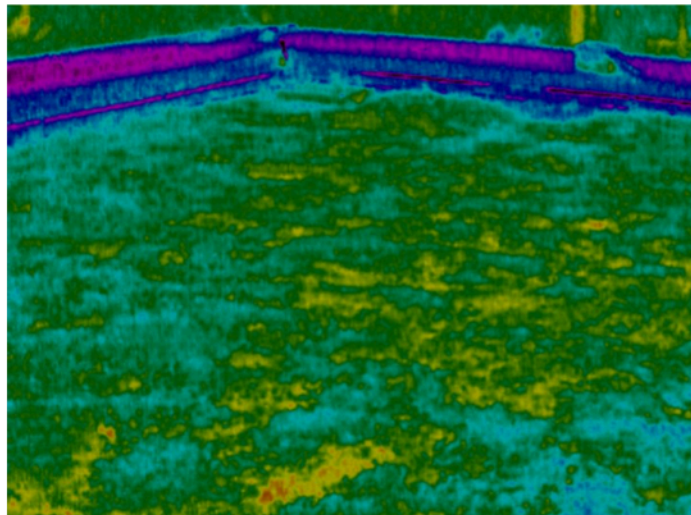
Fig. 5. Thermalvision image of vegetation carpet

The slight differences in the temperatures in the roof surface in Figure 5 were caused by the different thickness of the substrate layer or the partial absence of roof vegetation, even so the temperatures here differed by only 2 to 3°C.

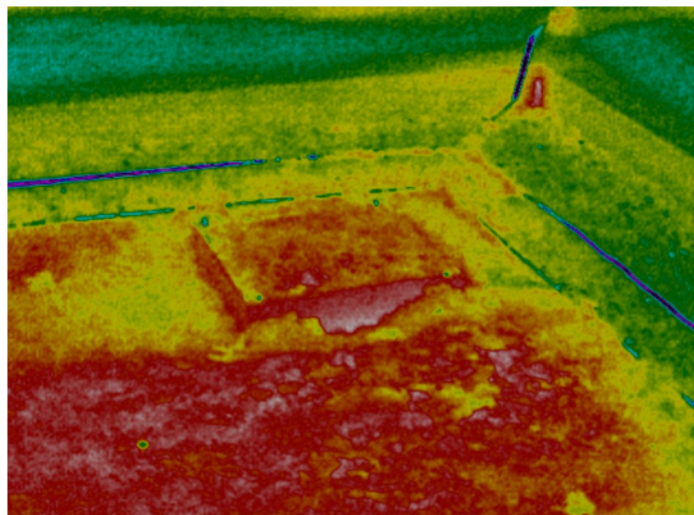
An interesting finding was the measurement of the control segment of the green roof on the Figure 6. It is made of rolled sheet metal and painted with an anti-corrosion agent. However, the implementation in the layers of the roof caused the segment to be almost invisible on thermal images. Small temperature differences are caused by the irregular thickness of the substrate around the segment, as well as inaccuracy during the installation of the hydroaccumulation layer.

Fig. 6. Thermalvision image of control segment

The control segment therefore has no negative effect on the conduction of heat in the structure and is therefore not a thermal threat or a source of thermal bridges. In this case, the segment is not sufficiently covered with substrate and therefore we can see the square outline of the structure in the picture. In cases where it would be properly sprinkled and lined with hydroaccumulation material, the temperature difference in the surroundings will be minimal.
