THE IMPACT OF THE LOW THROW FAULT ON THE STABILITY OF ROADWAYS IN A HARD COAL MINE

PIOTR MAŁKOWSKI

Key words: fault, roadway stability, roadway convergence, floor heaving

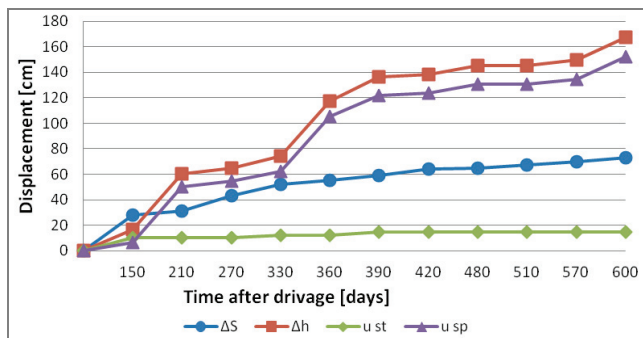
Studies conducted in the fault zone lasted 16 months; 11 measurements were taken. During 450 days of observations, the biggest dimension change has been obtained (Table 4). The drivage of the D-2 maingate in the fault zone has caused its 71 cm horizontal convergence, which is around 12% of the nominal width of the roadway. The weakening of rocks and extensive stress in the fault zone have considerably influenced the vertical convergence of the roadway. Roadway height, since its drivage, has decreased by ca. 170 cm, which resulted in additional works that would ensure stability of the roadway – floor brushing has been carried out three times; its values were

taken into account in the results obtained. Thus, total average floor heaving for the roadway located in the fault zone would be 150 cm. If rocks had not been brushed from the floor, the roadway cross section would have been at as little as 45% of its original value, which means almost complete loss of the roadway functionality.

Fig. 5. Maingate D-2 convergence – base on 757 m (ΔS – roadway width change, Δh – roadway height change, u_{st} – roof displacement, u_{sp} – floor heaving)
