DIAGNOSIS AND REPAIR TECHNOLOGY OF DAMAGED ELEMENTS OF CASA AIRCRAFT

Michał Salacinski
Piotr Synaszko

Air Force Institute of Technology, Warsaw, Poland

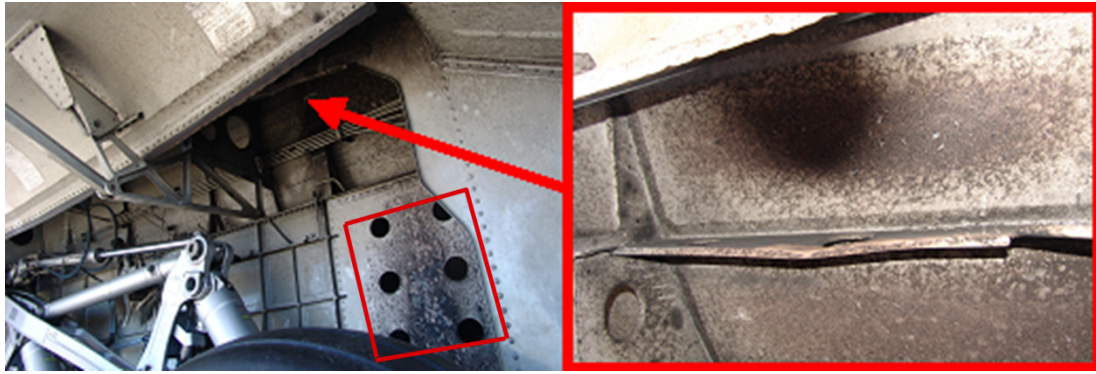
Fig. 1. Area of interesting

During take-off, the breaks broke down and got blocked, which caused burning of the composite panels. The fire was not big, but the composite panels and the metal longeron as well as the elements inside the left gear’s deflector required nondestructive inspection and repair.

The second object under investigation was the longeron (Fig. 1). For the longeron, the conductivity inspection was performed with the Phasec 2200 equipment.

The fire caused failure in three composite elements, but this paper focuses on the vertical panel only (Fig. 1).

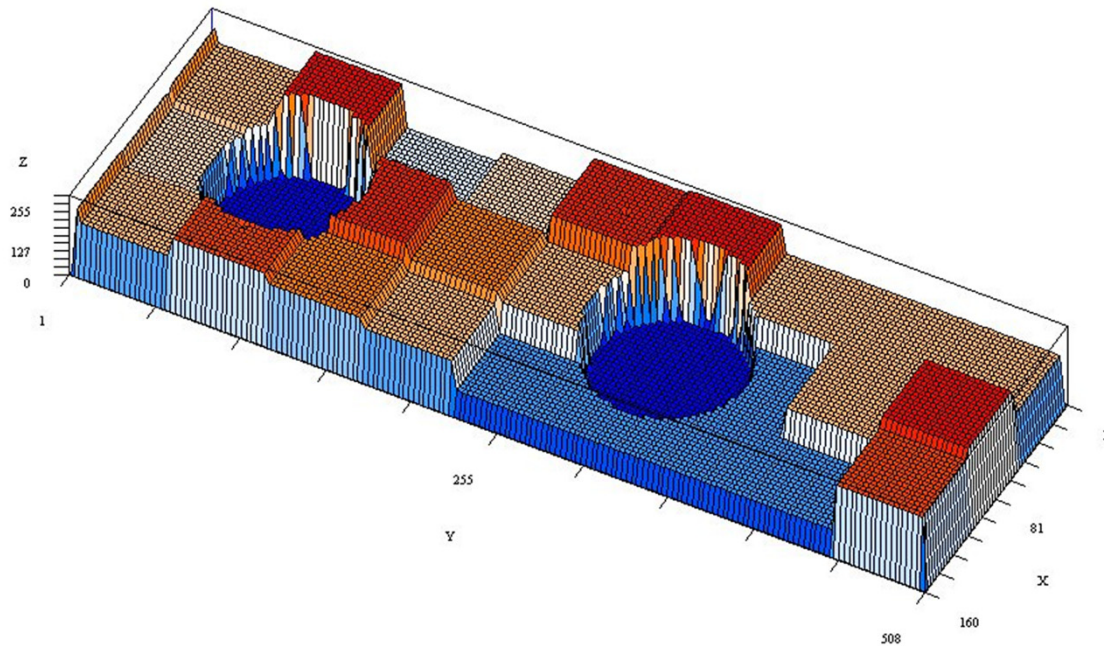
Fig. 3. Map of conductivity of longeron in damage area

In the figure below, the blue color represents a “good” area. Other colors represent higher conductivity.

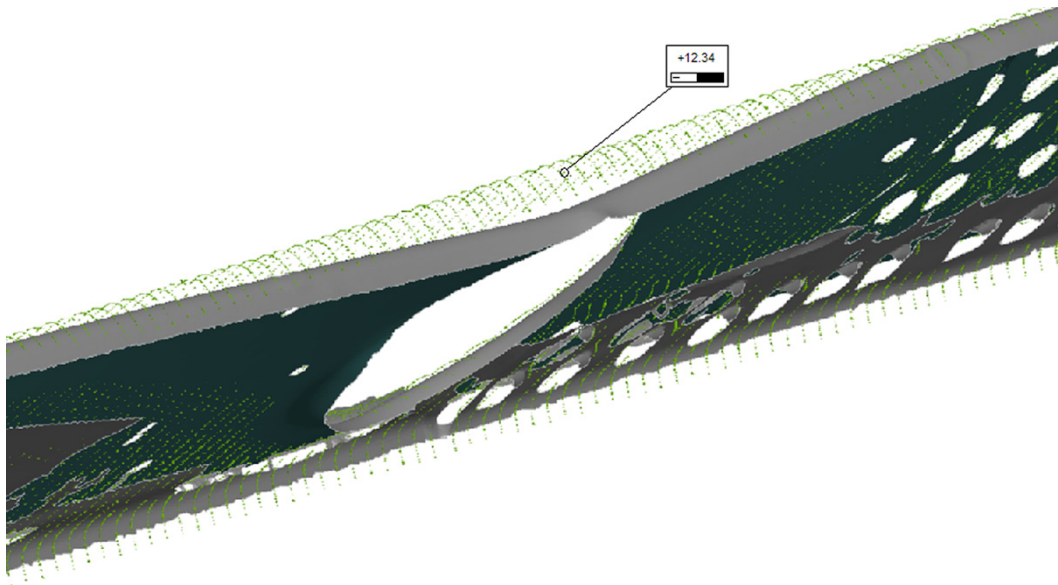
Fig. 4. Displacement of longeron in damage area

In the picture above (Fig.4), the deformation of the longeron caused by the heat treatment can be seen.

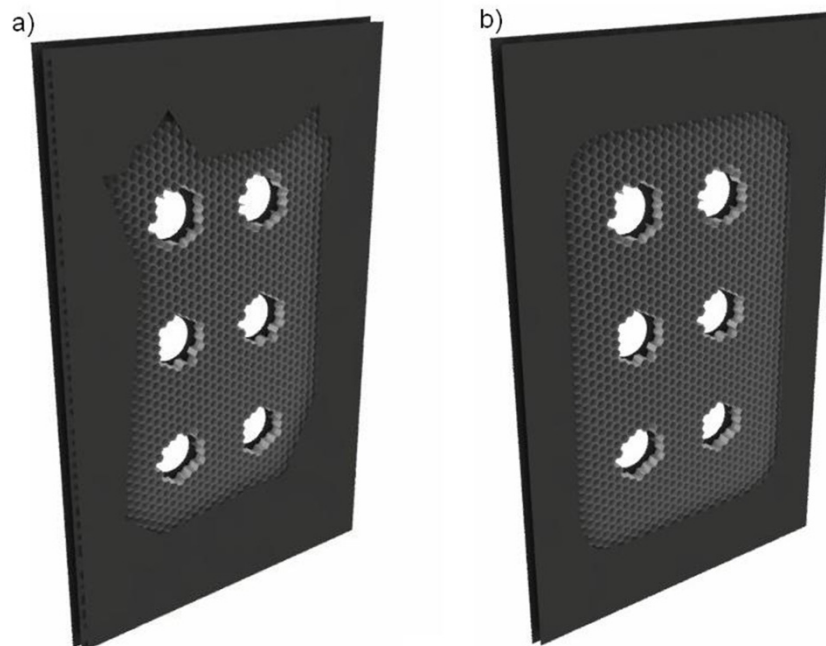
Fig. 9. Reduction influence of the notch, a) before tooling, b) after tooling

The fire caused disbonding between the skin and the core. The first step is removing the damaged skin and cleaning the core. The corner is a notch, so the corners radiuses should be increased.
