# Bunker demolition located in a conservation protection zone in the light of technical, national defense, functional-utility and economic conditions

## Abstract

The paper presents a description of the technical condition of the Bunker building located at the port quay, which has been out of use for several decades. The direct reason for the cessation of exploitation was the deletion of Bunker from the Civil Defense records. The paper contains a detailed analysis of the Bunker's technical condition, also taking into account the national defense, functional and utility aspects and the issues of economics of carrying out renovation works. The paper shows that despite the location of the Bunker in the conservation protection zone, the optimal solution was its demolition and the final use of the area where the Bunker was located as a place for the construction of warehouse buildings with parameters adapted to the current needs and target transshipment capabilities of the port quay.

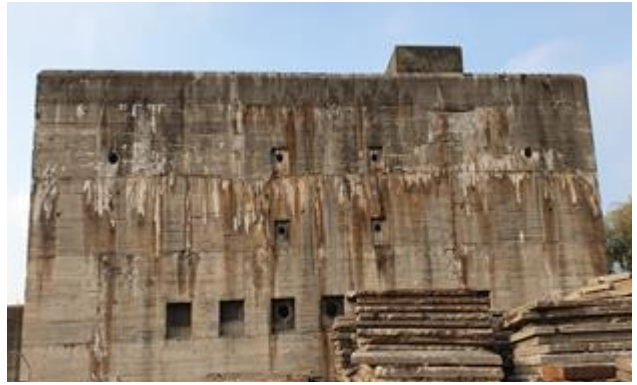
On the front elevation, numerous concrete damages were visible in the form of scratches, cracks and concrete losses, as well as multi-colored efflorescence in places of concrete discontinuity (cracks and cracks), caused by leaching of calcium compounds from the concrete and corrosion of the reinforcement (Photo 1a). Pores and capillaries were visible on the surface of the concrete, and the concrete had an open structure.

Photo 1: Bunker building elevations: a) south-east: external longitudinal (front) wall from the land/water side, b) south-west: external gable (transverse) wall from the land side (left), c) north-east: external gable wall (lateral) landward (right)

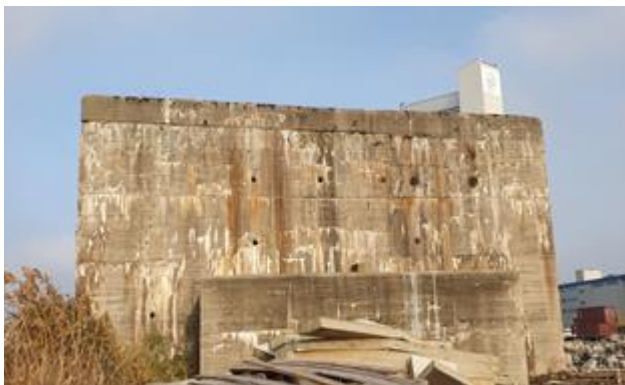
b)

A single-storey annex adjoined the external gable wall on the left (Photo 1b). The condition of the left gable wall was similar to the condition of the front wall in terms of the extent of damage - there were numerous places (cracks and cracks) from which calcium carbonates were leached, especially intensive in the upper part of the wall (Photo 2).

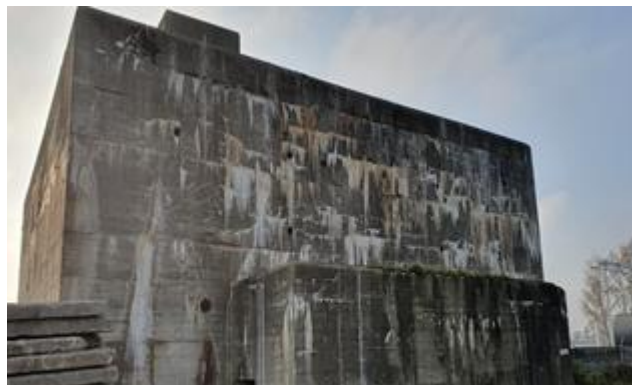
c)

A single-storey annex was also adjacent to the outer right gable wall (Photo 1c). The condition of the right gable wall was similar to the condition of the front wall and the left gable wall in terms of the extent of damage.

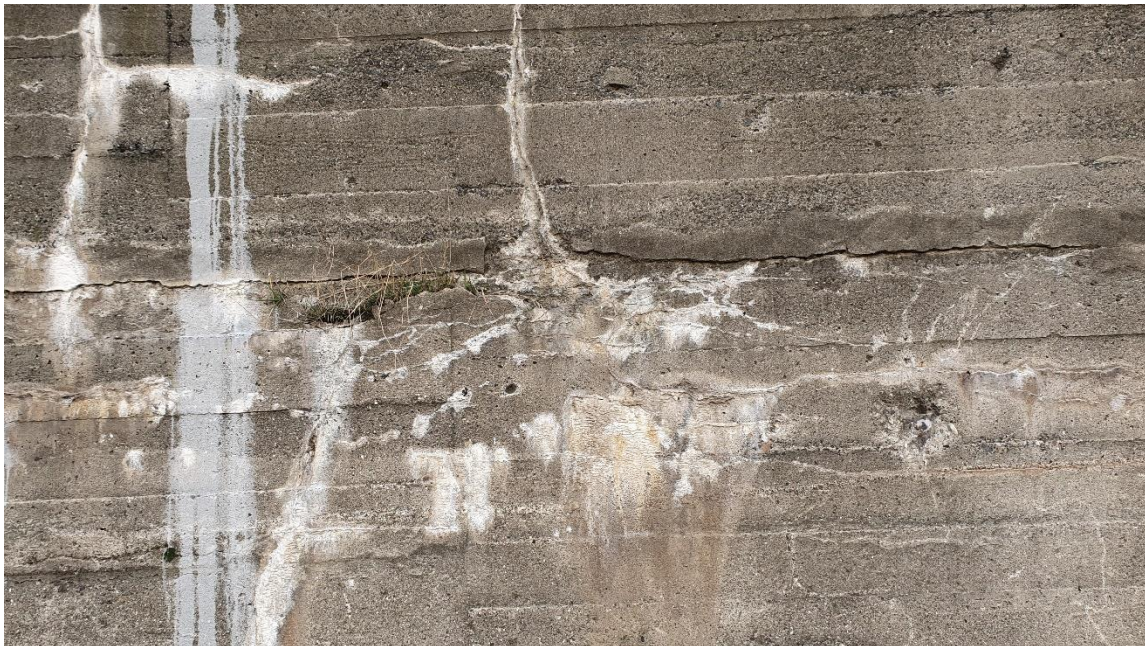
Photo 2: Examples of calcium carbonate leaks on the south-west elevation (external gable (transverse) wall from the land side (left)) of the Bunker building

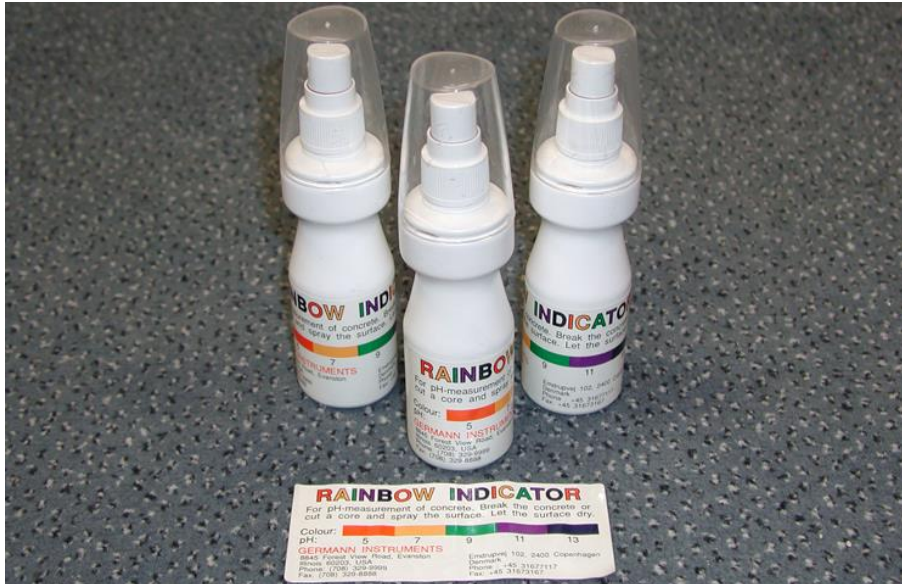
- 11-13 - concrete free from carbonation effects,
- 11 - limit value (reduced cover ability to protect reinforcement),
- ↓9 (< 9) - reinforcement corrosion hazard,
- ↓7 (< 7) - corrosion of reinforcement bars.

Photo 3: Interpretation of Rainbow Test results using Rainbow Indicator Fluid

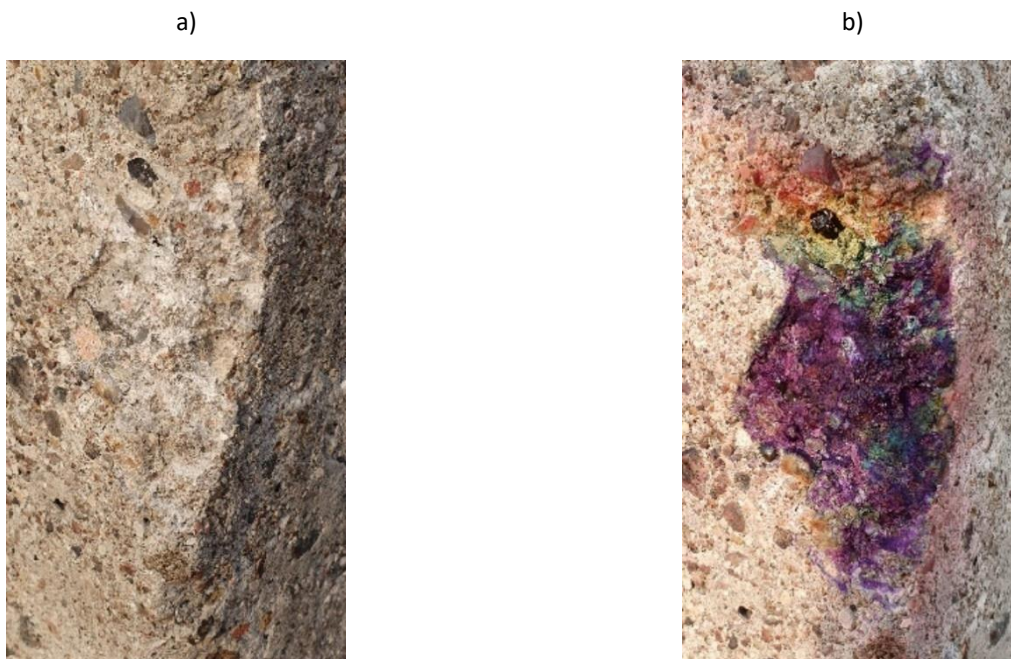
On the walls of Bunker, based on chemical tests, high carbonation of concrete, i.e. low pH value ( $\sim 10$  pH) was found (Photo 4). This means that the concrete cover has lost its natural ability to protect the reinforcement against corrosion, which results in the acceleration of the destruction of the concrete structure on the one hand, and on the other hand, it means that the process of corrosion of the reinforcement bars is active and progressing, which was confirmed by brown-rust tarnish on the concrete surface. Photo 5 shows the study of the degree of concrete carbonation on the external wall in the place of a wet crack.

Photo 4: Discoloration of concrete after the Rainbow Test in the place of forging the concrete cover to a depth of 2 cm in the corner of the left annex - view of the test site: a) before, b) after the test: purple-green coloration indicates advanced carbonation of the concrete cover and its reduced capacity to protect the armament

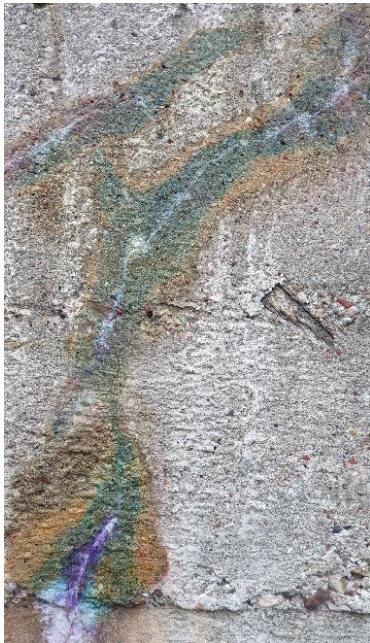
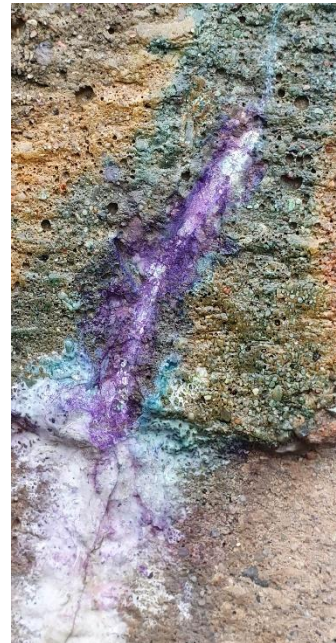
Photo 5: Discoloration of concrete after the Rainbow Test on the concrete surface, in the place of a crack on the wall of the right annex - test site after the test: a) view, b), c) close-up: green-violet coloration indicates advanced carbonation of concrete and its reduced ability to protect the reinforcement, the orange color indicates advanced carbonation of the exposed concrete surfaces, washing out of calcium carbonates is visible in the area of cracked concrete fragments
