On Degradation of Cast Iron Surface- -Protective Paint Coat Joint

M. Tupaj ^{*a}, A.W. Orłowicz ^a, A. Trytek ^a, M. Mróz ^a, G. Bąk ^b, T. Abram ^b

The paper is a presentation of a study on issues concerning degradation of protective paint coat having an adverse impact on aesthetic qualities of thin-walled cast-iron castings fabricated in furan resin sand. Microscopic examination and microanalyses of chemistry indicated that under the coat of paint covering the surface of a thin-walled casting, layers of oxides could be found presence of which can be most probably attributed to careless cleaning of the casting surface before the paint application process, as well as corrosion pits evidencing existence of damp residues under the paint layers contributing to creation of corrosion micro-cells

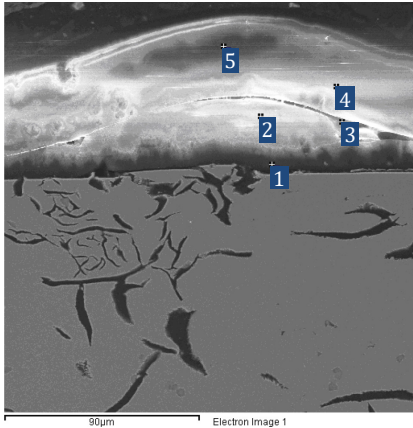
Metallographic analysis of specimens cut out in the plane perpendicular to the painted surface allowed to conclude that two paint coats were applied in the production process. The coat differed from each other in chemical composition, and in particular in chlorine content. Example results of metallographic examination of the paint coat are presented in Fig. 1. The first coat was rich in chlorine (above 17% Cl), while the second revealed low chlorine content (0.44–1.89% Cl, Fig. 1).

Spectrum No.	Element content, % wt.		
	C	O	Cl
1	71.14	10.95	17.92
2	66.87	16.13	17.00
3	75.79	19.61	4.59
4	84.36	15.20	0.44
5	89.22	8.89	1.89

Fig. 1. An example specimen microstructure in transverse section with two layers of paint. Note a discontinuous chlorine-rich paint layer (point 2) and continuous layer of paint with low chlorine content (points 4 and 5)

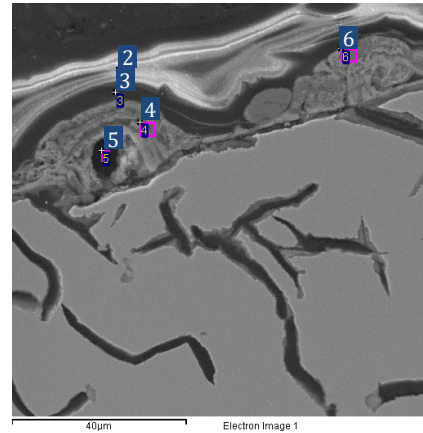
Results of microscopic examination indicate presence of corrosion traces passed over in the surface cleaning process in the form of convex oxide particles adhering to the casting surface (Fig. 2). This is evidenced by presence of a thin paint layer over the areas where oxide particles are found. Observed were also oxide layers adhering to casting surface and covered with a paint coat of normal thickness (Figs. 3, 4). Moreover, discontinuities of the paint coat could be visible with layers of oxides adhering locally to the substrate (Figs. 5, 6) and corrosion pits emerging on the casting surface, filled with oxides and covered with a layer of paint (Figs. 7, 8). This suggests that the paint could be applied onto a surface of casting some areas which were dampened. In presence of moisture, already under the paint layer, the corrosion process could develop penetrating then the casting material. It turned out that easy corrosion paths run through separation surfaces between flake graphite precipitates and the matrix. The corrosion process was intensified by presence of chlorine which most likely came from the paint used to coat the product.

Spectrum No.	Element content, % wt.				
	C	O	Si	Cl	Fe
2	77.24	22.33	0.00	0.43	0.00
3	68.23	15.74	0.25	7.52	8.25
4	6.78	37.31	1.92	0.00	53.31
5	0.00	0.00	0.00	1.52	98.48
6	12.71	34.70	0.00	2.01	50.58

Fig. 2. An example specimen microstructure in transverse section. Note oxide particles with convex shapes adhering locally to casting surface and covered with thinned coat poor in chlorine

Location of oxides found on the substrate surface onto which the paint coat was applied suggest two main causes of their presence. The first is the failure to remove oxides from metal surface. This is evidenced by presence of oxides adhering to the casting surface and the paint coat covering them being thinner than in the areas free from oxides. The second cause consists in the casting surface retaining locally some moisture which, in presence of chlorine coming most likely from the paint, became an electrolyte contributing to creation of micro-cells. In such cases, corrosion penetrated deep into the casting wall.

- To ensure that surfaces of painted cast-iron castings will maintain high aesthetic qualities, it is necessary that the substrate will be thoroughly cleansed of any traces of corrosion and made free of micro-residual damp.
- The used paint should not contain chlorine, as presence of the element in areas with micro-residual damp results in occurrence of corrosion micro-cells, creating conditions for penetration of corrosion deep into the casting material.
- The paint coat should have no discontinuities exposing surface of the casting, because in conditions of free access of damp, in particular in atmospheres typical for maritime regions, local corrosion centres can be created.

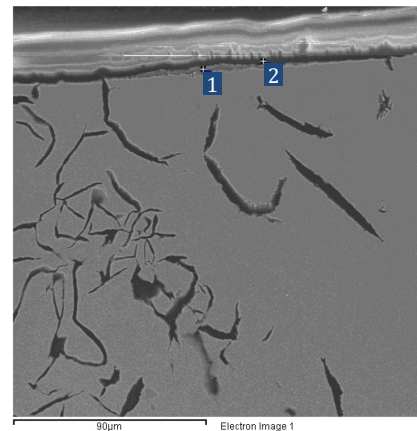
Spectrum No.	Element content, % wt.					
	C	O	Si	P	Cl	Fe
1	15.51	35.71	1.69	1.28	1.16	44.65
2	67.68	16.22	0.00	0.00	12.12	3.97

Fig. 3. An example specimen microstructure in transverse section. Note a layer of oxides adhered locally to the casting surface and covered with a layer of paint with similar thickness

Graphite precipitates turn out to be easy corrosion paths. The process takes place after application of the paint coat which is evidenced by similar coat thickness on both corrosion centres and corrosion-free areas.

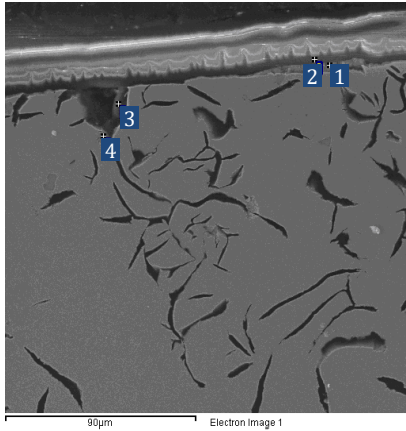
Spectrum No.	Element content, % wt.				
	C	O	Si	Cl	Fe
1	19.51	28.50	1.23	2.44	48.33
2	70.12	15.30	0.00	11.33	3.26
3	99.09	0.00	0.00	0.00	0.91
4	53.60	0.00	1.54	0.00	44.86

Fig. 4. An example specimen microstructure in transverse section. Note a layer of oxides adhered locally to the casting surface and covered with a layer of paint with similar thickness

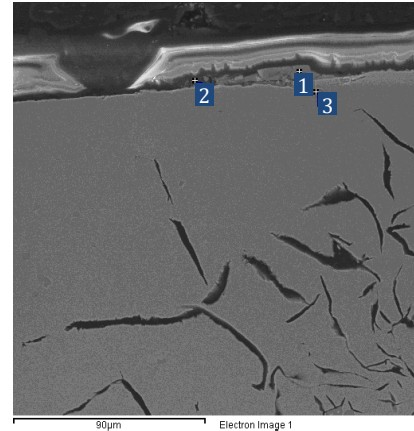
Spectrum No.	Element content, % wt.							
	C	O	Si	S	Cl	Ti	Mn	Fe
1	9.08	35.08	1.10	0.00	0.68	0.00	0.00	54.06
2	64.12	16.91	0.00	0.00	12.65	0.00	0.00	6.32
3	11.79	0.00	0.00	30.80	0.00	2.74	52.45	2.22

Fig. 6. An example specimen microstructure in transverse section. Note a layer of oxides adhered locally to the casting surface covered with a layer of paint with diversified thickness and flat face. Note also discontinuities of the paint coat

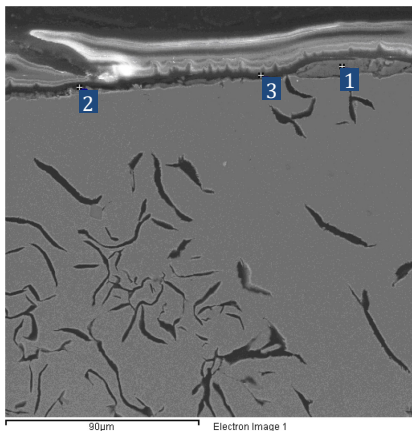
Spectrum No.	Element content, % wt.				
	C	O	Si	Cl	Fe
1	7.15	36.73	2.19	1.34	52.58
2	39.61	33.61	1.34	2.74	22.71
3	68.21	16.45	0.00	11.31	4.03

Fig. 5. An example specimen microstructure in transverse section. Note a layer of oxides adhered locally to the casting surface covered with a layer of paint and discontinuities of the paint coat

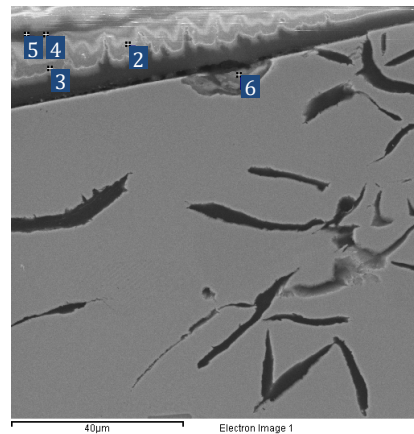
Spectrum No.	Element content, % wt.						
	C	O	Si	P	Cl	Ca	Fe
2	75.50	23.90	0.00	0.00	0.60	0.00	0.00
3	76.77	20.05	0.00	0.00	3.19	0.00	0.00
4	80.11	19.42	0.00	0.00	0.47	0.00	0.00
5	81.04	18.35	0.00	0.00	0.61	0.00	0.00
6	12.10	44.71	6.88	0.50	0.82	1.21	33.78

Fig. 7. An example specimen microstructure in transverse section. Note a corrosion pit on casting surface filled with oxides (point 6), covered with a layer of paint in which the first coat is characterised with low chlorine content (points 2 through 5)

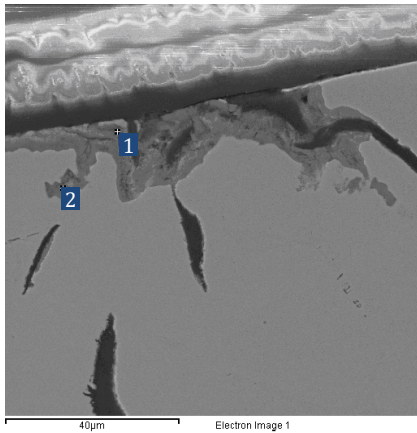
Spectrum No.	Element content, % wt.						
	C	O	Na	Si	P	Cl	Fe
1	7.95	40.50	0.66	6.65	0.56	1.00	42.67
2	5.46	37.79	1.16	5.06	0.00	0.89	49.64

Fig. 8. An example specimen microstructure in transverse section. Note a corrosion pit on casting surface filled with oxides at presence of chlorine (points 1 and 2), covered with paint coat
