Janusz Krawczyk\*, Jerzy Pacyna\*

**THE ROLE OF METALLURGICAL DEFECTS  
AND MICROSTRUCTURE ON FAILURE FORMATION  
IN ROLL NECKS OF CAST IRON ROLLS**

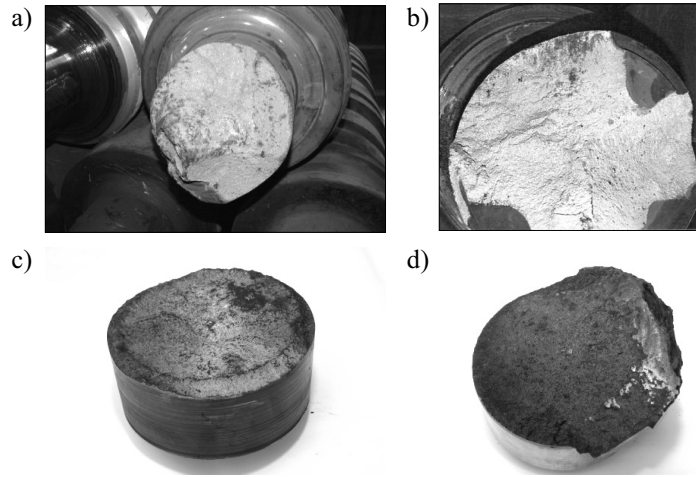
**Fig. 1.** Damaged roll necks: a) roll No. 1 after roll neck break off; b) roll No. 2 after roll neck break off; c) broken off part of the neck of the roll No. 3; d) broken off part of the neck of the roll No. 4

phase, neighbouring with shrinkage porosity. These cracks propagate from the core of the roll neck (areas, where shrinkage porosity exists), along the maximum shear stresses (acting during roll bending) towards the roll face (Fig. 1a, b). Such character of a damage of the roll neck should always lead to investigation of metallurgical faults inside the roll neck core, as the most probable reasons for damage formation. It is worth to notice, that shrinkage porosity forms particularly easy in the upper part of the casting, what should be taken into account while choosing which roll neck should be placed on the side of the roll drive.

Described above disadvantageous morphology of transformed ledeburite was the reason for failure of the rolls No. 3 and No. 4 (see Figs. 1c, and 1d), but shrinkage porosity was not observed in their microstructure. The way of development of original fatigue crack was mostly influenced by the state of sheer stresses in the neck of these rolls. That is why in roll No. 3 the crack propagates to a depth of about 15 mm by “jumping” over from one band of ledeburite to another. When this fatigue crack reached the critical length, the microstructure (banding) had predominant influence on its development. Similar mechanisms were observed in the case of the roll No. 4 with this only difference that initial crack developed only on one side of the roll neck (see Figs. 1c and 1d).

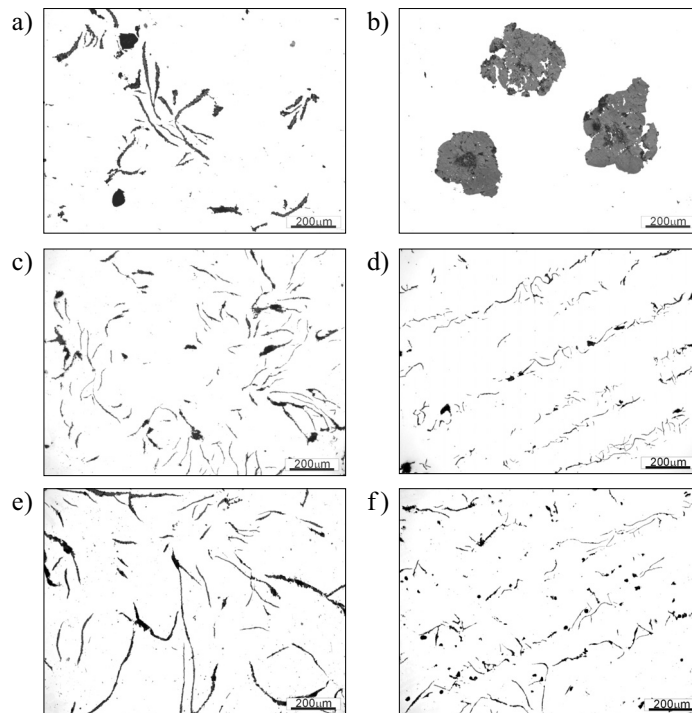
For investigation of reasons for failure of rolls necks four rolls were chosen (Fig. 1). The chemical composition of the rolls is shown in Table 1. Roll No. 2 was made of cast iron with modular graphite, and rolls No. 1, 3, and 4 were made of cast iron containing flake graphite (Fig. 2). It should be noticed, that morphology of graphite precipitates in the case of the rolls No. 3 and 4 is different in the core of the roll neck than that in the vicinity of its surface (Figs. 2c÷f). It results from the conditions of crystallization. In the vicinity of the roll neck surface a banding character of graphite precipitates could be noticed (Figs. 2d, f).

**Fig. 2.** Precipitates of graphite in investigated rolls: a) roll No. 1; b) roll No. 2; c) roll No. 3 (precipitates of graphite in the core of the roll neck); d) roll No. 3 (precipitates of graphite near the surface of the roll neck); e) roll No. 4 (precipitates of graphite in the core of the roll neck); f) roll No. 4 (precipitates of graphite near the surface of the roll neck)

7. The use of flake graphite cast iron for metallurgical rolls increases a risk of the fracture of roll neck. In rugged working conditions (for example strong bending of rolls), spheroidal or vermicular graphite cast iron should be used, which is more crack resistant [5].

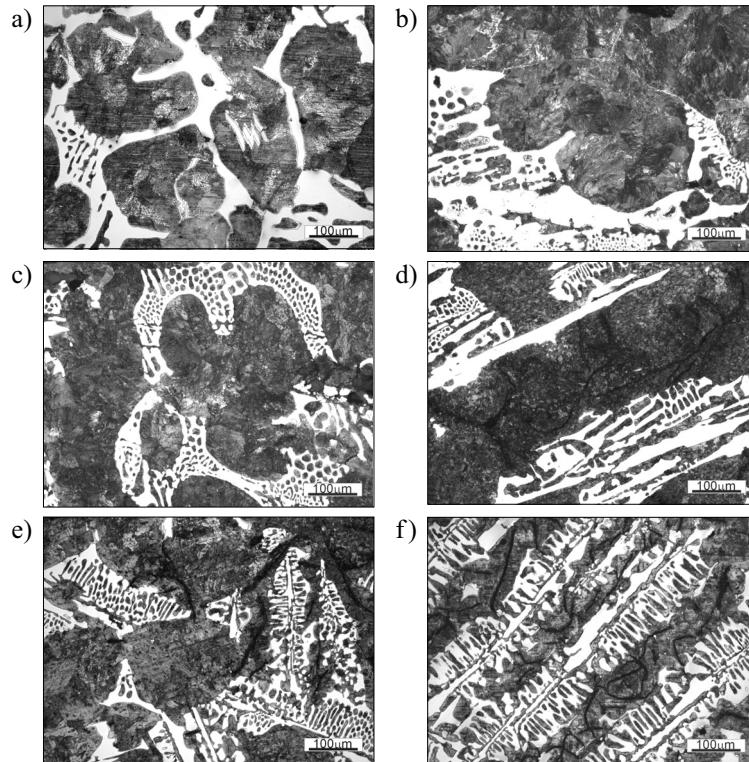
**Fig. 3.** Microstructure of investigated rolls: a) roll No. 1, b) roll No. 2, c) roll No. 3 (core of the roll neck), d) roll No. 3 (near the surface of the roll neck), e) roll No. 4 (core of the roll neck), f) roll No. 4 (near the surface of the roll neck). Etched with 2% nital

The microstructure of investigated rolls was shown in Figure 3. In the microstructure of all investigated rolls transformed ledeburite as well as pearlite could be observed. It should also be noticed, that volume fraction of hard, but also brittle ledeburitic cementite is high in the case of rolls No. 1, No. 3, and No. 4. Besides, it forms a continuous net, which is unfavorable from the mechanical properties point of view. As can be seen, precipitations of transformed ledeburite (originally ledeburite, so eutectic mixture) and flake graphite in the vicinity of the roll neck of rolls No. 3 and No. 4 exist in a form of bands. The conditions of crystallization of the roll neck influenced such banding of its structure. Originally, dendritic crystals were formed on the surfaces, in which the flakes of graphite were precipitating, and then quasieutectic (ledeburite) precipitated out of remaining mixture.

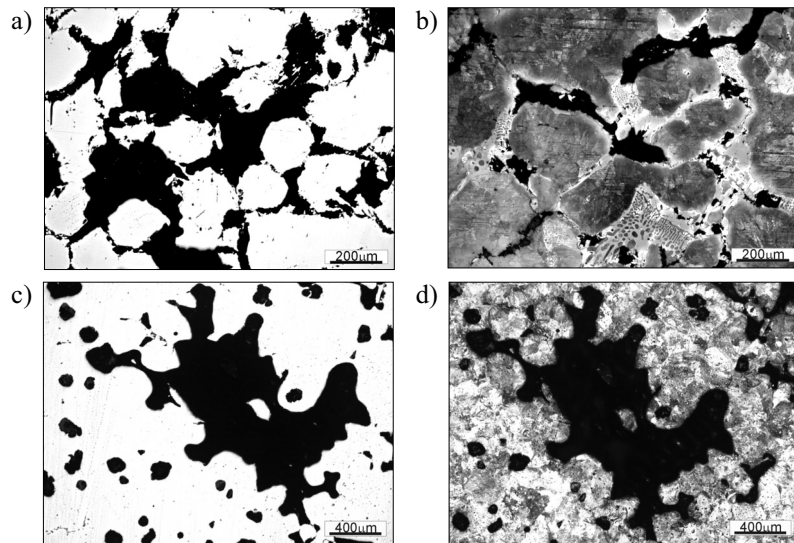
The most common reason for defects in roll necks is a presence of shrinkage porosity in their interior. In the case of investigated (damaged) roll necks, the areas of shrinkage porosity were detected in roll No. 1 and roll No. 2, what was shown in Figure 4. As can be seen, the pores are distributed in the areas where eutectic should exist. Such porosity is most common place of crack nucleation. Then, these cracks propagate along brittle carbide

**Fig. 4.** Shrinkage porosity area: a) roll No. 1 (unetched cross-section); b) roll No. 1 (etched cross-section); c) roll No. 2 (unetched cross-section); d) roll No. 2 (area from Fig. 4c after etching). Etched with 2% nital

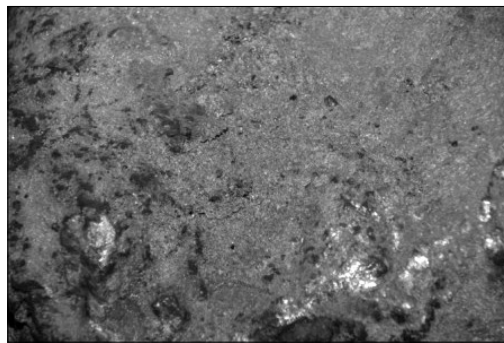
**Fig. 5.** The area of shrinkage porosity on fracture surface of the roll No. 1

Macroscopic observations of the roll neck can also allow identifying the shrinkage porosity. Figure 5 shows the fracture surface of the roll No. 1, where shrinkage porosity can be noticed.

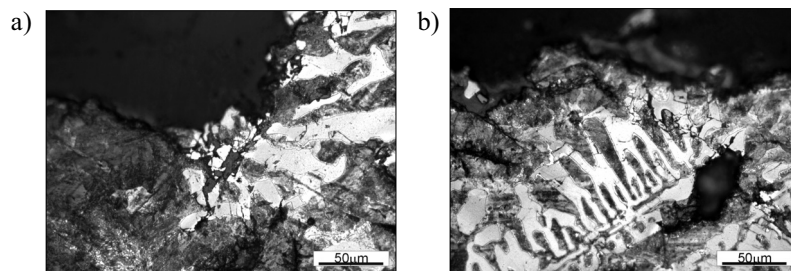
**Fig. 6.** Fracture propagating through the precipitates of ledeburitic cementite (roll No. 4): a) selected area; b) second selected area. Etched with 2% nital

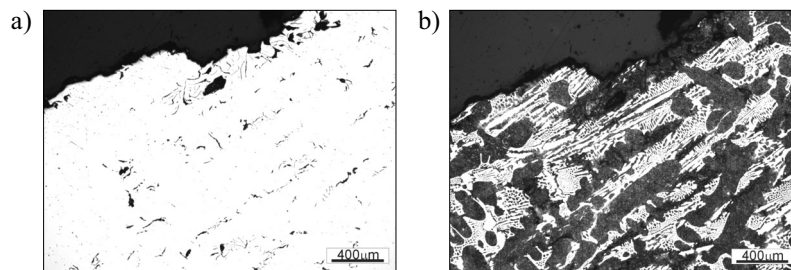
**Fig. 7.** Fracture propagating along ledeburitic cementite bands (roll No. 3): a) unetched cross-section; b) area from Fig a after etching. Etched with 2% nital

In the microstructure of rolls No. 3 and No. 4, flake graphite precipitates facilitated crack migration from one band of transformed ledeburite to another (Fig. 8). The bands of flake graphite precipitates also formed the paths for crack development (Figs. 7 and 11).

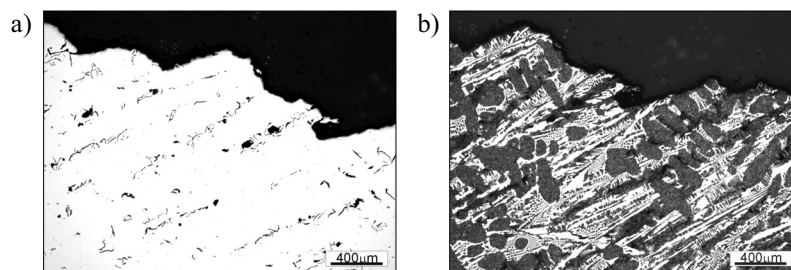
In the microstructure of almost all rolls (except roll No. 2), continuous net of ledeburitic cementite exists (with cementite built up on it, precipitated from austenite in the result of decreasing solubility of carbon in austenite ongoing with a decrease of the temperature). This continuous net of ledeburitic cementite facilitates crack propagation (Fig. 6). In the case when precipitates of ledeburite are in a form of bands, cracks will propagate along these bands (Fig. 7). If stresses cause different than parallel to these bands direction of cracking, then cracking will propagate by “jumping” over from one band to another through “cementite bridges” between them (Fig. 8).

**Fig. 8.** A profile of the fracture in the surface area of damaged neck of the roll No. 3: a) unetched cross-section; b) area from Fig a after etching. Etched with 2% nital

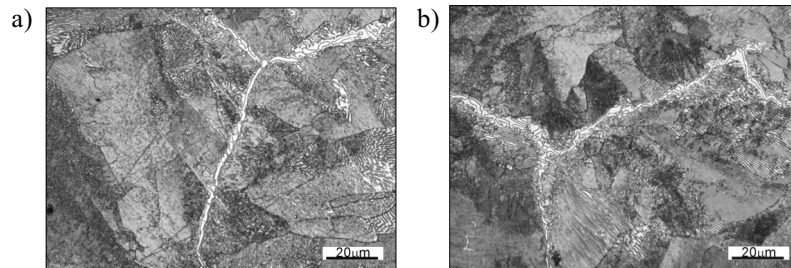
Secondary cementite in mottled cast irons can build itself on the net of transformed ledeburite, but it can also occur as independent component of the structure. Considering crack resistance, the most disadvantageous is precipitation of such cementite along grain boundaries of austenite. In the case of the roll No. 2 secondary cementite precipitated in a form of very thin, continuous net along austenite grain boundaries (Fig. 9).

**Fig. 9.** Continuous net of secondary cementite precipitated along boundaries of former grain of austenite in the structure of the neck of roll No. 2: a) selected area; b) second selected area. Etched with 2% nital

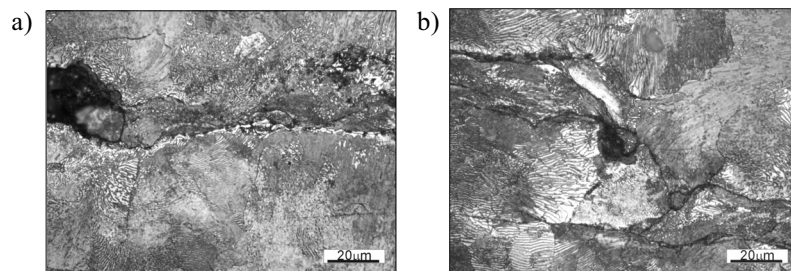
**Fig. 10.** Development of the crack along continuous thin net of secondary cementite (roll No. 2): a) selected area; b) second selected area. Etched with 2% nital

Even so thin net of secondary cementite significantly facilitates propagation of the crack (Fig. 10). This thin net of secondary cementite combined with shrinkage porosity became a reason for damage of the neck of the roll No. 2.

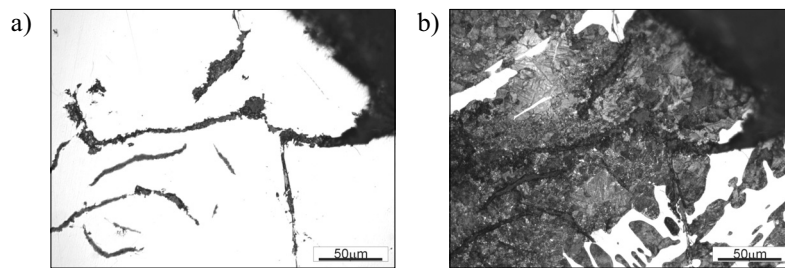
**Fig. 11.** Contribution of flake graphite precipitates in crack development (roll No. 3): a) unetched cross-section; b) area from Fig. a after etching. Etched with 2% nital
