Miloslav Kopecký*, Luboš Hruštinec*, Martin Ondrášik*, Jana Frankovská*

DEFORMATION OF UNSTABLE SLOPE AT THE RESERVOIR DAM NOVÁ BYSTRICA**

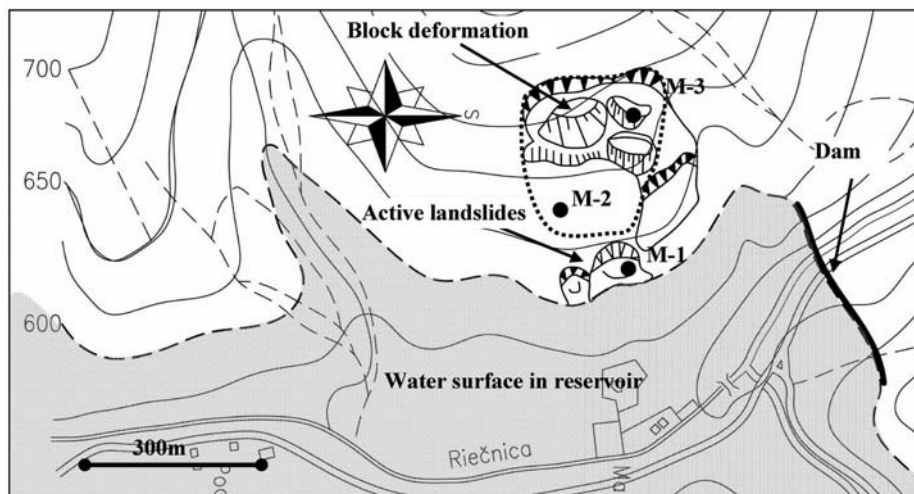
Two slope deformations of varying activity can be allocated on the slope. In the area between the reservoir shoreline and the forest road there are active landslides with overall area about 120×60 m (fig. 2). The landslides were probably caused by improper interference during building of the forest road. Active landslides are bound only to the slope debris containing coarse fragments from 40 to 80% and the shear surfaces were detected by the inclinometric measurements at depths from 3,5 to 5,0 m.

Fig. 2. Scheme of the landslides in the slope located on the dam left-hand side

In the higher part of the slope (in the range of about 630–690 m above sea level) there is a block deformation (fig. 2). Based on initial investigation works [1] its dimensions were predicted to approximately 100×140 m. According to our latest knowledge, this could be up to 220×140 m (dotted line in fig. 2). Block deformation is result of gravitational movement of relatively rigid sandstones over the surface of plastic siltstones, and during the movement from the main slope zone the sandstones were disintegrated to individual blocks. The maximum depth of the shear surfaces was detected by inclinometric measurements at a depth of 34,0 m below the around surface.

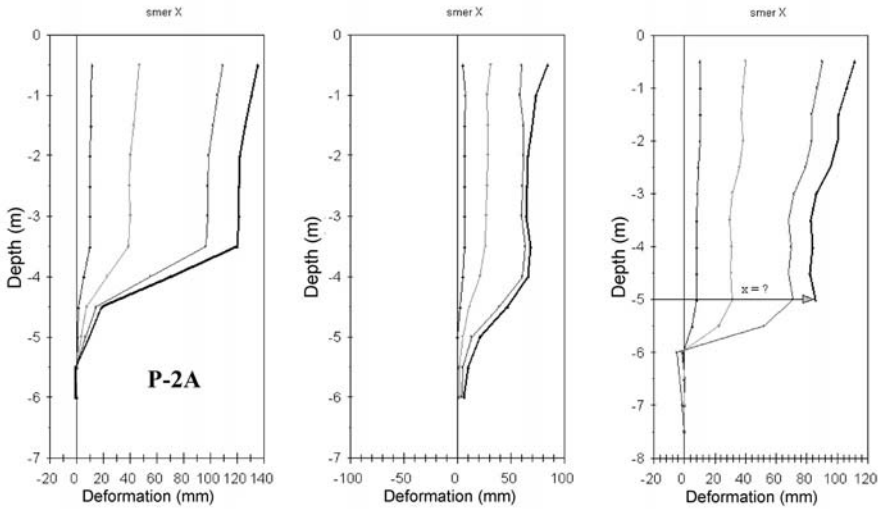
In the landslide area with the forest road it has been confirmed that the activity of the movement still persist. The maximum deformation observed from 1993 to 2006 is 300 mm (sum of deformations from two inclinometers). The movement is probably not a continuous and uniform, it occurs only under extreme climatic conditions (rainfall and snow melting).

Fig. 3. Movements in the inclinometer located in the active landslide on the forest road

The depth of the shear surface of the active landslide on the forest road was found 3.0–5.5 m below the surface (fig. 3).

It is obvious that, if no remediation works will be made on the active landslide area with the forest road [2], in some time there will be an absolute destruction of the slope and sliding of the diluvia sediments to its lower part and partially into the water reservoir. About 55 000 m³ of debris can get into the movement. However we assume, that in this process there is no threat to the inflow waterworks facility remote about 150 m from the accumulation of the active landslides. On the other hand, removal of rock masses from this area can cause acceleration of movements of the block deformation situated above the forest road.

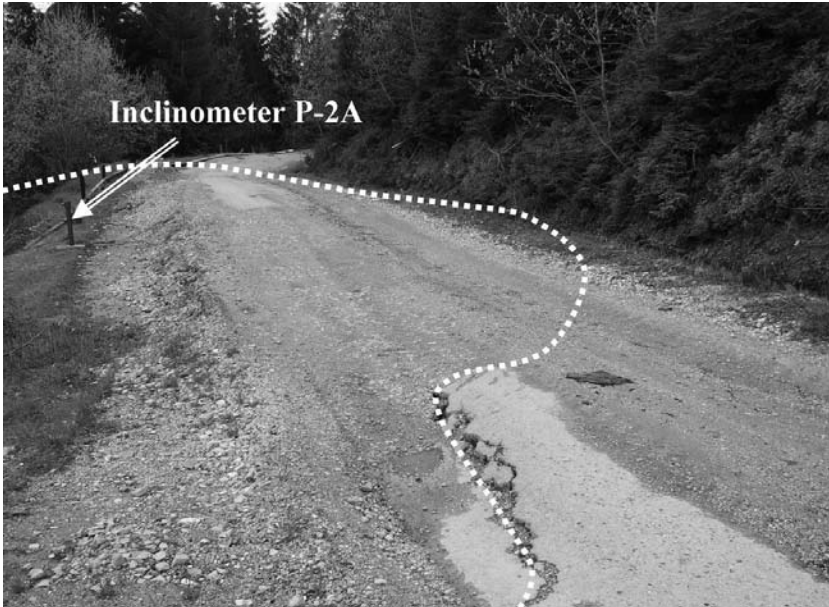
Based on the analysis of the inclinometric measurements in 2 inclinometric boreholes located outside the presumed area of the landslide active in 1993, it was found that since 1999 there was gradual expansion of the landslide and significant distortion of the forest road (fig. 4).

Fig. 4. Main slope area of the active landslide in the body of the forest road

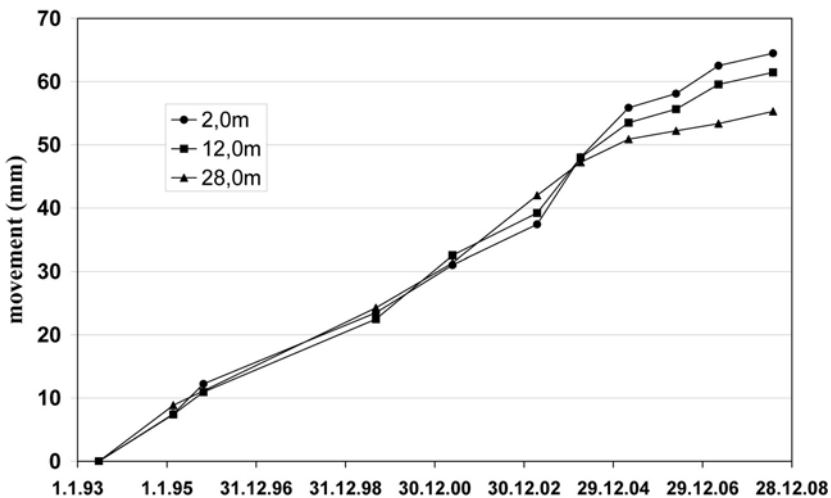
The block deformation, which is situated in the slope above the forest road, there is a gravitational movement of relatively rigid sandstones over the surface of a plastic claystone. Inclino-metric measurements under the main scarp zone of the block deformation (borehole M-3) confirmed the existence of a relatively thick shear zone (about 7 meters), along which there is

Fig. 5. The time course of movements in different depths in the borehole M-3

a movement of the block of sandstone up to 24 meters thick. Total movement of 44 mm for 13 years was detected. However it is important that the movement at a depth of about 28.0 meters is up to now relatively uniform (fig. 5).

If there are demonstrably accelerated movements in the area of the block deformation, it will be necessary to proceed to remedial or other measures, because at certain acceleration
