Miloslav Kopecký*, Martin Ondrášik*, Darina Antolová*

UNSTABLE SLOPES ON RIGHT-SIDE END OF THE DAM BODY OF LIPTOVSKÁ MARA WATER RESERVOIR**

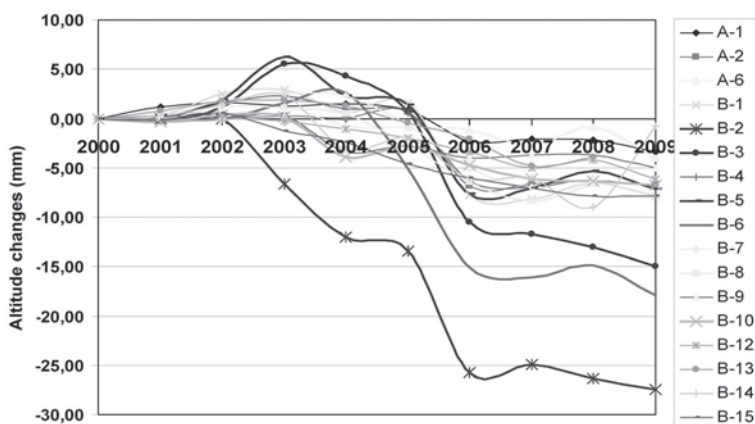
In late March 2006, the abrupt warming and rapid melting of very thick snow cover led to infiltration of water from the melted snow and to increase of groundwater levels in the sliding slope to maximum ever observed during the entire observation period. These high groundwater levels were synchronously with changes of elevation of the survey points. A significant decrease was recorded on points from B-1 to B-6, which are located in the head of the landslide area (from 6.9 to 12.2 mm — 9.8 mm in average! Fig. 3), and what indirectly points to a partial activation of the landslide area.

Fig. 3. Cumulative curves of altitude changes (mm) of fixed observation points during years 2000–2009

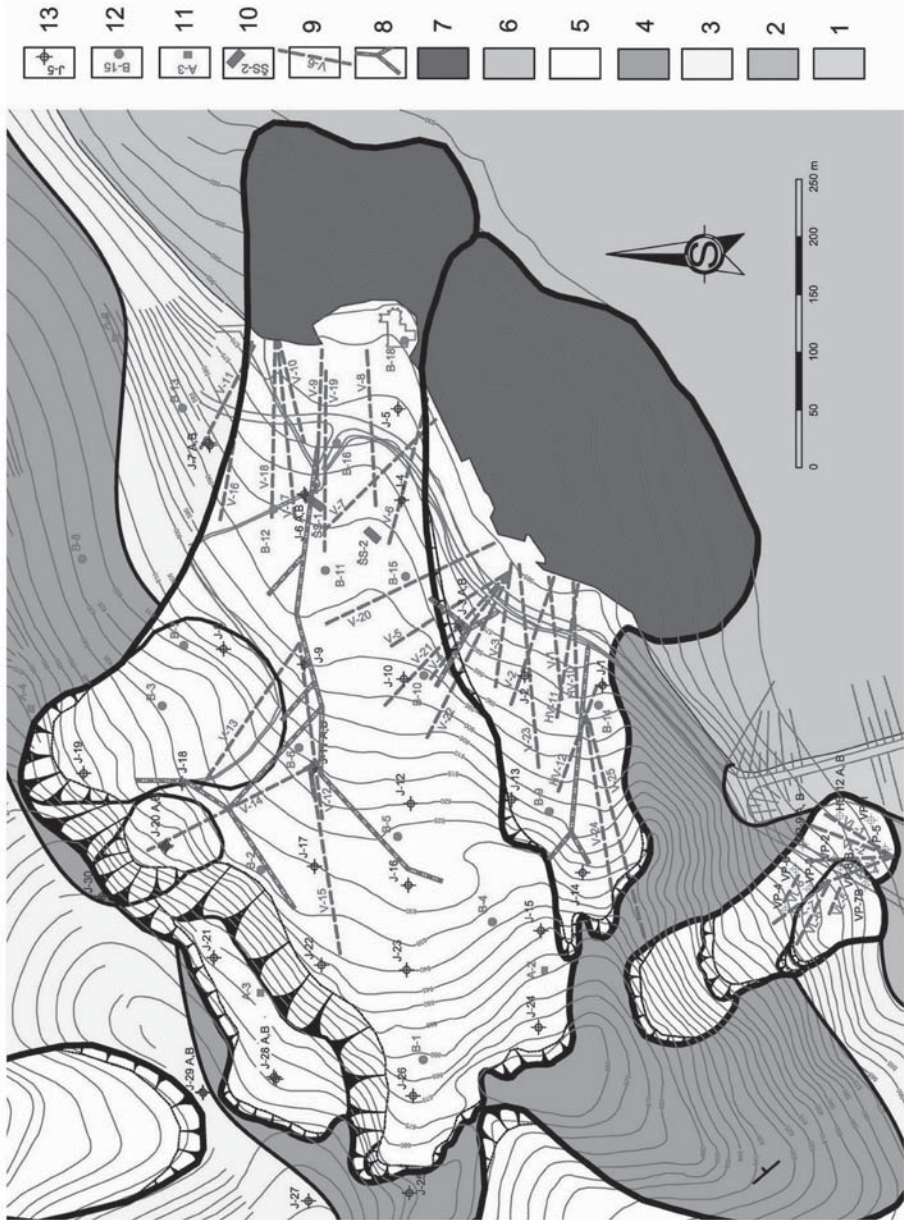
Fig. 4. Scheme of existing monitoring points and remediation measures on Vel'komarský and Malý Vlačianský landslides [2]

The monitoring network (fig. 4) of both landslides was built 35 years ago. On the Veľkomarský landslide in 1974–1975 there were built sites for observation of ground water levels (observation wells — 30 pcs). As remedial measures also 28 horizontal drainage wells with the total length of 3 800 m were built in 4 stages.

On Malý Vlačianský landslide the groundwater level is monitored in 13 observation wells and discharge rate in 8 HDW with frequency once per 7 days. Geodetic points are not built on this landslide. After 35 years of operation the monitoring elements are in different condition. Since installation several observation wells have been destroyed or become dysfunctional in terms of clogging by fine slurry in the bottom of the well.

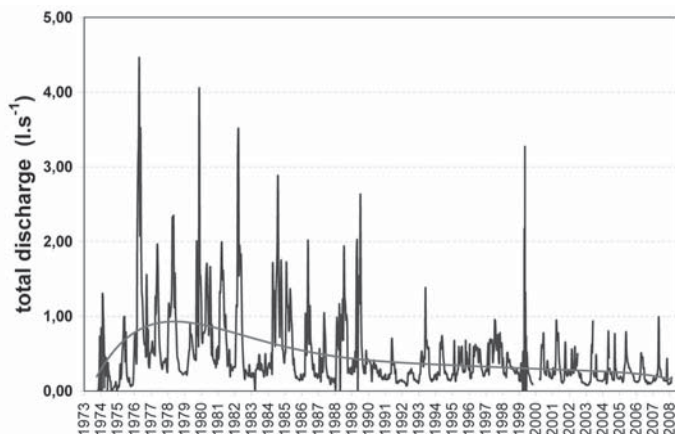
With regard to long term monitoring of the HDW discharge, it is possible to observe decrease of the total volume of the water being removed from the landslide (fig. 5).

Fig. 5. Downward trend of the total discharge from all HDW on Veľkomarský landslide

However, this overall groundwater level decline does not have to play a role in reducing of local slope stability, unless due to decrease in water discharge from HDW the groundwater level is not increased in the nearby observation wells. The negative impact of the discharge decline in HDW from V–12 to V–15 located in the landslide head area is quite obvious. In this area, in observation wells J–16, J–17 (fig. 6), J–18, J–11B, J–11A the groundwater level is increasing for long time period, in the case of J–11A the groundwater freely flows out the well as

b)	piezometer — reconstruction of approximately 11 pcs — 265 m	Reconstruction of the broken wells
	c)	horizontal drainage wells — about 2000 m	Cleaning those HDW which show long-term decline in discharge rate and those in which there is a rise of GWL (fig. 5) In the case of inefficient cleaning new HDW will be necessary to build.

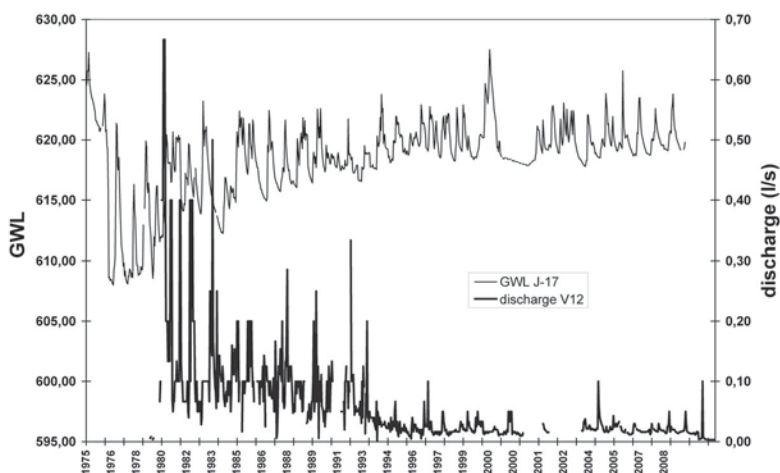
Fig. 6. Decrease of effectiveness of HDW V-12 and gradual increase of GWL in borehole J-17
