*Wojciech Anigacz **, *Krzysztof Drożdżol **, *Elżbieta Kokocińska-Pakiet **

EXAMINATION OF AN EARTH SLOPE SETTLEMENT

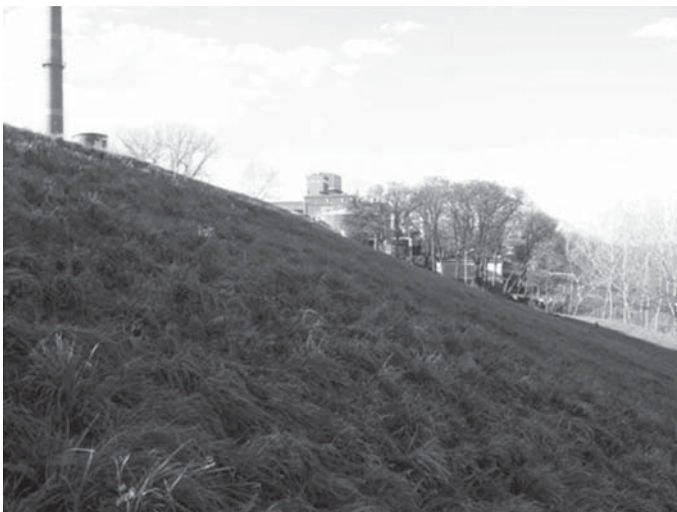
Fig. 1. Present view of the embankment dam [5]

On the basis of tests carried out on the soil embankment dam held in the period of 1997–2011, it has been stated that the present condition of the soil embankment dam of the bleaching soil settlement tanks is good and that it does not threaten any possible instability.

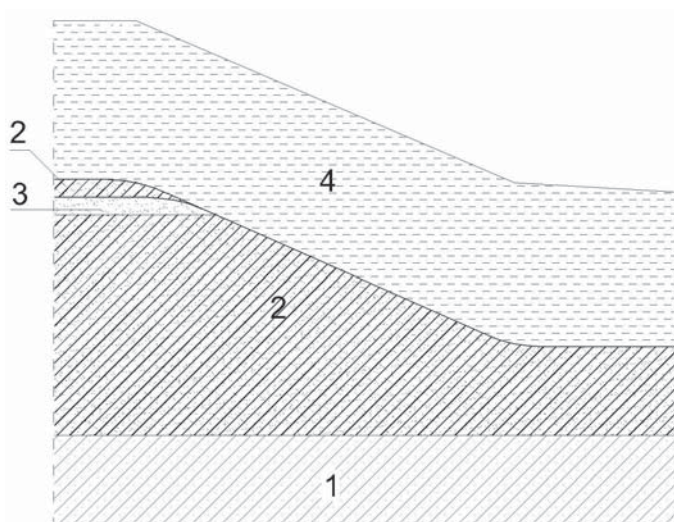
Fig. 2. Geological cross section of the embankment dam: 1 — clay, 2 — sandy loam, 3 — medium sand, 4 — embankment of loamy sand [5]

The main body of the structure was build on the existing base which had not been undermined by Odra river waters. The embankment footing is formed of silt existing at a depth of about 14 m below the embankment base. Above it there is a layer of sandy clay, of a thickness ranging from 5 m below the embankment base to 14m below the soil surcharge. In this part of the soil surcharge there is also an interbedding of medium sand, approximately 2 m thick, at the depth of 10 m below the surface of the top of the embankment. The top layer of the slope is made of a fill of clayey sand. The geological cross section of this has been shown in figure 2 [3, 4]. The layout and the shape of the slope on site has been shown in figure 3 [1].

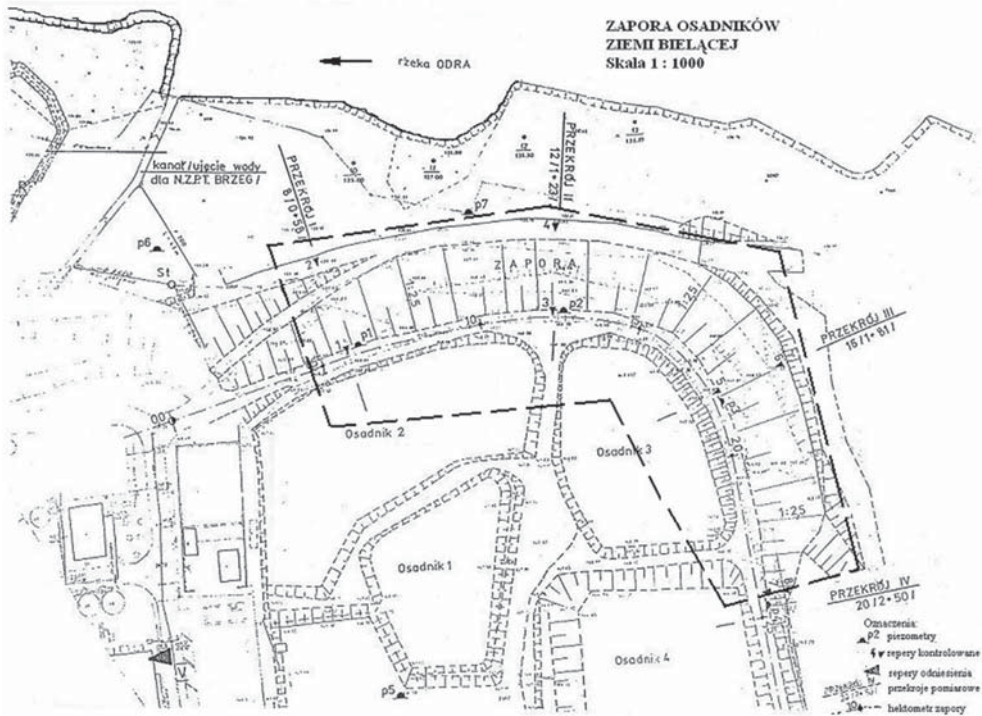
Fig. 3. Location of the embankment dam on site [2]

In the course of long-term observations, the second section appeared to be the most susceptible to settlement and local landslips. During the course of the examination additional measurement points were installed in this section.

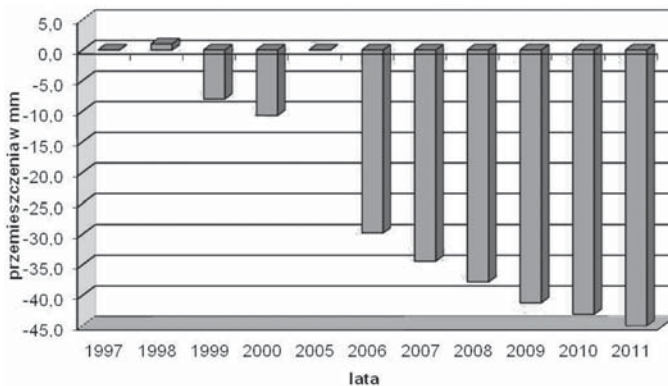
Figure 5 presents the settlement of the no 9 bench mark located on the slope, in section II, about 1.5 m below the soil surcharge of the embankment. This bench mark is settling in a steady way, and its total settlement amounts at 45 mm within 15 years. It is located in a place where a local landslip was observed. The behaviour of the bench mark indicates that this landslip has stabilised. In relation to the settlement of the neighbouring marks, this one does not show any increased vertical dislocation.

Fig. 5. The settlements of benchmark no. 9 in the period of 1997–2011
