Aleksandra Borecka *

DESCRIPTION AND EVALUATION OF THE LANDSLIDE HAZARD. A CASE STUDY IN A LANDSLIDE IN RADZISZOW

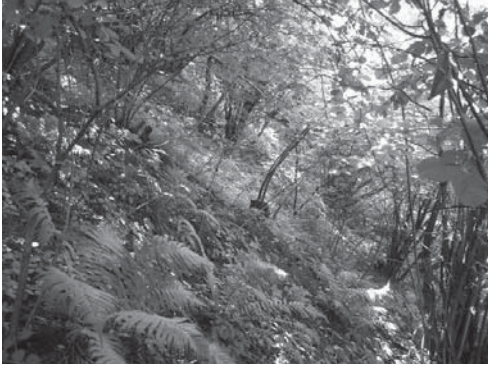
The landslide in Radziszow is a large and complex landslip, which occupies the whole length of the slope from its ridge to foot. It is localized on the western and north-western slope of the hill and it is almost 100ha in area. Its starting point is a distinct main scarp, which is about 8 m high and inclined at an angle of 45°, (Fig. 2). Downwards, the scarp is distinguished with recurrent slopes, namely, Wyczyszczek, but it is difficult to localize due to thick flora, such as, trees, bushes. There is a landslide ditch, below the scarp, which is filled with water (Fig. 3), originating from the main scarp's water seepages and precipitation. The inter-landslide relief is diversified (Fig. 4). There are numerous humps, step-like and flattening forms, and hollows, which are sometimes filled with water (marshes, bog spring) (Fig. 5). Their biggest centre was observed in the northern part.

Fig. 2. The main scarp of the landslide.
(Photo by A. Borecka)

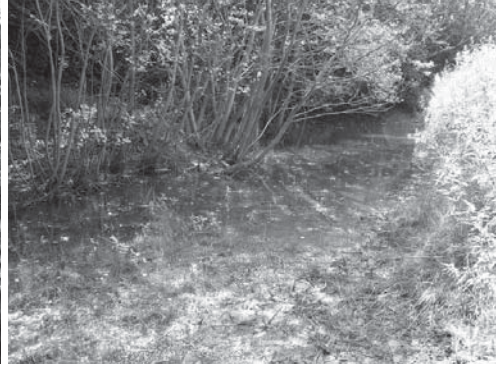
Fig. 3. The landslide ditch filled with water below the main scarp of the landslide.
(Photo by A. Borecka)

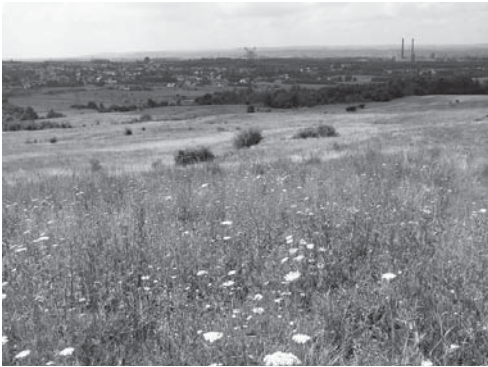
Fig. 4. A view over the central part of the landslide with characteristic undulating surface, such as, step-like forms, hollows.
(Photo by A. Borecka)

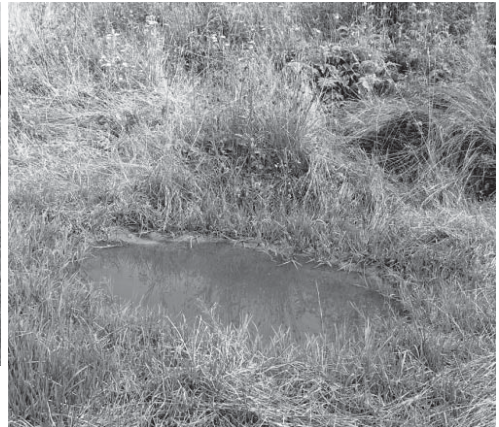
Fig. 5. Bog springs in the area of the landslide.
(Photo by A. Borecka)

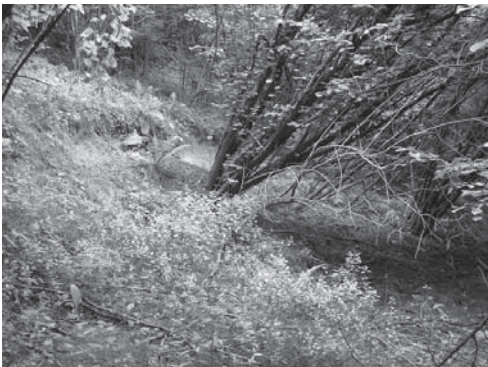
Fig. 6. Fresh detachment faults and tree movements in the crown zone in its northern part.
(Photo by A. Borecka)

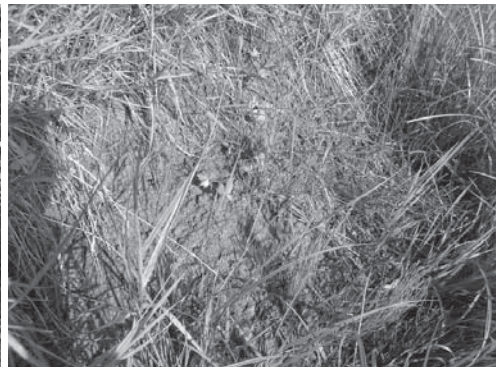
Fig. 7. Water seeps from the crown of the landslide in its western part near Skawinska street.
(Photo by A. Borecka)

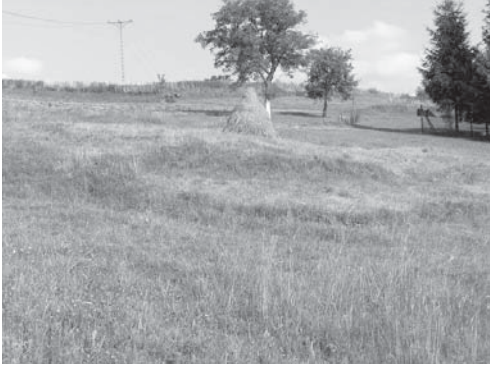
Fig. 8. The crown of the landslide and its deformation and soil ripples, with characteristic steps, hollows and interstices, which are the result of the colluvial masses movement in the western part of the landslide near Skawinska street.
(Photo by A. Borecka)

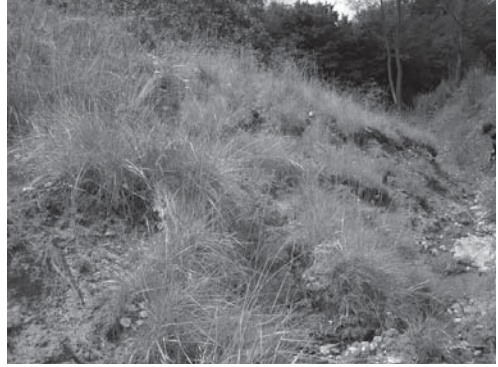
Fig. 9. The crown of the landslide with fresh detachment faults in its northern part, near Lutowka water-course, which shows that there is a very dynamic slip of colluvial masses in the area. There are visible water seepages from the crown of the landslide. (Photo by A. Borecka)

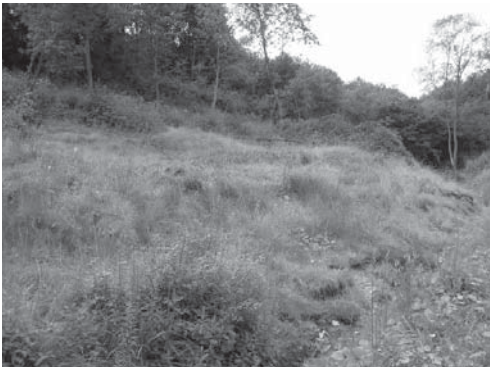
Fig. 10. The crown of the landslide with fresh detachment faults in its northern part, near Lutowka water-course. Fallen trees prove that there is a very dynamic slip of colluvial masses in the area. (Photo by A. Borecka)

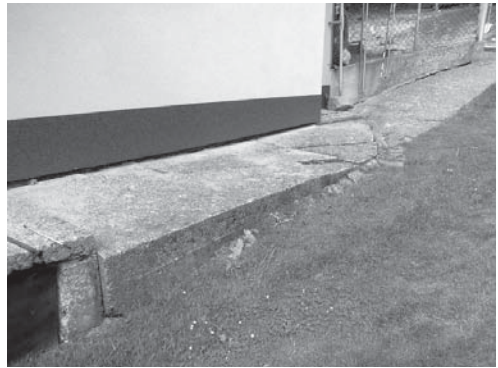
Fig. 11. Cracked concrete pavement near a utility building, Skawinska street, which is a consequence of the landslide's crown pressing forward.
(Photo by A. Borecka)

buildings are located (Kamienna street and the slope below and Pod Gora street in its upper part). There is current observation of the cracks on the buildings and its foundations, cracked concrete pavements surrounding the buildings, damaged property fencing and tilted pylons with taut wires (Fig. 11–15). It shows the effect of the long-term activity of the landslide, chiefly, a creep.

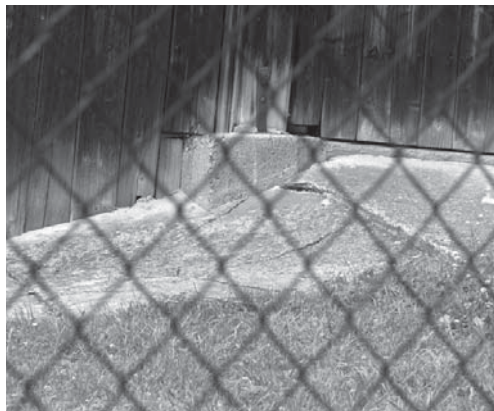
Fig. 12. Cracked concrete pavement near a utility building, Kamienna street, which is a consequence of the colluvial masses movement. (Photo by A. Borecka)

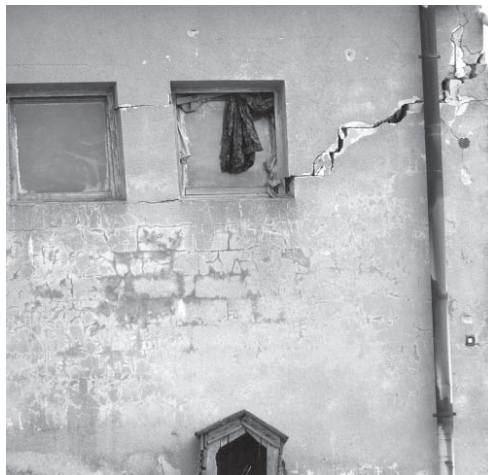
Fig. 13. Cracked walls a utility building, Kamienna street, which is a consequence of the colluvial masses movement. (Photo by A. Borecka)

It should also be pointed out that there is a considerable hazard of damage to buildings in the active zone of the landslide during successive landslide movements. In the case of their occurrence, which will result in cracks and damage to the buildings, it will be necessary to relocate the inhabitants and move all the transmission poles away from the active zone of the landslide.

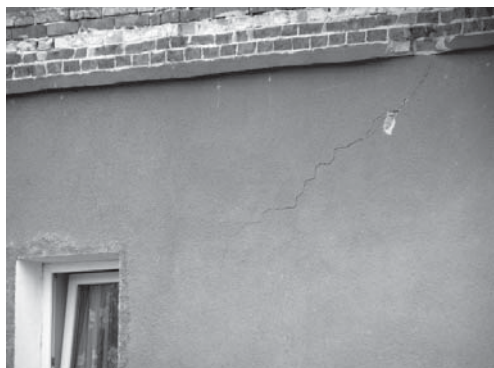
Fig. 14. Cracked walls a single-family building, Kamienna street, which is a consequence of the colluvial masses movement. (Photo by A. Borecka)

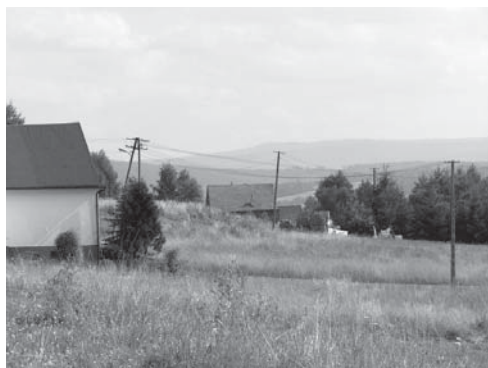
Fig. 15. Tilted pylons near Kamienna street, which is a consequence of the colluvial masses movement. (Photo by A. Borecka)
