Jerzy LISTEWNIK, Antoni WIEWIÓRA
Maritime University, Szczecin

CONSIDERATIONS ON LIMITING THE ELEMENTS OF HUMAN FACTOR INFLUENCE ON BREAKDOWNS OF SHIP'S MACHINERY ILLUSTRATED BY SOME CASE STUDIES

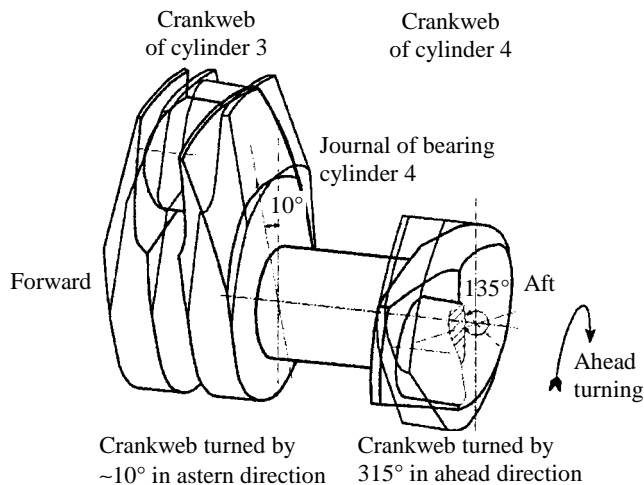
A container ship built in 1995 of 2480 TEU capacity and a MAN-B&W 6S70MC main engine of 16860 kW, 91 rpm suffered a very serious main engine crankshaft breakdown two crankwebs on cylinders No. 3 & 4 have slipped. The crankweb on cylinder No. 3 had been turned by 10° in the astern direction and cylinder No. 4 crankweb was shifted by 315° in the ahead direction: see Fig. 3. The following sequence of events took place: Automatic ME safety system triggered an engine slow down due to "Piston Cooling Flow on cylinder No. 3" announcement. The engine was stopped manually by the engineer on watch. The ship was in ballast condition. Stormy weather caused the ship to roll up to 45° on both sides.

Fig. 3. Detailed picture of damage to crankwebs cylinders No. 3 and 4

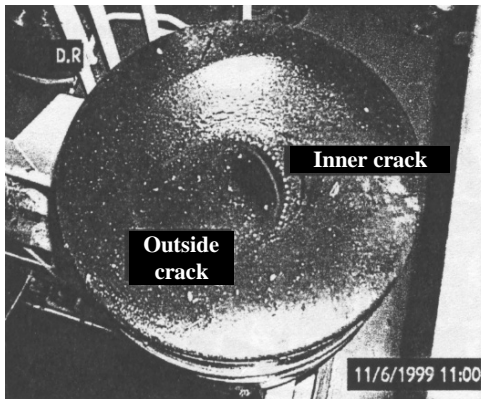
The engineers checked the piston cooling oil flow and found o.k. The drain pipe from the underpiston space of cylinder No. 3 was checked and no flow was present – o.k. (but later it was stated that the drain pipe was clogged). After 5 minutes of M.E. stoppage, the engine was started again in ahead rotation. Immediately after that an enormous thump was heard (like an internal explosion), and the engine was brought to a stop. Cause stated: hydraulic impact in combustion chamber of cylinder No. 3, which was caused by the slippage of crankwebs cylinder No. 3 and cylinder No. 4. During later inspection, it was discovered that the piston crown of cylinder No. 3 had two cracks (an inner crack and an outer). During the 5 min engine stoppage, the cooling oil seeped through into the combustion chamber of cylinder 3 (see Fig. 4).

Damage
Cracks in piston crown

Cause:

- Hydraulic thump in combustion chamber of cyl. No. 3
- Slippage of crankwebs on cyl. 3 & 4

Fig. 4. Damage details on piston crown of cylinder No. 3

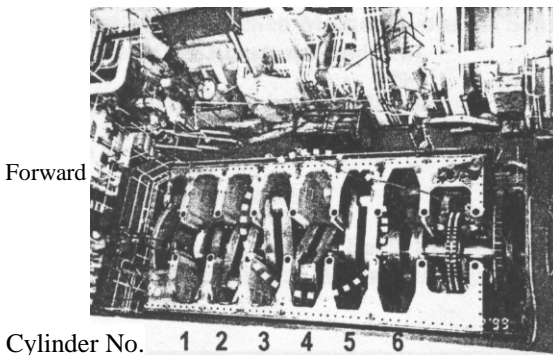
The final picture of the damage (see Fig. 5), crankwebs of cylinders 1, 2, 3 turned by about 35° in relation to crankwebs of cylinders 4, 5, 6. The aft crankweb of cylinder 3 and forward crankweb of cylinder 4 have shifted outwards by about 2 mm. Undertaken temporary repair to bring the ship from Azoren area to Hamburg; piston of cylinder No. 3 pulled out. Cylinders 1 and 2 cut off. Permanent repair: first, it was intended to bring back the slipped crankwebs into original position, but this was given up, due to the excessive turning of the crankwebs; second, a proposal was made to build in new crankwebs, but this turned out to be too expensive compared to fitting a new crankshaft.

Damage Picture

- Crankwebs of cyl. 1, 2, 3 turned by about 35° relative to crankwebs 4, 5, 6

- Aft crankweb of cyl. 3 and forward crankweb of cyl. 4 projecting about 2 mm outwards

Fig. 5. Picture of turned crankwebs seen from top of the engine bedplate

The question arises: Could this damage have been avoided? The straightforward answer is "yes". It could be avoided if routine procedures were observed. It means that the turning gear was clutched in, and the engine rotated

with open indicator cocks to observe eventual emission from the indicator cocks. If this procedure would have been carried out, the engineers could have noticed the oil being ejected from cylinder No. 3, but this was not done. The normal procedure had been violated with fatal results. The only excuse for the engineers' action can be the state in which the ship was sailing (heavy rolling) and the clogged drainpipe from the underpiston space of cylinder 3; however, if this drain valve has been regularly opened, it would not have been chocked. Again, there was some negligence on the engine crew side.
