## NON-DESTRUCTIVE DIAGNOSTICS OF CONCRETE CANTILEVER BEAM AND SLAB BY IMPACT ECHO METHOD

Magdalena RUCKA<sup>1</sup>, Krzysztof WILDE<sup>1,2</sup>

<sup>1</sup> Department of Structural Mechanics and Bridge Structures, Faculty of Civil and Environmental Engineering, Gdansk University of Technology

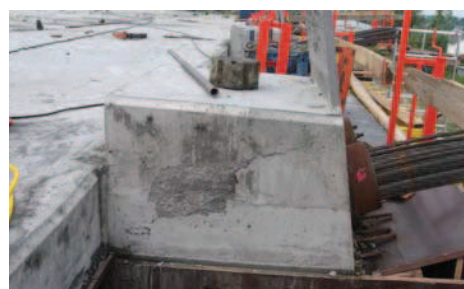
The object of the study is the road bridge (Fig. 2) in Nowy Dwór Gdański over the road no. 7 Gdańsk-Warsaw. During construction process the cantilevers of transverse beams were prestressed according to the plan (this state is referred here as 'state 0'). After prestressing process, cracks and cavities appeared on the cantilever surfaces (Fig. 3). Therefore repair operation was undertaken in the form of additional reinforcement and new gunite parts, but the cracks were not injected before gunite process. The aim of performed diagnostics was assessment of technical condition of cantilevers after repair (this state is referred here as 'state 1'). The impact-echo method was applied to non-destructive testing of the considered structure.

Fig. 3. Damaged cantilever no. 4 after prestressing

In order to improve reliability and safety of the bridge, the injection of the epoxy resin was preformed. Both cantilevers were injected with about 5 liters of epoxy resin, and then ultrasonic testing was repeated. After injection the values of wave speeds considerably increased and the distribution of wave speeds became regular (Fig. 7b). In the cantilever no. 4 wave speeds hold in the range of 88% to 110% of the average values.

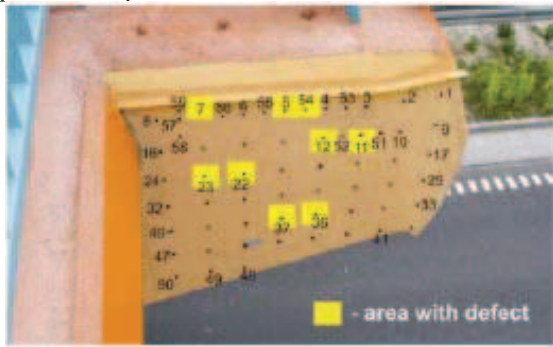
Fig. 5. Measurement points for cantilever no. 4 with marked damaged areas

As results, a map of distribution of wave speeds in 59 measurement points was plotted in Fig. 7a for the cantilever no. 4 at 'state 1'. The average value of P-wave speed in cantilever no. 4 was 4352 m/s. There are several points in which wave speeds are significantly smaller than average value. Points in which wave speed was smaller than 90% of average values were indicated as damaged areas (points 5, 7, 11, 12, 22, 23, 36, 37, 54). They are marked in Fig. 5 and they cover with localization of cracks observed at 'state 0' (c.f. Fig. 3).

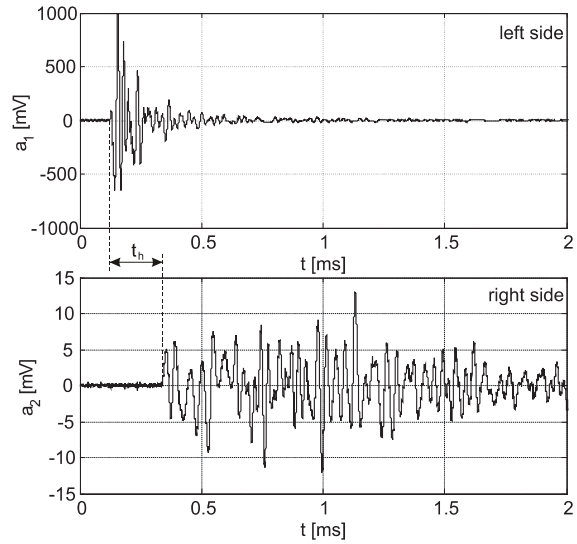
Fig. 6 shows signals registered in point no. 6 for the cantilever no. 3. The  $a_1$  signal is the acceleration measured on the left side of the cantilever, while the  $a_2$  is the acceleration measured on the right side, after passing through the structure. The time-of-flight  $t_h$  was 217.8  $\mu$ s what enabled to calculate velocity of the P-wave as 4527.09 m/s. This procedure was repeated in all selected points.

Fig. 6. Acceleration signals measured in point no. 6 for the cantilever no. 3

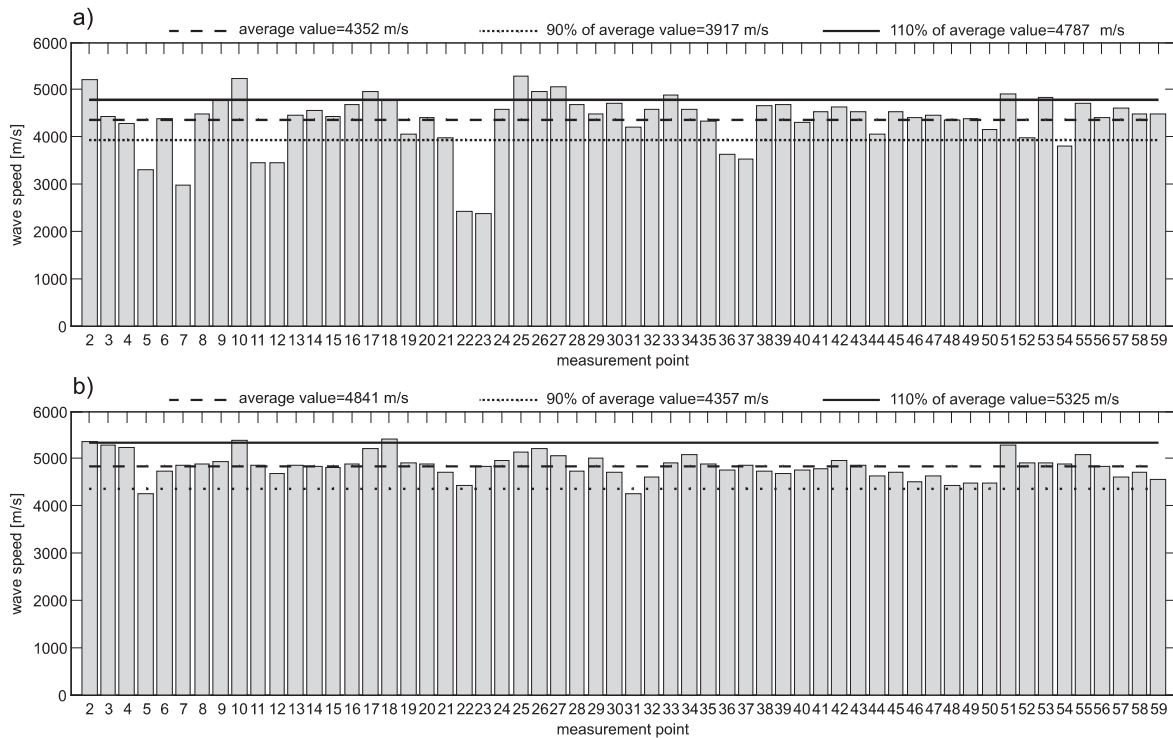
Fig. 7. Distribution of wave speeds in measurement points: a) cantilever at 'state 1'; b) cantilever after injection ('state 2')

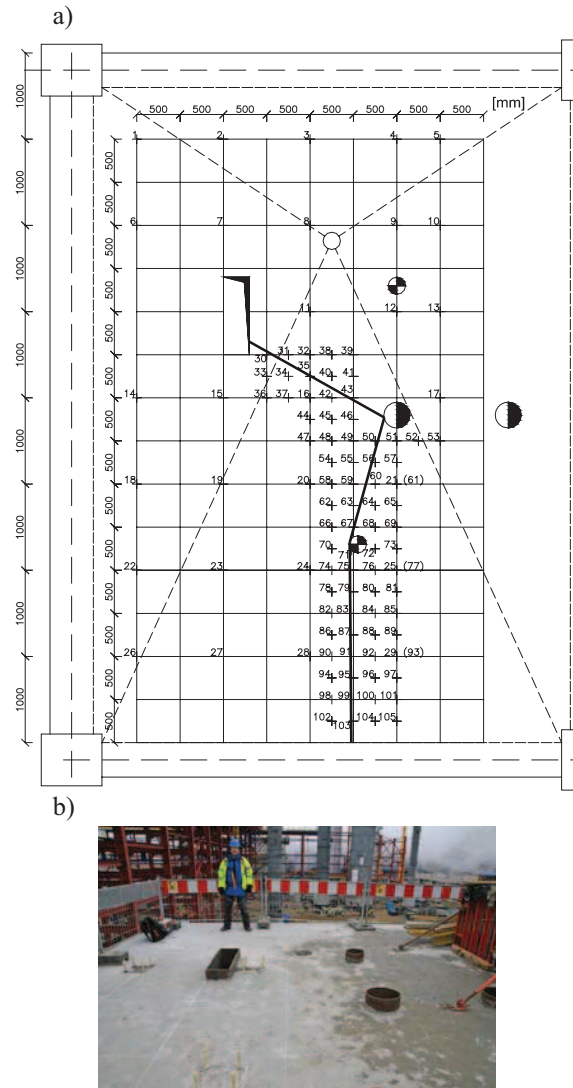
The object of the research was the concrete floor slab (Fig. 8). Due to disturbances in concrete delivery during the slab casting, the homogeneity of the concrete became in question. The non-destructive test was performed with the use of the impact-echo method to determine presence of discontinuities.

The geometry of the slab is shown in Fig. 8a. The number of measurement points was 105. They were distributed along the line of potential discontinuity, depicted as thick solid line in Fig. 8a. The hardware equipment was the same, as in the case of bridge measurements (c.f. Section 3.2). In this experiment, one-side measurement was performed, i.e. both mechanical impact and acceleration measurements were realized on the upper side of the slab only. The slab height, varied from 17 to 19 cm, was calculated in the measurement points based in known slab slopes.

Fig. 8. Concrete floor slab: a) geometry and measurement points; b) the photo

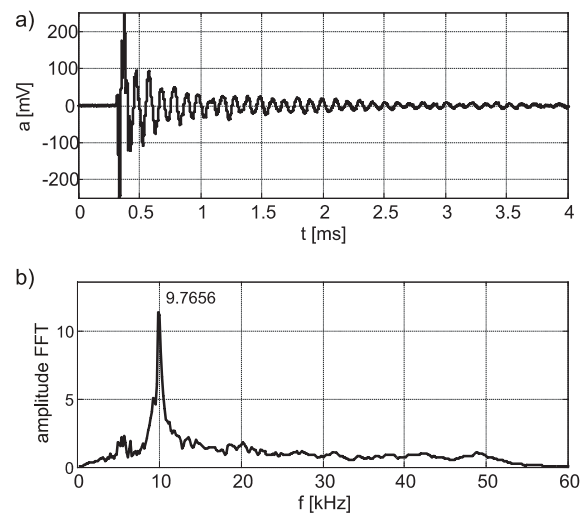
Data analysis was carried out in frequency domain by interpretation of spectra obtained from time domain signals. Fig. 9 shows example of signal registered in point no. 98. In the frequency domain, one distinct peak dominates of frequency 9.77 kHz, what is equivalent of the thickness frequency  $f_h$ . By knowing frequency and the slab height P-wave speed can be determined from Eq. (1). Distribution of wave speeds were relatively regular with all measured point and the average value was 4100 m/s.

Fig. 9. Acceleration signals measured in point 98: a) in time domain; b) in frequency domain

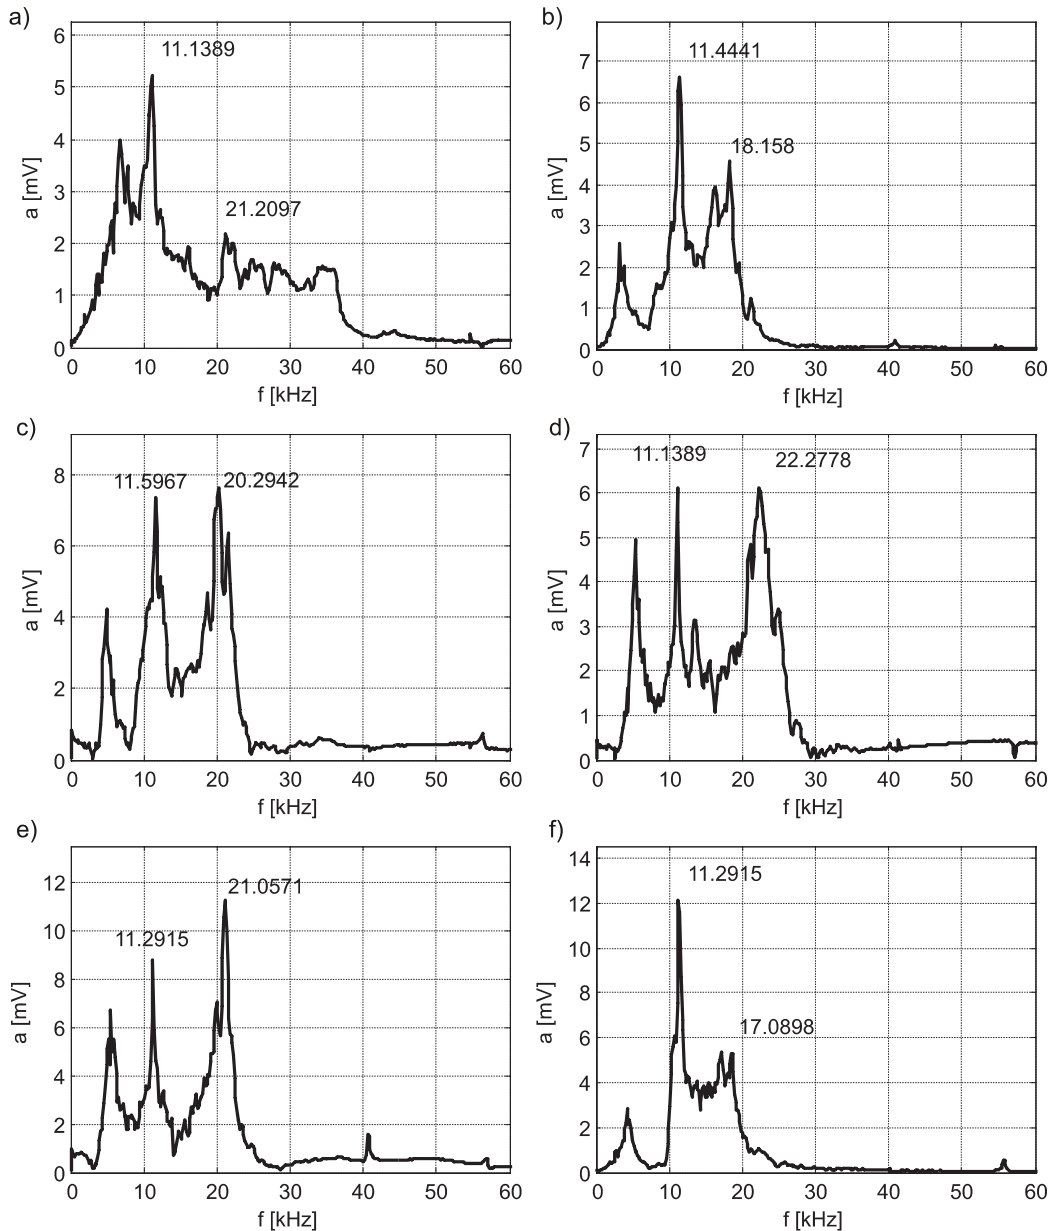
Fig. 10. Spectrums of signals measured at selected points: a) point 30; b) point 31; c) point 32; d) point 33; e) point 34; f) point 35

Spectral responses in majority points were similar to the spectrum shown in Fig. 9b. However, in points no. 30 to 35 additional peak appeared in the signal transformed to the frequency domain. Fig. 10 shows spectra for points 30 to 35. For all these points, additional peaks appeared of frequency 17.0898 kHz to 22.2779 kHz. The presence of higher frequencies indicates reflection of wave from internal defect at depth about 10 cm (from 8.96 cm to 11.84 cm). Points 30 to 35 were situated in the neighbourhood of the line of potential discontinuity.
